A CASE STUDY: RESTORATION OF HISTORICAL MUSEUM IN SARAJEVO (1963) – A MODERNIST RUIN

AMIR CAUŠEVIĆ, AIDA IDRIZBEGOVIĆ-ZGONIĆ, NERMAN RUSTEMPAŠIĆ &
LEJLA KAHROVIĆ HANDŽIĆ

Faculty of Architecture, University of Sarajevo, Bosnia and Herzegovina

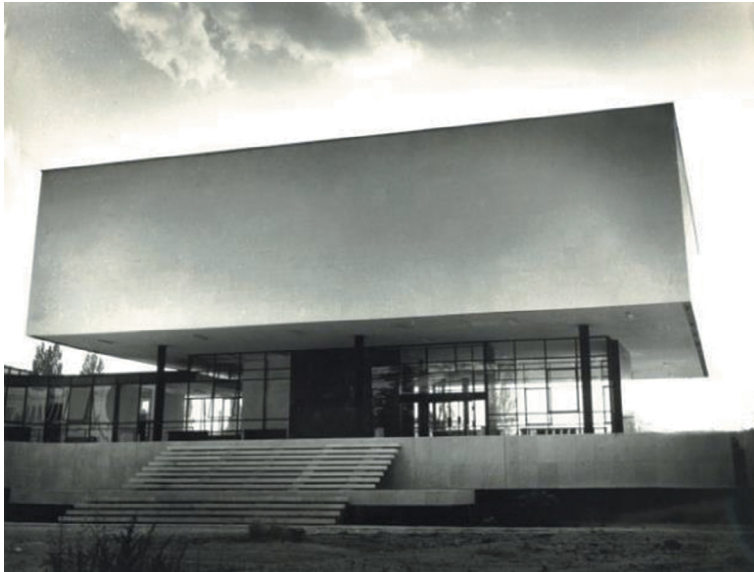
Figure 1: White stone cladding and glass façade, ‘modernist ruin’.

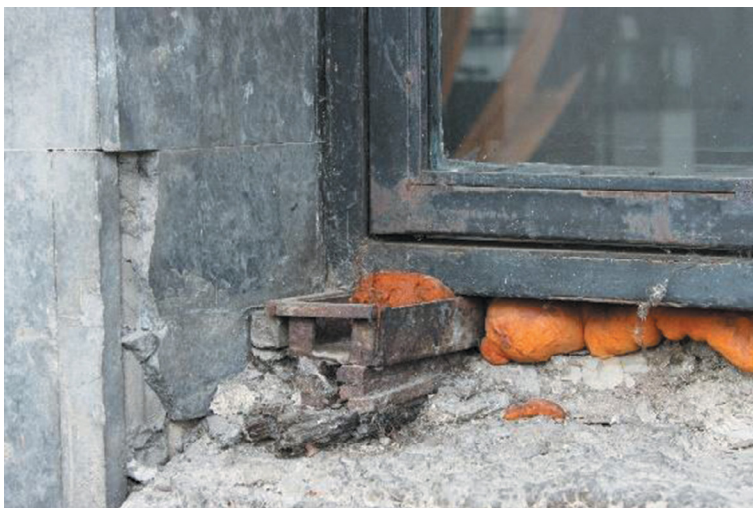
Through a detailed architectural survey and drawings, current state of the building has been recorded and analysed. In general, one can state that the outer shell – surfaces of roofs, façades and pavement – is in a state of disrepair and even crumbling. It is possible to state that 50% of stone cladding is damaged or missing and that ground floor's transparent glass and iron façade has severe corrosion throughout all segments and some are nearly collapsing (Fig. 2).

Figure 2: Ground floor openings that show improvised repairs.

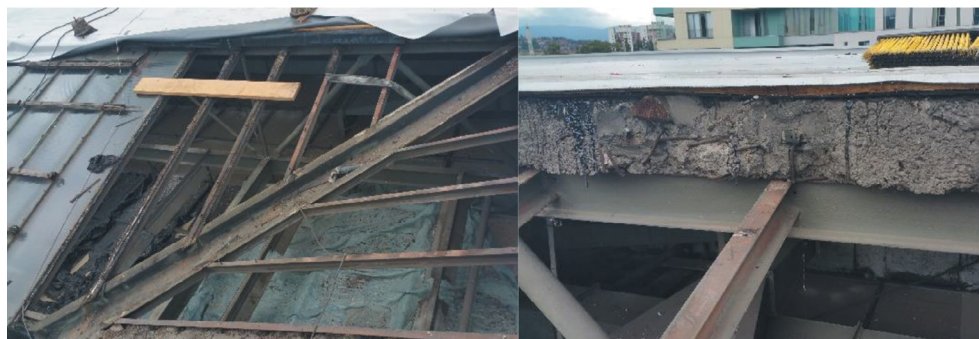
At 19 July 2016, works on the roof have started. After booting the cover strips and existing reinforced glass on the south-western parts of the roof we discovered bays. Supervisors noted that the sheet metal and insulation under glass are in a degraded state and therefore unusable.

The discovered bay also showed unacceptable damage to the reinforced concrete beams that support steel sections, which do not meet current standards for this type of structure. These existing concrete structures have significantly reduced cross section with a visible structure, forks that are not closed and concrete largely separated from the beams. It is necessary to replace the collapsed concrete.

The damage in reinforced concrete structures caused by external loads manifest cracks in concrete (vertical and inclined cracks) and separation of the protective layer of concrete reinforcement. These cracks still do not represent a sign of unsatisfactory capacity of the structure. Cracks in this case allow access to reinforcement, and the aggressive actions of environment further cause a change in the structure of the steel reinforcement. The reinforcement that is corroded with reduced cross section does not meet the required capacity and on the surface of the concrete causes peeling (Fig. 6).

Figure 6: Degraded state of sheet metal and insulation under glass.

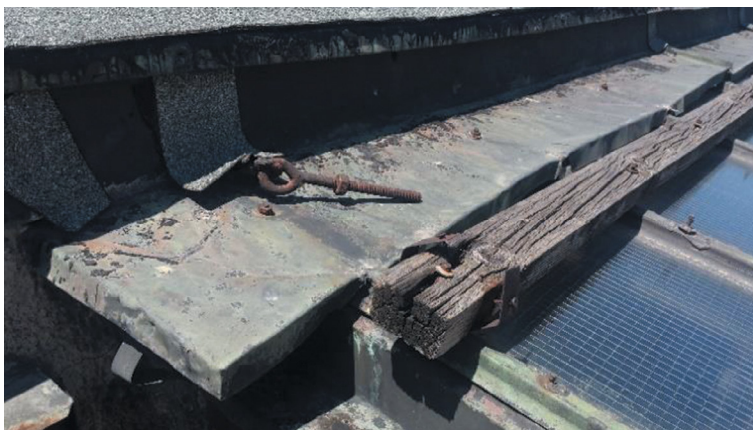
During works on the roof the remaining parts of ties were discovered. There were three ties in both directions that facilitated the lower parts of the construction which is cantilevered left outside the main cube. Today there are only anchored parts, the ties are missing and investor should find the way to finance its construction (Fig. 7).

Figure 7: Remaining anchored parts.

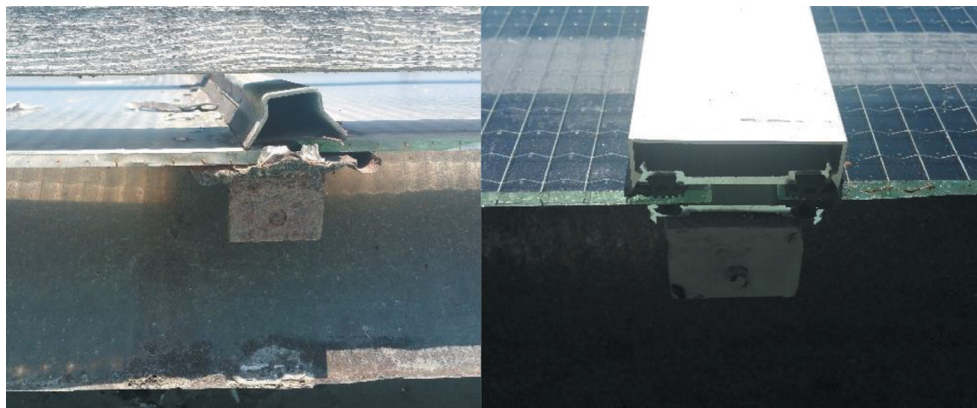
Figure 8: Connection between reinforced glass (old and new ones).

About 70% of existing undamaged reinforced glass is thoroughly cleaned and reused. Appropriate procedures for the reinforcement of the structure are needed. We suggest using some of these methods: rehabilitation of beams by using additional steel stirrups, reinforcing beams by increasing the cross section and reinforcement, reinforcement beams connecting the existing and additional reinforcement, the use of steel sections glued with epoxy adhesive for concrete section or reinforcing section with carbon strip (Fig. 8).

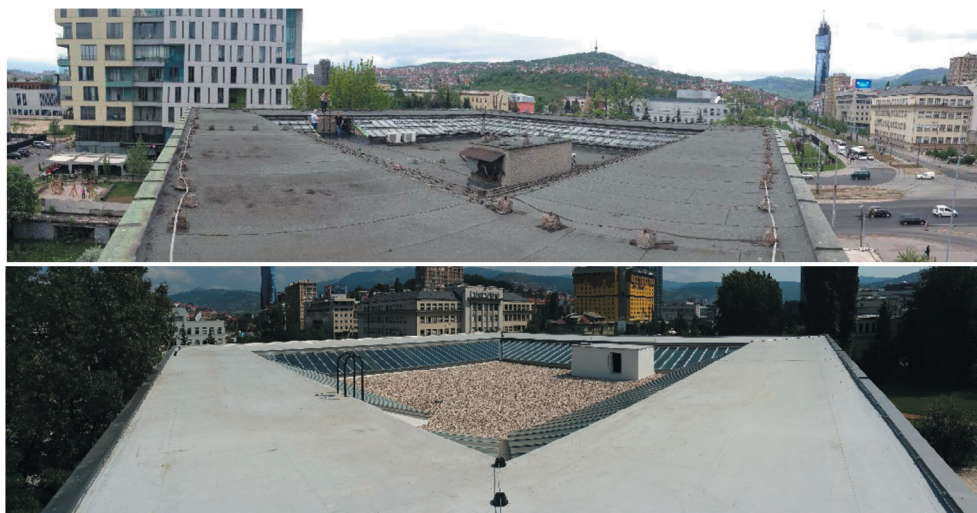
All roof surfaces have major leaking problems that were partially addressed during the last 10 years, but there was never a comprehensive restoration of the entire or large portions of the roof. Flat parts of the roofs are damaged and they consist of layers, thermal insulation, water drainage pipes and surface inclines that are inadequate.

Figure 9: Condition of the roof (before and after).
