Visual screening for a potential evaluation of seismic vulnerability of historical building: Palace of the Dey (Citadel of Algiers)

A. Abdessemed-Foufa

Department of Architecture, Blida University, Algeria

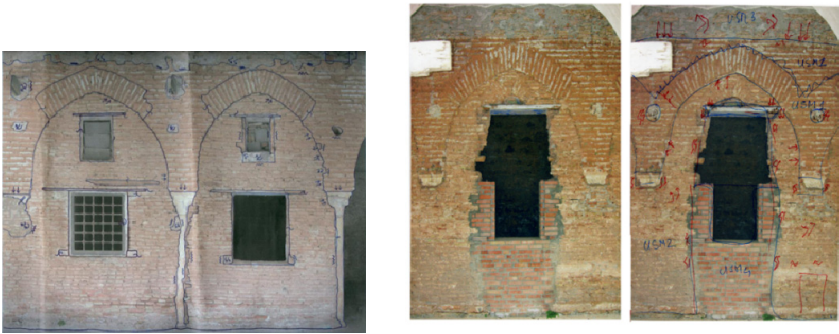
Figure 5: (a) and (b) south-eastern frontage with various layers and interfaces (Abdessemed-Foufa [7]).

While the south-eastern face underwent many phases of construction. On the part of this patio's frontage (gallery wall), negative interfaces due to the demolitions and positive interfaces due to the rebuilding of these same negative interfaces are visible. The architectural layers for this wall are laid out in various directions. Thus appears according to this following stratigraphic study that the interior line of arcades was built. This would tend to conclude that this part of the ground floor was like its opposite frontage. In such way there were initially two galleries on both sides (Figure 6).

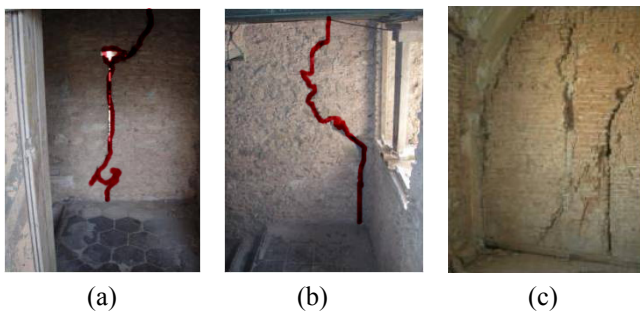
Cracks exist in walls of both spaces. Vertical cracks have developed across the bricks masonry walls extending to all their depth and can also be recognized in the exterior. The cracks in the music room are due to the ageing of materials, to the highest compression of cupola, the excessive loads and effects of the historical and recent earthquakes. In the stairwell the orthogonal walls are not connected that induced the vertical cracks which are due to the heightening of the floors which were constructed without taking account of any state of art to build (absence of chaining) (Figure 10).

Figure 10: (a), (b) vertical cracks in the stairwell and (c) in the music room (Abdessemed-Foufa [7]).

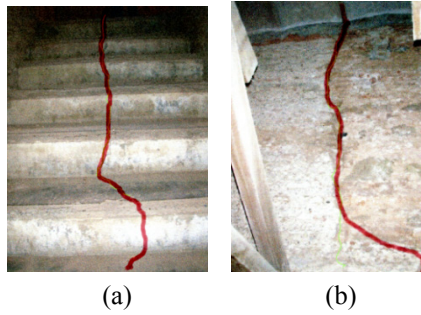
Horizontal cracks have developed across the wooden floor and the marble staircases. These cracks are due to the exercise of a bending stress introduced by an overload (Figures 11(a) and 11(b)).

Figure 11: (a) Horizontal cracks in stairs, (b) horizontal cracks in floors (Abdessemed-Foufa [7]).

upwards. The cracks observed on the marble stairs and wooden roofs are due to excessive loads caused on one hand by the soldiers during colonization (1830–1962), on the other hand by undue occupying which have squat the places after independence (1963–1979). In addition to that, the wooden beams; acting as elements of wind-bracing; inserted in the external wall of the stairwell and on the wall of the *sqifa* were divided. This created a displacement and a dextral deformation of external wall of the secondary entry hall. This weakened this angle and increased its vulnerability. During the French colonization, the city-wall of which the thickness reached more than 1m 50 and which leant against the music room was destroyed by the French army engineers during the great transformation of Algiers city (Figure 14). This external wall acted initially as wind-bracing to this massive block of constructions (north-east of the palace). Since its demolition, the angle is in a constant instability whence the appearance of these various disorders which amplified its vulnerability.

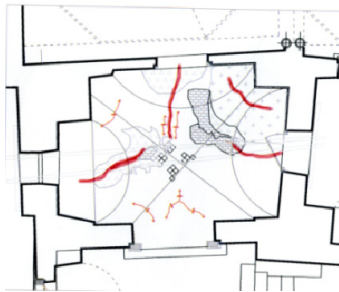
In the cross vault of the music room in north-eastern angle, cracks have developed following the keystone of the transverse sides (Figure 12). These cracks are due to the horizontal displacement of abutment.

Figure 12: Cracks in the cross vault.

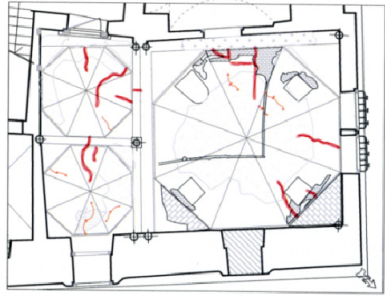
In the octagonal cupola of the music room cracks have developed following the transverse sides. These cracks are principally due to the horizontal displacement of abutment and also to the decompression generated by the displacement of lateral walls (Figures 13(a) and 13(b)).

Figure 13: (a) Cracks in the cupola, (b) different cracks in the music room (Abdessemed-Foufa [7]).

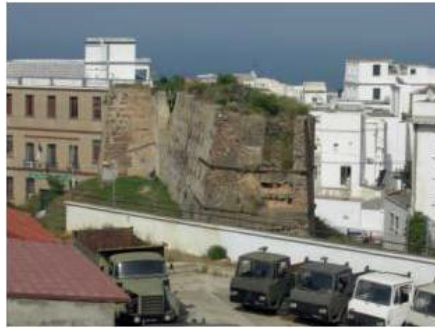
Figure 14: External view since the room of music of the reminder city wall (Abdessemed-Foufa [7]).
