Study of the seismic damage regularity of ancient masonry pagodas in the 2008 Wenchuan Earthquake

Y. Jianli & L. Shengcai

*Architectural Science and Engineering College,
Yangzhou University, China*

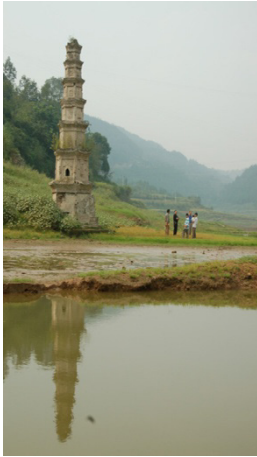
Figure 2: Shenba pagoda.

Shenba pagoda is a 7-storey hexagonal multi-storey-pavilion brick tower, 14 meters high. The pagoda is located in the inundated area of a lake for a flood reservoir, and the foundation is damaged by a change in water level. During the Wenchuan Earthquake, the foundation of the pagoda was subsidence, and led to a serious tilt of the tower body (Fig. 2).

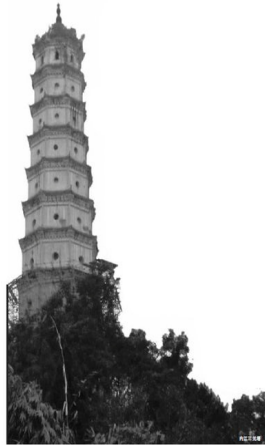
Figure 3: Sanyuan pagoda.

Sanyuan Pagoda is a 10-storey octagonal multi-storey -pavilion brick tower, 62.7 meters high. The pagoda is located on the top of San-yuan Mountain, shrubs and weeds growing into the brick joints resulted in cracking and an incline of the foundation. The seismic action of the Wenchuan Earthquake aggravated the inclined condition of San-yuan pagoda. According to the measure of global positioning system, the top displacement value is 0.631 meters and the deviation angle is 14°41'50", so this pagoda has been identified as a dangerous tower (Fig. 3).

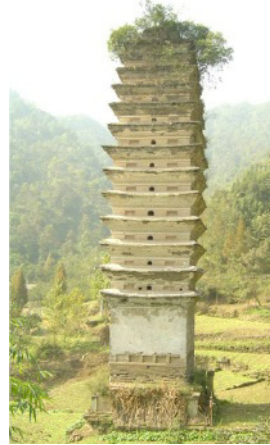
Figure 4: Yunjuyuan pagoda.

Yunjuyuan pagoda is a 13-storey square Dense-eaves brick tower, 20.9 meters high. The pagoda is located on the hillside of a mountain and the foundation had been damaged by long-term soil and water loss before the Wenchuan Earthquake. The Wenchuan Earthquake led to the serious displacement of the foundation, and the tower body tilted about 10 cm; obvious cracks appeared (Fig. 4).

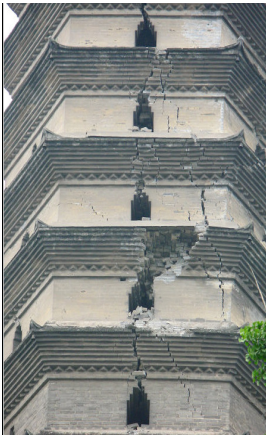
Figure 5: Kuiguang pagoda.

Kuiguang pagoda is a 17-storey hexagonal multi-storey-pavilion brick tower, 52.7 meters high. The door holes are set up in the same position of each storey (Fig. 5). During the Wenchuan Earthquake, the wall cracked thoroughly from the fifth storey to the top on the southwest and northeast sides of the tower body, the maximum crack width is 15 cm.

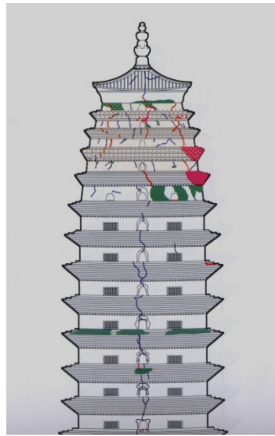
Figure 6: Lonhu pagoda.

Lonhu pagoda is a 13-storey square dense-eaves brick tower, 37.8 meters high. During the Wenchuan Earthquake, on the north and south sides of the tower body the through cracks appeared from the bottom to the top along the vertical midline of the wall. The cracks split the tower body into two parts, leading to the destruction of the structure (Fig. 6).

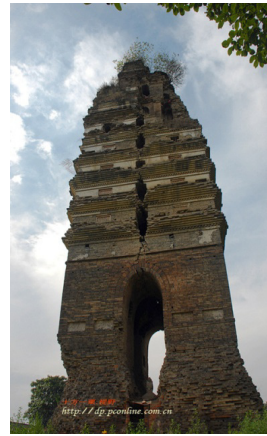
Figure 7: Zhengjuesi pagoda.

Zhengjuesi pagoda is a 13-storey square dense-eaves brick tower, 27.54 meters high. Under the seismic action of the Wenchuan Earthquake, visible cracks appeared on the four sides of tower body. On the west side of the tower body, a through crack of about 5 cm in width appeared along the vertical midline extending from the upside of the arch to the top of the tower (Fig. 7).

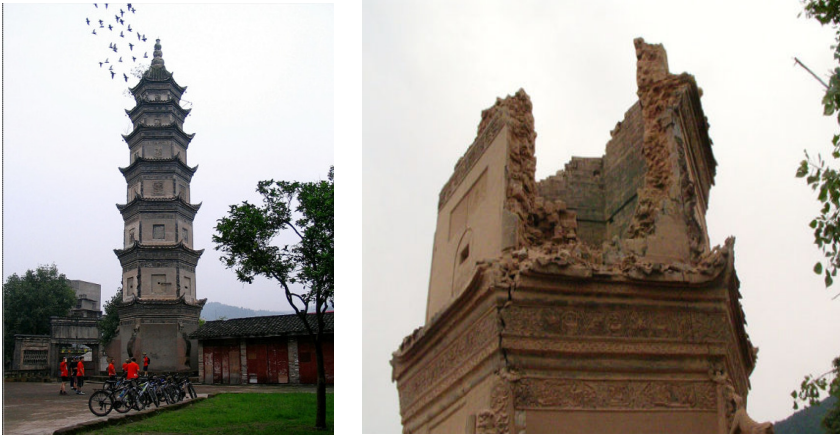
Figure 8: Bita pagoda (left: before the earthquake; right: after the earthquake).

Bit a pagoda is a 7-storey hexagonal multi-storey-pavilion brick tower, 31 meters high. The pagoda is located in a seismic intensity area of VII degree and the

construction site is flat ground. However, the upper five storeys have collapsed, with only the 9-meter high bottom storey remaining (Fig. 8). Testing after the Wenchuan Earthquake shows that the material strength of the pagoda is low and the masonry quality is poor. The niches weakened the structural stiffness of the thin wall, leading to the deficiency in seismic performance of the overall structure.

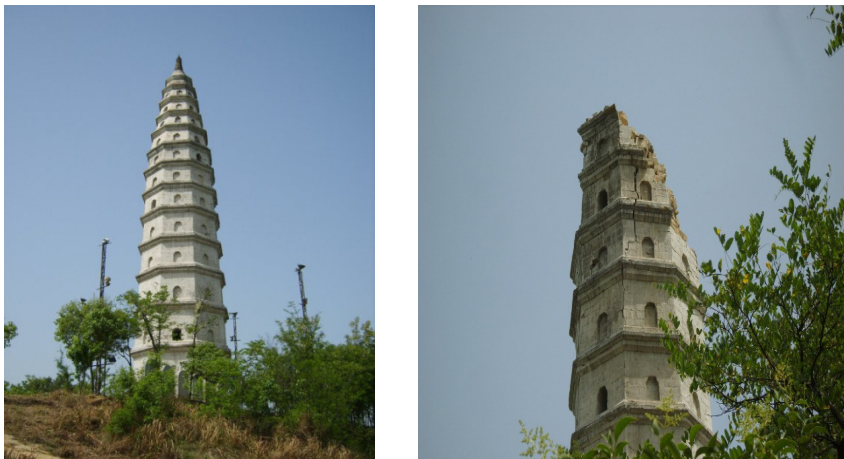
Figure 9: Laiyan pagoda (left: before the earthquake; right: after the earthquake).

Laiyan pagoda is a 13-storey octagonal multi-storey-pavilion brick tower, 36 meters high. When the Wenchuan Earthquake took place on May 12th, 2008, the

8th storey to the top of the tower body collapsed at once. After that, a lot of aftershocks took place on May 25th to 27th in Qingchuan County and Ningqiang County, which led to the Laiyan pagoda being damaged again and the 6th and 7th storeys also collapsed (Fig. 9). Analysis shows that, Laiyan pagoda, being built on a mountaintop, its slenderness ratio H/D of 5.3, the amplifying effect of the mountain height on the action of the earthquake as well as the large slenderness ratio of the tower, are the important factors of pagoda collapse.

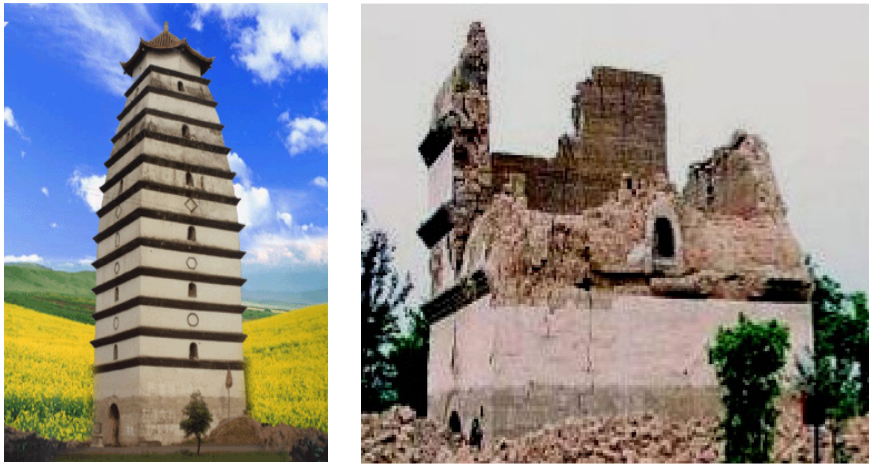
Figure 10: Wenxing pagoda: (left: before the earthquake; right: after the earthquake).

Wenxing pagoda is a 13-storey square multi-storey-pavilion adobe brick tower, 28 meters high; the first storey with a lower stone base and the remaining 12 storeys built from adobe brick. Its unique architectural materials and construction pattern are no longer seen in existing pagodas. The adobe brick is made from hemp, grass fibre and clay, with the mortar using sand, clay and a glutinous rice paste mixture, so the structural integrity of masonry tower is not high. Following up to IX degree seismic intensity in the region, the strong earthquakes led to this adobe tower collapsing entirely, with only the bottom, about 6 meters high, remaining (Fig. 10).
