A review of process safety catastrophes on the Texas Gulf Coast

R. G. Carranza

Chemical Process Engineering Consultant, Montgomery, Texas, USA

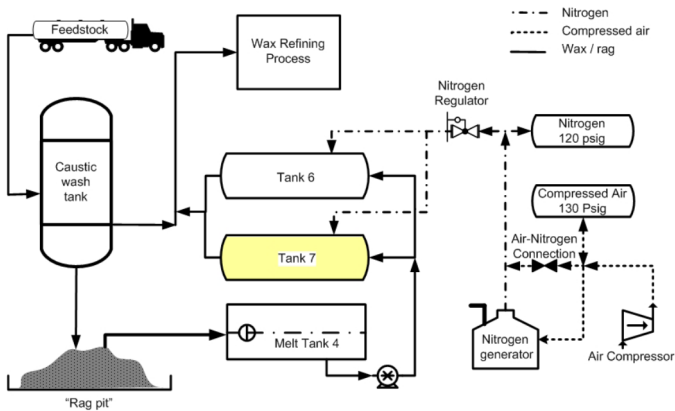
Figure 1: Schematic of Marcus Oil processing facility for polyethylene wax [1].

CSB determines that Marcus Oil alters the vessel design of several tanks on the property, including Tank 7. A 24 inch hole is cut in Tank 7 to install and maintain the steam coils. A metal plate is welded over the hole that does not adhere to ASME section VIII. The poor welding fails when the vessel is pressurized with nitrogen to 67 psig, the regulator set pressure.

Furthermore, the company’s nitrogen generator is incapable of supplying sufficient nitrogen to the system. A bypass line is connected to the company’s plant air system to supplement the nitrogen system during peak times. Thus, the oxygen content in the gas blanket over Tank 7 is 18% oxygen instead of the desired maximum of 8%.

When the plate is blown from the tank, it hits the ground and creates a spark. The molten hydrocarbon is in an oxygen rich environment and an explosion occurs. The heads on the tank are shattered and the 50,000 pound vessel is hurled 150 feet. Luckily, no deaths occur. Some local residents are slightly injured due to flying debris and concussion. Three fire fighters sustain minor injuries.

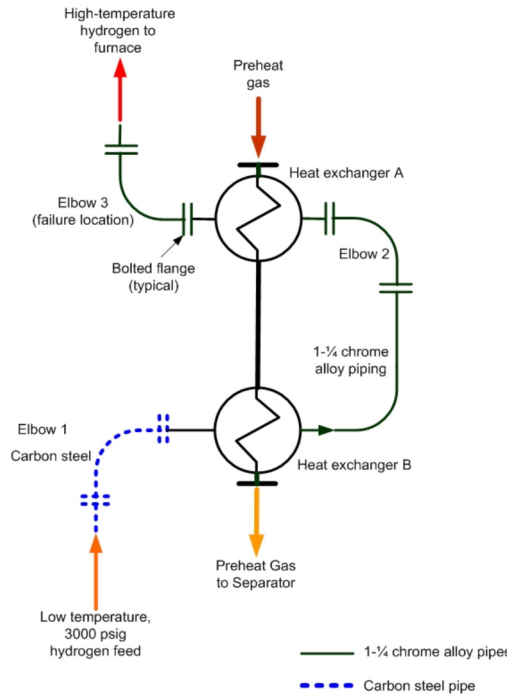
Figure 2: Elbow and heat exchanger arrangement for hydrogen preheat [2].

As is seen in fig. 2, elbow 1 is made of carbon steel; and elbows 2 and 3 are made from low alloy steel. The reason being temperature variation. However, when the exchangers are disassembled for maintenance in January of 2005, the contractor mistakes elbows 1 and 3 for one another. The elbows are reversed during reassembly. Carbon steel and low alloy steel are indistinguishable to the naked eye.

It is concluded that elbow 3 fails in less than 3000 hours of service due to HTHA. The result is that the hydrogen escapes from the corroded pipe and ignites. British Petroleum requires positive material identification (PMI) for new projects, but does not have a requirement for maintenance projects. PMI is easily accomplished with portable hand-held devices like an X-ray fluorescence

instrument. Furthermore, the contractor is simply sloppy with respect to tagging piping components and reassembly. The entire event is entirely avoidable with proper tagging. CSB passes these recommendations to both British Petroleum and the contractor. One minor injury to plant personnel is reported and no deaths.

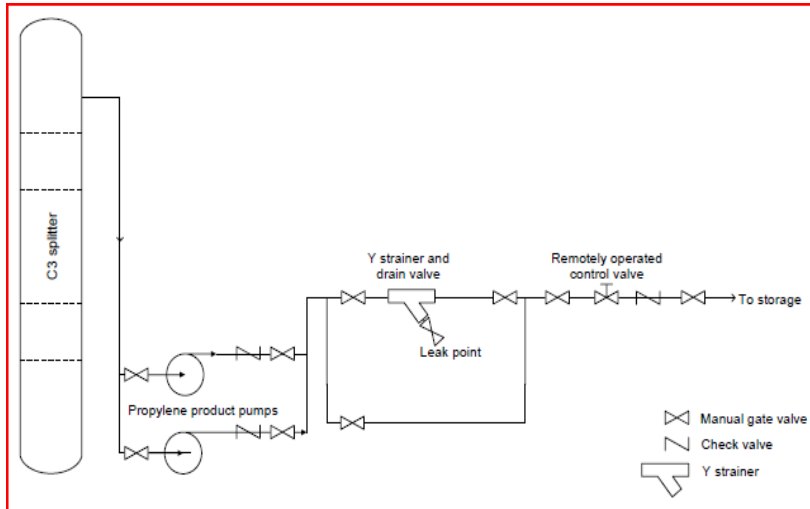
Figure 3: Process Schematic of the Formosa Unit [3].

Formosa Plastics experiences a plant explosion and fire in its Olefins II unit. [3] The reason for the incident is damage to the process piping from a motorized vehicle. A trailer being pulled by a forklift pulls a manual valve off a strainer. Liquid propylene pools on the ground, vaporizes, and explodes. The explosion is categorized as an “unconfined, low speed, deflagration”. Fig. 3 is a schematic of the process.

Note that the schematic does not appear to be entirely representative of the situation. A C3 splitter is usually fractionating propylene from propane; thus, the tower product is propylene, but a condenser/heat exchanger seems to be missing between the tower and the pumps.

- When Formosa conducts a process hazard analysis of the unit, it is determined that barriers protecting process equipment from vehicular collision are necessary; but not for the process area in question because the probability of a collision is highly remote – one in twenty years. Thus, the strainer and associated piping are not protected from vehicular collision.

- Within the area that is consumed with fire, there is a pipe rack that also contains a flare header. Although most of the columns supporting the rack are fireproofed, one row of columns is not. This allows the rack to fall and the piping to the flare is crimped. Propylene, instead of being vented, is allowed to feed the fire. M. W. Kellogg is hired to design the Olefins I unit in 1988 – at the same time API publishes its fireproofing guidelines, Publication 2218, which states that all flare network piping should be supported by steel columns with fireproofing. In 1996, Formosa hires M. W. Kellogg again, this time to design Olefins II. Kellogg simply uses the old Olefins I design without updating the fireproofing on the steel columns.

- An important point in this study is the fact that Formosa did not isolate the distillation column with automated shutoff valves. The check valve stopped flow from storage; and thus, did not allow the fire to be fueled from this source. However, the distillation column is a source of fuel and there is nothing to prevent the fire from being fueled by this source. CSB recommends that all vessels with large inventories of flammable materials be isolated with automated valves. Formosa only has hand valves to shutoff flow to the fire that originates from the distillation column.

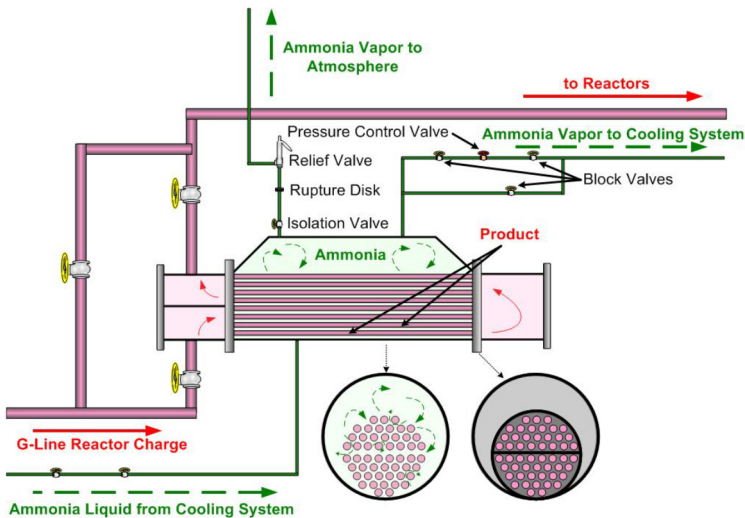
Figure 4: Process schematic of Ammonia Heat Exchanger [4].

The explosion at the Goodyear plant killed one worker and injured six others [4]. The reason is operator error. Essentially, a heat exchanger is blocked-in during operation; the resulting overpressure ruptures the vessel, and flings debris and ammonia throughout the production unit.

- Fig. 4 is a schematic of the heat exchanger and the associated piping.
- Ammonia (shell side) is used as a coolant for a reactor feed (tube side).
- On the late afternoon of June 10th, an operator closes the isolation valve to the shell side relief valve in order to replace a rupture disk.
- The disk is replaced but the isolation valve is not reopened.
- Early the next morning, a worker closes the block valve upstream of the control valve on the shell side exit. The system is now completely blocked-in.
- The worker then flows steam through the tube side to clean the exchanger; however, the extra energy evaporates excessive amounts of ammonia and the exchanger ruptures.

Despite the fact that Goodyear's emergency and maintenance procedures are described in one word, "sloppy", the entire incident could have been avoided by following two guidelines provided by ASME Boiler and Vessel Code, Section VIII:

- "... when a pressure vessel relief device is temporarily blocked and there is a possibility of vessel pressurization above the design limit, a worker capable of releasing the pressure must continuously monitor the vessel. Goodyear's maintenance procedures did not address over-pressurization by the ammonia

when the relief line was blocked, nor did it require maintenance and operations staff to post a worker at the vessel to open the isolation valve if the pressure increased above the operating limit.” [4]

- “. . . over-pressure protection shall be continuously provided on pressure vessels installed in process systems whenever there is a possibility that the vessel can be over-pressurized by any pressure source, including external mechanical pressurization, external heating, chemical reaction, and liquid to vapor expansion. Workers should continuously monitor an isolated pressure relief system throughout the course of a repair and reopen blocked valves immediately after the work is completed.” [4]
