Influence of the maintenance in seismic response of Lorca historic centre masonry residential buildings after the 11 May 2011 earthquake

L. Basset-Salom & A. Guardiola-Víllora

Departamento Mecánica de Medios Continuos y Teoría de Estructuras, Universitat Politècnica de València, Spain

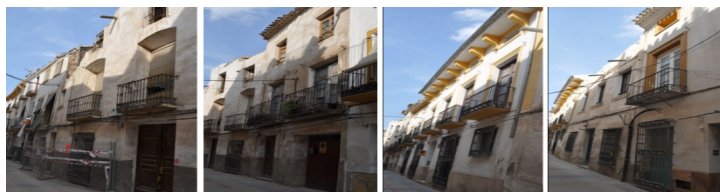
Figure 2: Buildings with heterogeneous damage in Cava Street.

Visual information of 1200 buildings regarding geometry, masonry materials, structural and construction characteristics, conservation status, crack patterns and damage level was collected and more than 3000 photographs were taken. Observed data and cadastral records (building age, area, etc.) were stored in a database connected to a Gis system and analysed. During this survey the authors found that, despite of being built at the same period and having, apparently, the same constructive and structural characteristics and dimensions, URM residential buildings in the target area showed very heterogeneous damage (fig. 2).

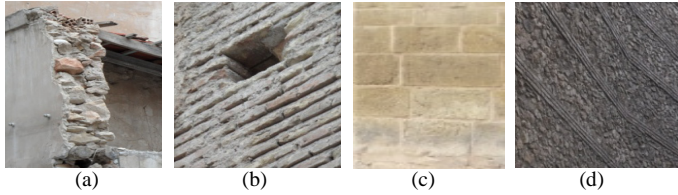
Masonry fabric varies according to age, style and typology: (a) multi-leaf rubble or poorly cut stone (small or medium sized) with lime mortar; (b) brick masonry with lime, lime-cement or cement mortar; (c) regularly dressed well squared and graded stones blocks (in mansions) and (d) alternating layers of brickwork and rubble (fig. 3).

Figure 3: Masonry fabric: (a) rubble, (b) brick (c) stone blocks, (d) brick and rubble.

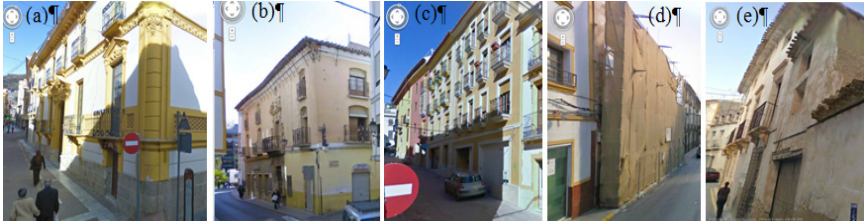
Figure 4: URM buildings before the earthquake (Google street view).

residential buildings with different levels of maintenance, (c) new apartment dwellings replacing the inside of a traditional building but keeping the original masonry façade without structural use, (d) cleaned up buildings with braced façades and (e) abandoned buildings waiting to be declared ruined (fig. 4).

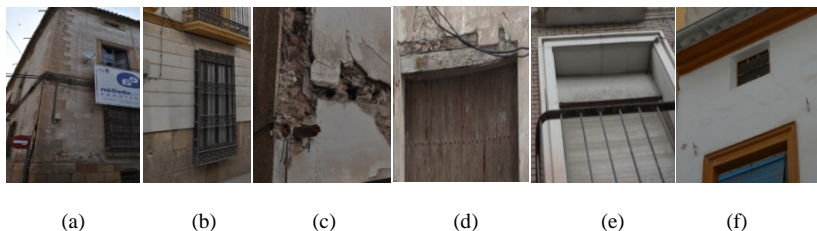
Figure 7: Reinforcement features (a) quoins, (b) plinths, (c) timber ties or ring beams, (d) timber lintels, (e) stone frames, (f) iron ties.

Being Lorca in a region of moderate seismicity, some reinforcement features (fig. 7) can be found (stone quoins, plinths, floor and wall timber ties or timber ring beams placed horizontally in the middle of the thickness of the wall, timber lintels, stone frames around openings and iron ties)

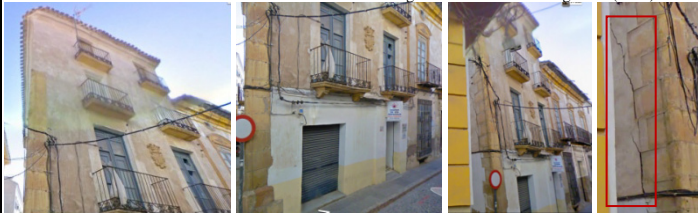
Figure 9: Building no. 47088-1, Selgas Street 11.

The first two buildings, no. 48100-23 and no. 47088-1, are shown in fig. 8 and fig. 9. They are located in a corner of the block, which is reinforced with quoins. Façade layout, spandrels and piers dimensions are similar in both cases. Pictures from the Catalogue (1994) and before the earthquake (January 2009) defined their maintenance level (good for building 48100-23 and medium for building 47088-1), confirmed also by the Catalogue’s file description. Earthquake effects have been different (see pictures taken in June 2011). While in the first building only a small number of unnoticeable slight cracks appeared, in the second one, the roof failed, the balcony partially collapsed and big cracks occurred in lintels and near the corner.

Building in January 2009 before the earthquake (Note the big crack next to the corner)

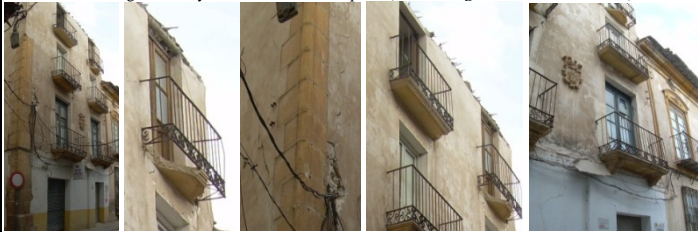
Building in June 2011, earthquake effects: roof collapse, balcony partial collapse, cracks in lintels and walls)

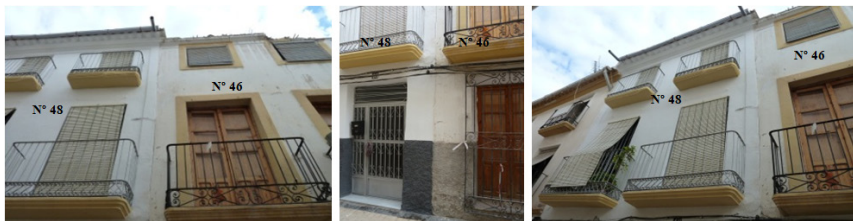
Figure 11: Cava Street 48, 46.

The second couple corresponds to adjacent protected houses, in “La Cava” street 48 (no. 49117-20) and 46 (no. 49117-19), built in the XIX century, sharing a partition wall and with nearly identical dimensions, construction techniques and structural characteristics. Masonry fabric consists of rubble stone and floors are made with timber joists orthogonal to the façade strengthened with timber ring beams (fig. 10). According with the Catalogue’s file description, the maintenance level in 1994 was good for house no. 48 and medium for no. 46. There isn’t any photograph from Google Street View, due to the street dimensions, however, in May 2011, before the earthquake, no. 48 was inhabited and well maintained while no. 46 was abandoned, as was reported by the neighbours. Earthquake effects are shown in fig. 11; while no. 48 has no damage, in no. 46 big cracks in the façade and total failure of the roof can be seen. A summary of both buildings is presented in figs 12 and 13, the only difference being their maintenance level.

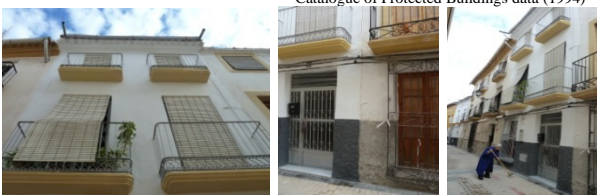
Figure 12: Building no. 49117-20, Cava Street 48.

The owner herself reported that the house had suffered slight damages

Building in June 2011, slight cracks in façade

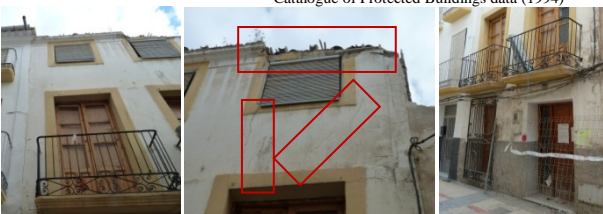
Figure 13: Building no. 49117-19, Cava Street 46.

However, next door owner reported that the house was abandoned before the earthquake

Building in June 2011, earthquake effects: roof and floors collapse

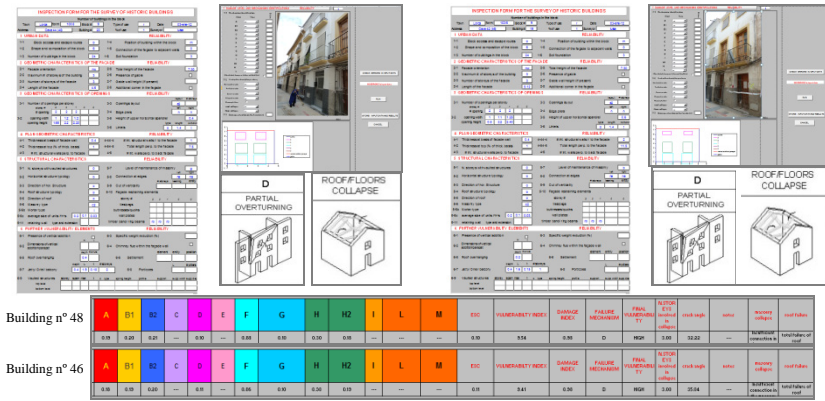
FaMIVE inspection forms, results and predicted mechanism are shown in fig. 14. The predicted mechanism for both façades is a partial overturning, mechanism D (D’Ayala and Speranza [7]), with a slightly different crack angle (32.22° for building no. 48 and 35.04° for no. 46). A total failure of the roof is also predicted, which matches with the observed damage and the crack pattern in house no. 46 (fig. 13) but not with house no. 48. It is worth mentioning that conditions regarding a bad maintenance level are difficult to define accurately, in fact, changing the masonry maintenance level in the FaMIVE inspection form, does not modify the final results of the predicted vulnerability index values,

damage index, failure mechanism and cracks angle, although this has been the reason for the different seismic performance.

Figure 14: FaMIVE forms and results.

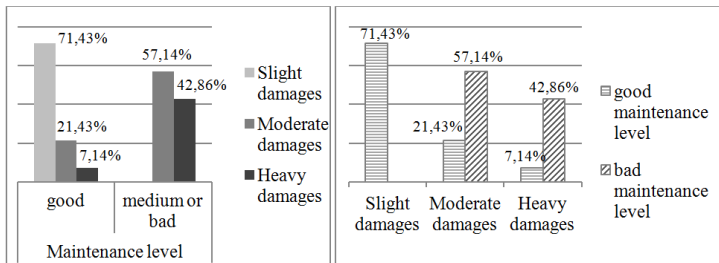
Final results are summarised in fig. 15: 71.43% of the buildings with a good maintenance level had slight damage, while all the buildings with a medium or bad maintenance level had moderate or heavy damage. However, a good maintenance level was not enough to guarantee a good seismic behaviour, as a small percentage (7.14%) of the studied well maintained buildings had heavy damage.

Figure 15: Damage grades and maintenance levels.
