STRUCTURAL ASSESSMENT OF DUBROVNIK CATHEDRAL, CROATIA

JOSIP GALIĆ, HRVOJE VUKIĆ & DAVOR ANDRIĆ
University of Zagreb, Faculty of Architecture, Croatia

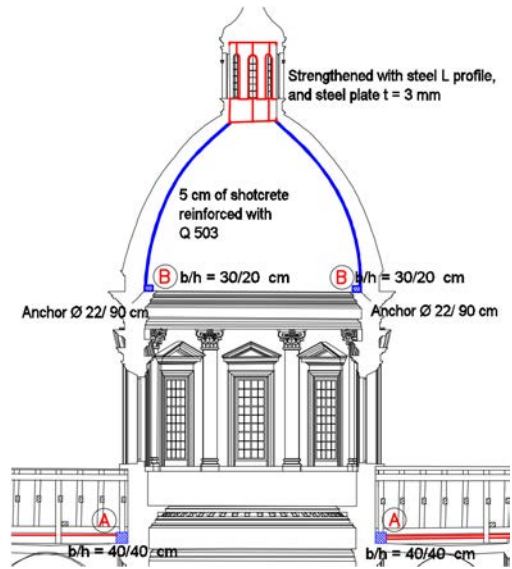
Figure 5: Strengthening of the dome and lantern.

1. All cracks in vaults, walls and arches were injected with a cement-based compound with added bentonite and slaked lime.
2. On the dome, strengthening was carried out using reinforced shotcrete of 5.0 cm with the added reinforced concrete tie beam of cross section $b/h = 30/20$ cm at the level +29.80 m (Fig. 5).

3. The lantern was also repaired in such a way that the bottom row of the lantern stone was connected to the steel sheets anchored by steel anchors. (Fig. 5).

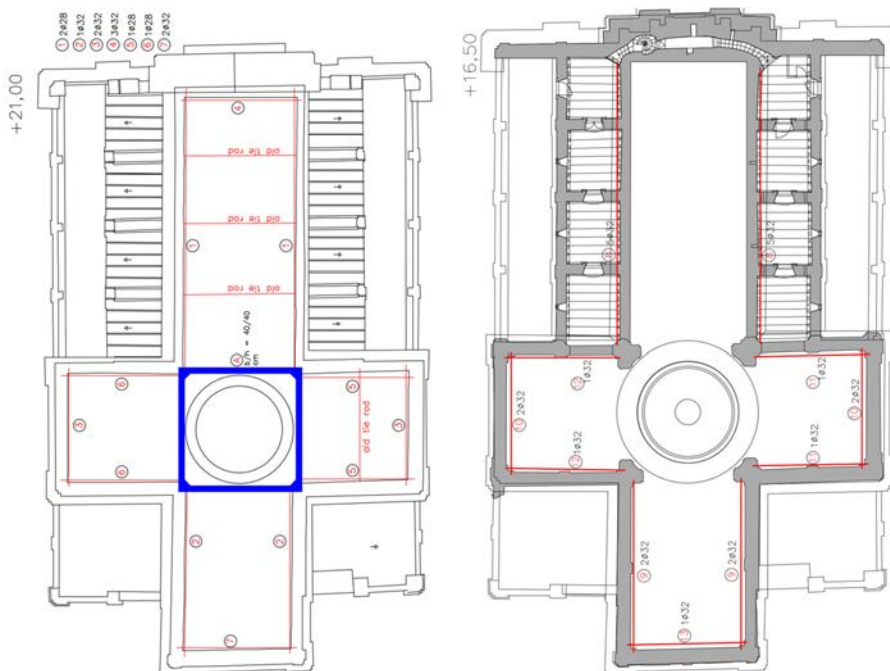
Figure 6: Strengthening at levels +21.0 m and at +16.5 m.

4. Global strengthening of the load-bearing structure was made by means of ties. Ties were executed in both longitudinal and transversal directions so that the façade walls are connected. In vertical view, ties are executed in four levels. The highest level is at +21.0 m which corresponds with the level of the vaults above the central nave. Ties are executed on fascia beam above all walls of the central longitudinal nave and transept. The second level of ties is at +16.5 m which matches the level of the lower edge of the window of the main central naves. At the same level, ties in the vault and arch spring were executed to disable shifting of vaults and arches. The third level of ties is at +13.40 at the terrace floor level and they are placed in the closed area above side naves. The fourth level of ties is at the arch spring above side naves and chapels and their purpose is to prevent shifting apart at the arch springs (Fig. 6).

5. At the level +21.00 m in the area under the dome, reinforced concrete tie beam was executed (horizontal frame) with cross section $b/h = 40/40$ cm. The tie beam is placed directly on the main columns under the dome and all ties that are placed at that level are anchored into it (Fig. 6).

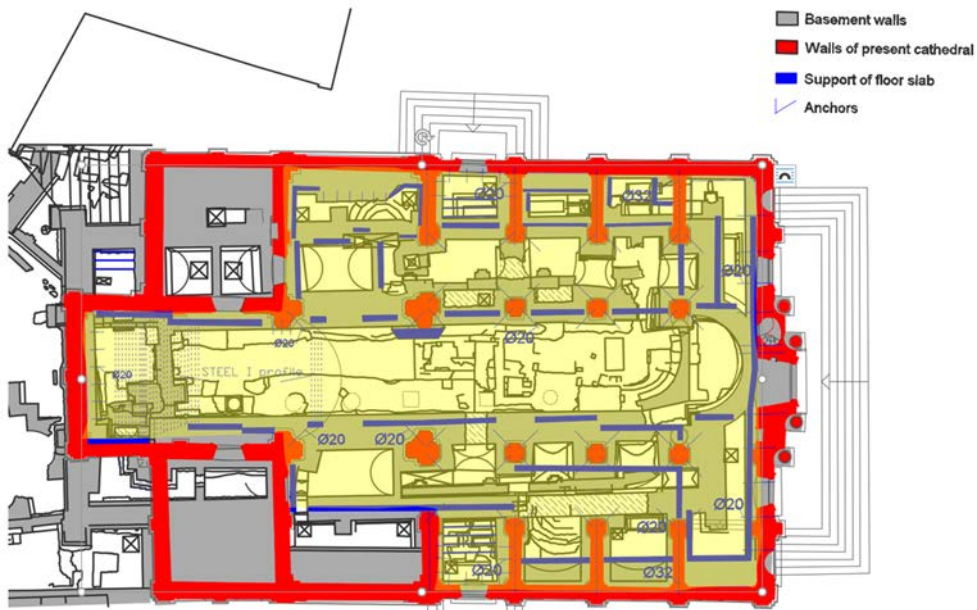
Figure 7: Executed bearing beams, anchors and reinforced concrete slab above the substructure.

6. Floor slab execution at the ground floor level further to excavations that started in 1981 for the purpose of the Romanesque cathedral archaeological investigations (Fig. 7).

In order to establish the museum area in the underground and for cathedral liturgical purpose, a reinforced concrete slab $h = 16$ cm thick separating the two units was constructed at the ground floor level above the underground excavations. The slab was constructed in such a way that it lies on thin concrete beams, which are made on the Romanesque cathedral foundations and foundation strip, to be as inconspicuous as possible, without at the same time leaning on the structures of the Byzantine basilica so that it looks as if it is floating. Practically, a rigid disk was formed with the slab which prevents the shifting of individual vertical structural elements at that level. Also, the beams are connected to the foundations of the Romanesque cathedral via anchor bars and by monolithic connection to the slab. The layout of the engineering solution for the floor slab execution is shown in Fig. 7.

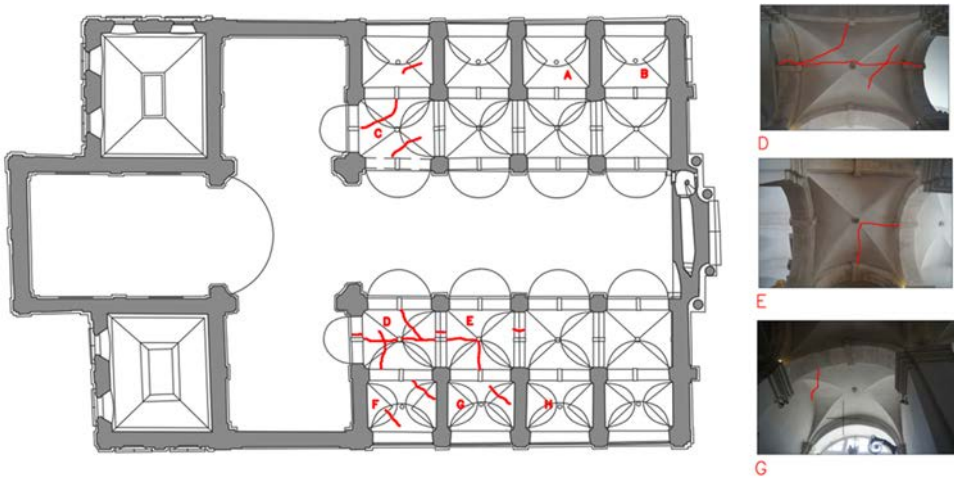
Figure 8: Drawing and photographs of characteristic cracks in the vaults.

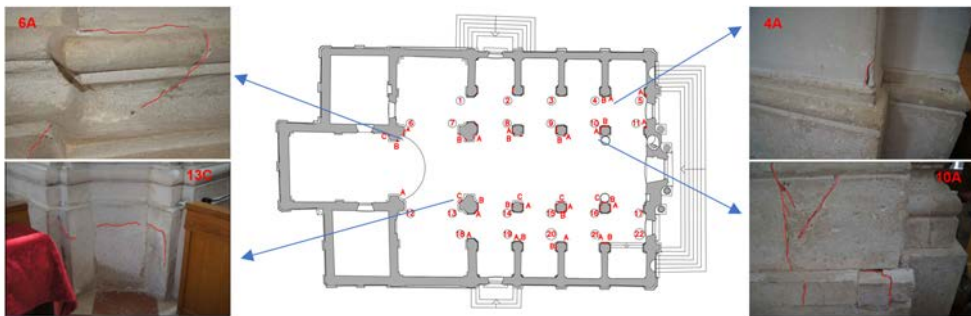
The reason for this analysis is the damaging of the footing of the main columns. It shall be noted that the said damaging occurred after the reconstruction and strengthening presented in the previous section. The basis for the presentation of the incurred cracks consists in visual inspections of the structure that were carried out twice in 2017 and 2018. During inspection the architectural surveys of the existing condition were used that were prepared by the

Figure 9: Drawing and photographs of characteristic cracks in the column footing.

was also studied. The observed details in the photo documentation later directed the research itself, because they identified the possible cause of the damage to the columns on the ground floor. During the visual inspection and investigation works, it was found that the walls were made of stone in lime mortar and as stone masonry of carved crushed stone. Investigations on determining the masonry mechanical properties (compressive and shear strength) were not conducted. The basis for the assessment of the masonry mechanical properties and elements was established based on the available data from testing similar structures and the experience of the researcher of this paper.

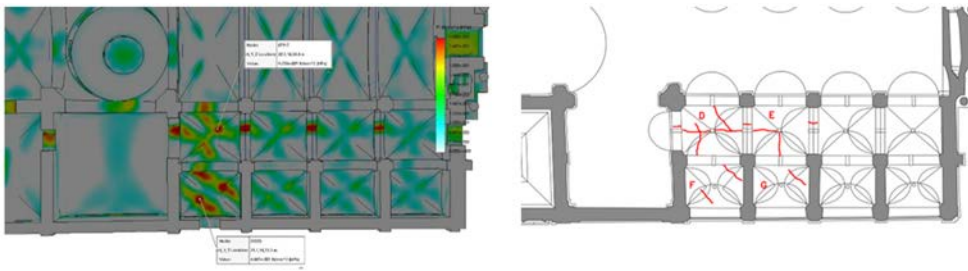
In the first phase, a static analysis of a model loaded with a dominantly permanent load and imposed load was performed (Fig. 10). The loads defined at this stage include the self-weight of the structure automatically calculated by the program, wind load according to [7], weight of the layers on the vaults, weight of the shotcrete on the inside of the dome and also the loads transferred from the roof structure that included permanent dead loads and imposed loads as wind and snow loads. Deformations and stresses caused by loads in static analysis of the structure indicate that the structure has sufficient rigidity and stability. The only areas that need to be reinforced to prevent further cracking of the structure are the arches at the base of the dome and the vaults of the side naves (Fig. 11). These locations of maximum stresses in numerical model coincide with the visible and observed cracks in the cathedral.

Figure 11: Presentation of tensile stresses of the side nave vaults in numerical analysis (left) and observed crack (right).

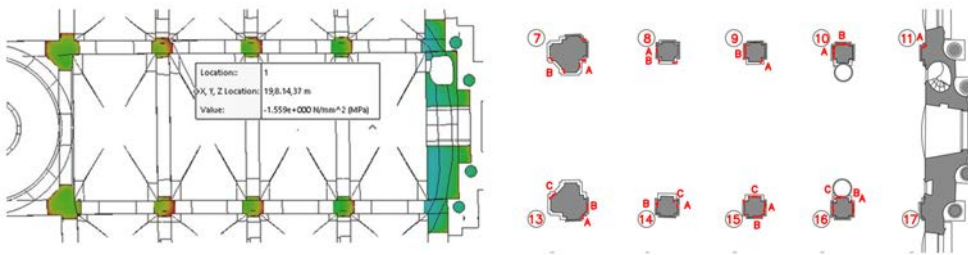
The position of cracks in the base of the columns as determined by visual inspection and the comparison with the position of stresses from the numerical analysis did not show any connection (Fig. 12).

Figure 12: Presentation of the compressive stress of columns in numerical analysis (left) and observed cracks at columns (right).

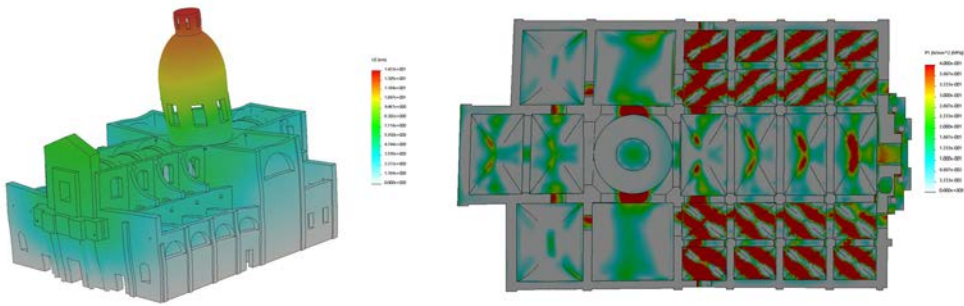
In the second phase, a dynamic modal analysis was performed. After the modal analysis was performed to determine the basic tones of oscillation of the structure, the horizontal load due to the earthquake action in the longitudinal and transverse directions of the structure was added to the previously defined permanent load. Earthquake was defined for reference return period $T_{NCR} = 95$ years, and corresponding reference peak ground acceleration $a_{gR} = 0.16 g$ [8]. The results of the dynamic analysis show that the direction of the earthquake along the length of the cathedral is critical for the structure (Fig. 13). With the combination of the vertical and horizontal forces brought on by the continuous action and earthquake impact, the structure suffers significant stresses and deformations that would certainly cause damaging greater than the one that is currently visible. In order for the structure to resist such action in the future, it is necessary to ensure the transfer of horizontal forces from the vaults to the longitudinal walls. In this respect, it is particularly necessary to reinforce the vaults of the side naves of the cathedral and to ensure the transfer of the said forces to the longitudinal walls, especially to the outer walls of the transept. In dynamic analysis, it is concluded that earthquake action is entirely dominant for global verification.

Figure 13: Presentation of deformations resulting from the earthquake impact (left) and tensile stresses in the cathedral vaults (right).

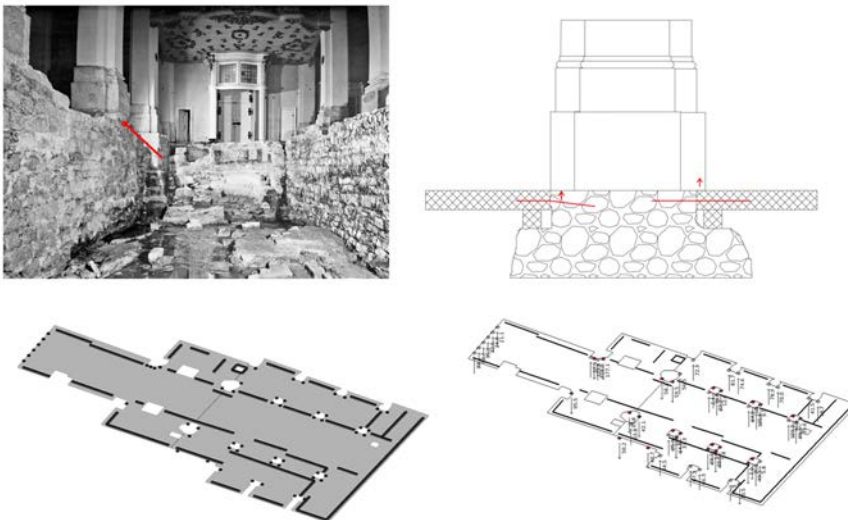
All documentation was examined again, and examining the photographs in the figures and the geometry of the floor slab with the position of its support, it was concluded that the bottom portions of some columns on certain sides had been chiselled off. Furthermore, the photographs of the executed floor slab do not show a visible separation of columns from the floor slab with some elastic material. Further to this, a floor slab numerical model was made. Load on slab was based on permanent load (weight of slab and layers) and imposed load according to [5]. Based on the analysis, negative reactions were obtained, that is, lifting off the slab at the places where the floor slab anchors had been installed. It is confirmed that on location where floor slab is connected with columns, cracks occur at column base. All of this may be seen in Fig. 14.

Figure 14: Presentation of the visible location of the secured parts of the columns and the lever effect, and the model of the floor slab on the basis of which the analysis was performed.

With respect to the analyzes performed, it can be concluded from the static numerical analysis that the positions of the significant stresses in the model at the vault positions corresponded to the observed cracks in the cathedral. However, the positions of the column stresses from the static numerical analysis did not correspond to the positions of the observed cracks, this mismatch was later confirmed by the lever effect of the floor slab. Dynamic analysis has confirmed that it is relevant in terms of maximum stresses, and also that the earthquake action in relation to the imposed load (snow and wind) is relevant for the global structural load bearing analysis. In this respect, it is particularly important to reinforce the vaults of the side naves of the cathedral to ensure the transfer of forces to the longitudinal walls, especially to the walls of the transept and shrine. Realistically, these are the only possible interventions on the additional strengthening of the bearing structure that are acceptable for this type of buildings. The recommended system of strengthening is one of the FRCM systems. In order to prevent further damage to the columns, it is proposed to release the connection of the slab to the columns at critical locations. The said release would be accomplished by cutting the slab and the anchors at the locations where slab lift off.
