# Analysis of damage parameters of the Chi-Chi Taiwan earthquake

E. Lekkas

*Department of Geology, University of Athens, Athens, Greece*

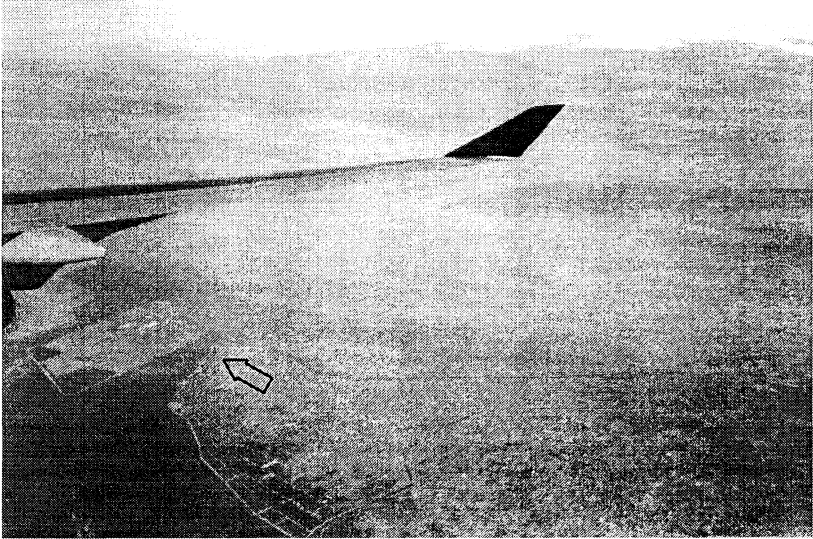
**Liquefaction.** Liquefaction occurred at a number of sites, causing considerable damage. It was significant at Yuan-lin- there was widespread settlement of building foundations, and water wells were completely filled by sand from sand boils. Liquefaction also led to settlement, failure and lateral spread of levees, and movements at bridge abutments at river crossings. However, despite signs of liquefaction and lateral spread close to the bridge foundations. Thaichung port, located some 45 km from the epicenter, experienced liquefaction-induced damage at the quays, port facilities and storage locations. More than twenty sites in the meizoseismal area were also affected by liquefaction, which damaged the road network, infrastructure and other facilities (Fig. 9).

Figure 9: Partial view of the affected area. The port facilities (arrow), which were damaged by liquefaction, are visible.

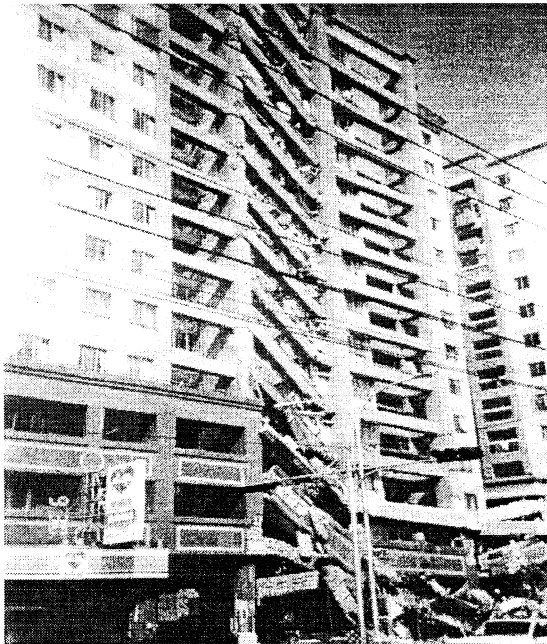
**Mid-Rise Buildings.** In urban areas, a substantial percentage of the residential units are in reinforced apartments of 12-15 stories. A number of these buildings collapsed in special Taichung City, Feng-Yuan, Dali and Taipei County. Typically, they are cast-in-place, special moment frame structures utilizing all frame lines in both directions. They generally have spread footings (Fig. 10). The exterior walls and the shaft walls are reinforced concrete, approximately 10 cm thick. These are considered nonstructural walls and are not included in the seismic design (EERI [14]).

Figure 10: Representative types of collapsed mid-rise buildings.

- Buildings up to 15 stories (50 m total height) suffered the most seismic damage, including collapses. However, compared to the total stock of such buildings, and considering the magnitude of the earthquake, the percentage of damage was small. The damage to these buildings could be attributed to the soft first story created by the «open space» policy, or to poor construction.
