# SEISMIC AND STRUCTURAL RISK ASSESSMENT OF AN EDUCATIONAL BUILDING FOR COMMUNITY SUSTAINABILITY: A CASE STUDY IN ZARUMA, ECUADOR

*Keywords:* seismic rehabilitation, building inspection, structural evaluation, reinforced concrete.

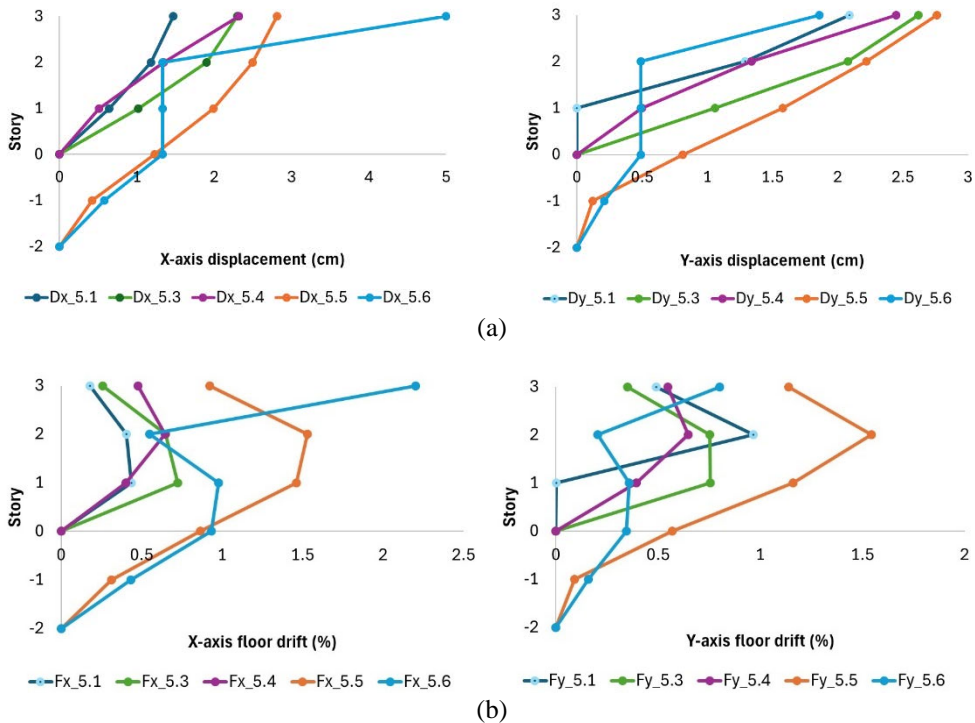
Table 3 and Fig. 3 show the period and modal analysis results for each school block, respectively. Buildings have potential seismic deficiencies. Consequently, in the event of severe earthquakes acting on a structure, there are indications that the buildings could perform inadequately. The limit states that could develop in the structural elements were masonry and column shear failures.

Block	Period (s)		
	T1	T2	T3
B5.1	0.62	0.55	0.47
B5.3	0.78	0.75	0.69
B5.4	0.79	0.68	0.55
B5.5	0.87	0.74	0.67
B5.6	0.54	0.74	0.38

Figure 3: Modal analysis of buildings 5.1, 5.3, 5.4, 5.5, 5.6 of the ‘San Juan Bosco’ School (a) displacements in the X–Y axes; (b) drifts in the X–Y axes.
