# Sonic tomography of the stone pillars of a 17<sup>th</sup> century church

L. Zanzi<sup>1</sup>, A. Saisi<sup>2</sup>, L. Binda<sup>2</sup> & E. Cardarelli<sup>3</sup>

Pulse sonic tests were applied to 8 massive stone pillars of a 17<sup>th</sup> century church (S.Nicolò all'Arena at Catania, Italy). The data were processed to obtain 28 tomographic sections showing the distribution of the elastic wave velocity within the tested pillars. The results of the tests are compared in order to check the morphology and the state of damage of the pillars. A preliminary frequency analysis of the data seems to indicate that these experiments can be used to extract the energy absorption distribution.

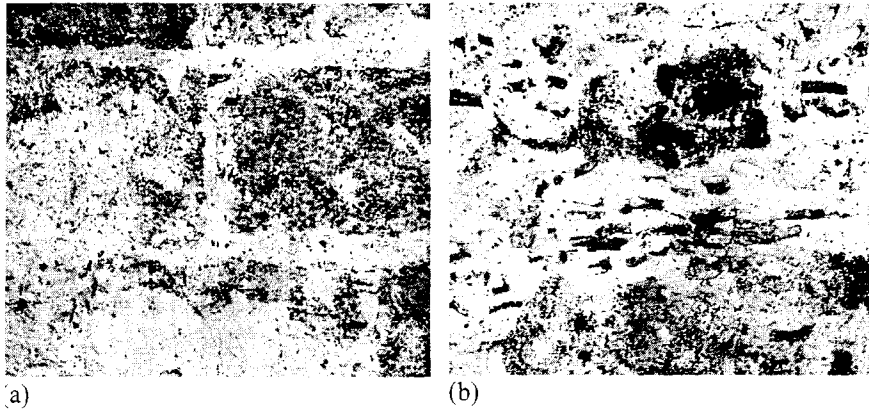
Fig. 3. Main masonry typologies of the Church. Regular block masonry (a) and "incoccio" (b).

The masonry appears characterised by two different typologies: (i) a solid masonry built by large and regular blocks and filled with rubble masonry made with rather strong mortar; (ii) a highly inhomogeneous stone masonry surrounded by a thick cover made with tile fragments, stones and rather weak mortar, locally called "incoccio" (Figs. 3a and 3b). Often the two typologies are present in the same structural element (Fig. 4). Apparently the second one was used as repair technique (Fig. 5).

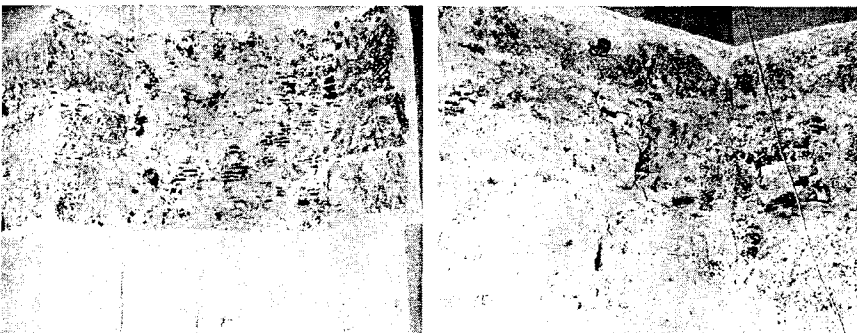
Fig. 4. Regular stones and "incoccio".

Fig. 5. "Incoccio" 30 cm thick, probably used to widen the section of the pillars.

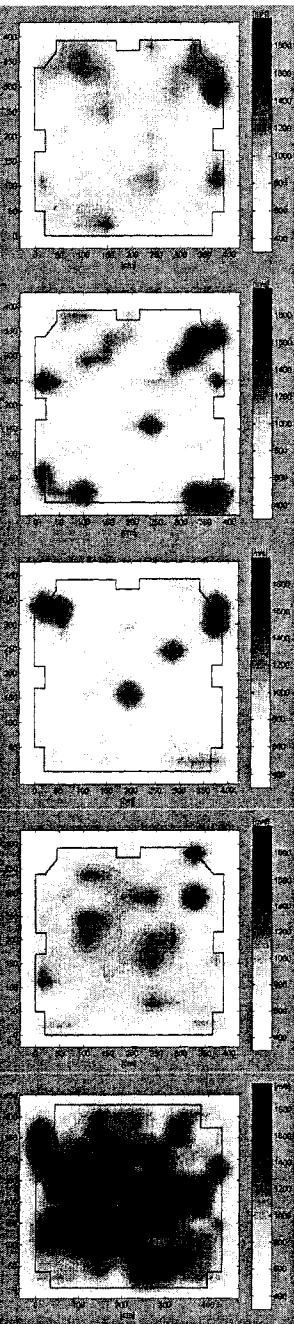
In Fig. 6 the sequence of the horizontal tomographies of pillar 2 are represented.

A typical distribution of the velocity on the pillars 1 and 2 shows average velocities at the base and at the top of the pillars and very low velocities in the middle. This is very clear in the vertical tomography of both pillars even if the vertical sections have a lower density of ray as shown in Fig. 7 and Fig. 8.

The very low velocities that have been found in the pillars 1 and 2 confirm the need of urgent preservation actions. From an external observation, the masonry texture seems, in fact, very poor, characterised by the presence of the so called "incoccio". It is also worth remembering that these pillars show a dangerous crack pattern (Fig. 9). From coring of the pillars it was also clear that the internal mortar was very weak.

Fig. 6. Horizontal tomographies of the pillar 2, at respectively 7.9, 7.6, 4.9, 3.8, 1.8 m.

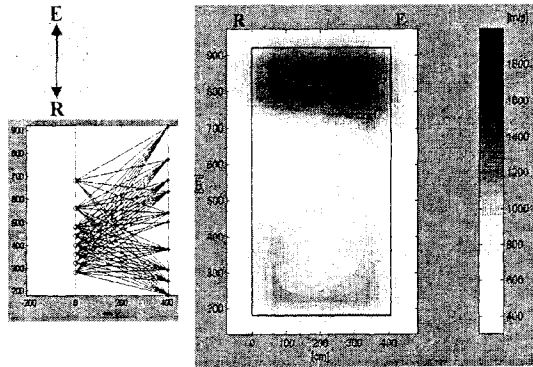
Fig. 7. Vertical tomography of the pillar 1

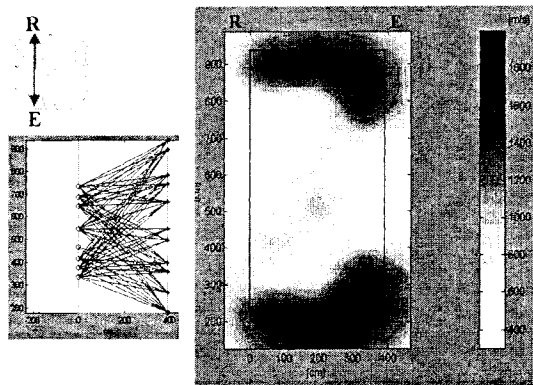
Fig. 8. Vertical tomography of the pillar 2

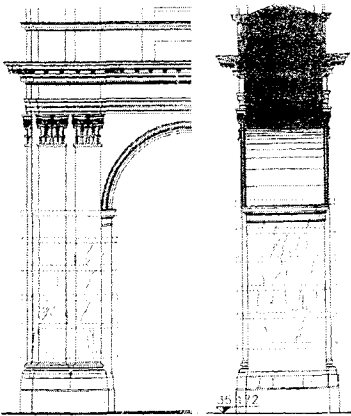
Fig. 9. Crack pattern of pillar 2.

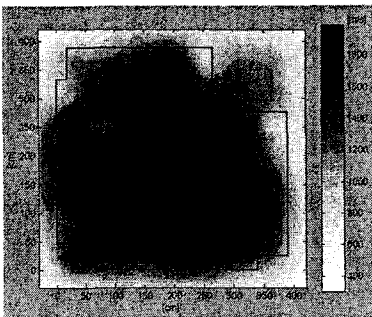
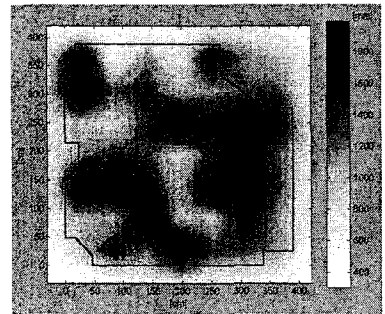
The other pillars that have been investigated generally present much higher velocities indicating a less alarming state of conservation (Fig. 10).

In particular the pillar 6 seems characterised by the better quality material. The observation of the masonry texture reveals a large block stonework, rather regular.

Fig. 10. Horizontal sections of pillar 6 and pillar 10 at 5.8 m.

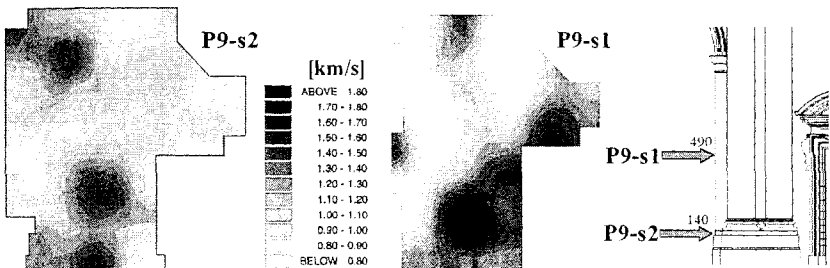
Some results on two very large pillars characterised by a complex geometry are worth of attention (pillars 9 and 12). They show higher velocities on the narrow side of the pillar and lower velocity on the large side (Fig. 11).

This trend is symmetrically observed on both the pillars and might be related to a specific construction design or to a non homogeneous state of degradation of these elements.

Fig. 11. Horizontal sections of pillar 9 at 1.40 and 4.90 m.
