## Investigation on structures and materials of the Castle of Avio (Trento, Italy)

L. Binda, L. Cantini, M. Lualdi, C. Tedeschi, A. Saisi & L. Zanzi  
*DIS – Department of Structural Engineering, Politecnico di Milano, Italy*

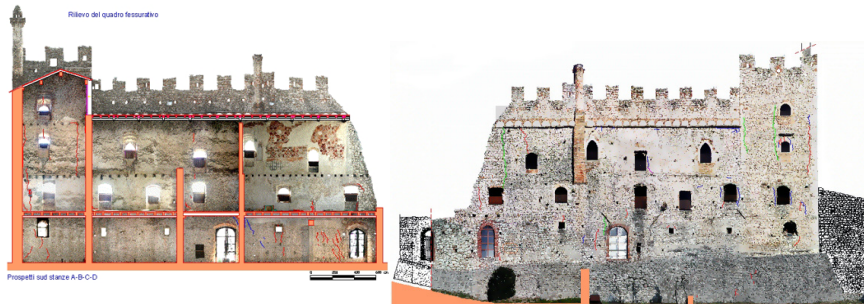
Figure 2: Avio Castle Crack pattern survey of the south wall.

Extended crack patterns are visible on the main walls of the Palace Tower and many rooms are characterised by remarkable vertical cracks crossing the wall section (Figs. 1, 2). The crack-pattern survey and classification together with a mapping of the discontinuities and of the masonry textures was carried out in order to have an important evaluation about the structural state of conservation of the building.

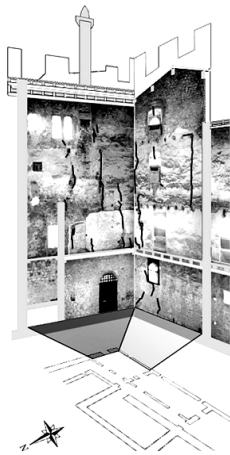
The most damaged among the structures of the Avio Castle is the Tower of the Palace. The cracks are close to the corners (Figs. 2, 3), and around the keystones of the upper arch windows.

This seems to indicate a lack of connection of the bearing walls in the corner, peculiarly in the upper part of the Tower where the timber floors are missed. Furthermore, cracks repaired with a dark grey mortar are visible, showing the long term existence of the structural problem.

Figure 3: Crack pattern of the Tower.

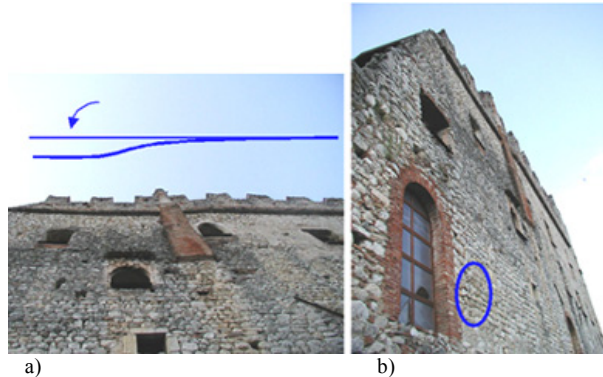
Figure 4: Deformation of the South facade toward the valley.

A relevant deformation of the western upper corner of the south wall (Fig. 4a) is visible. This inflection did not produce wide cracks and could date back to the collapse of the closer Tower, opposite to the Palace Tower, at the end of the 19<sup>th</sup> century since there floors were missing and the corner did not have any connection and protection.

Fig. 4b shows a wide out of plumb of the outside wall with stone expulsion, which produces a relevant crack pattern in the internal room. The cracks have similar slope. The damage probably is not connected with a deformation due to the height of the wall. The masonry seems very inhomogeneous, with round stones, also of small dimensions, and damaged mortar joints.

The wall of the Avio Castle at the basement level (Fig. 4), shows an evident out of plumb and some cracks which are monitored. Due to the large deformation, it was important to inspect the internal characteristic. Radar tests were carried out on parallel profiles in order to reconstruct the internal morphology.

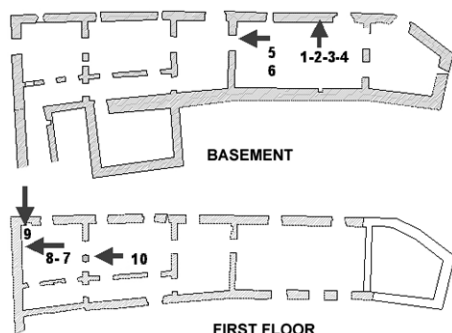
Figure 5: Localisation of the monitored cracks. Figure 6: Measurement.

In order to evaluate the differential movement of the Castle, the most serious cracks are being monitored since December 2002 (Figs. 5-8). The deformations are measured by removable extensometer (Fig. 6) every 3 months. It is important to stress that the monitoring should be continued for four to five year, being the minimum significant period at least 18 months, in order to calculate the influence of the thermal deformation. Fig. 7 shows the localisation of some monitored cracks. Peculiarly, the position 1-4 corresponds to the buckling wall in Fig. 4. Fig. 8 shows the displacements measured up to now. The results of the monitoring show that some position like 3 and 4, 6, 7, 8 and 10 tend to extra movements which do not follow the temperature variation as they should do in a stable situation of the cracks.

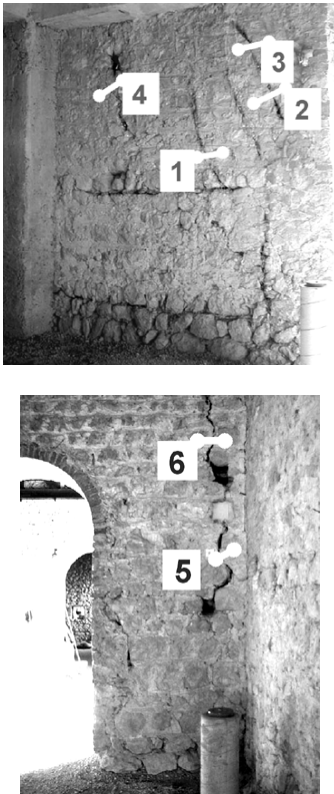
Figure 7: Localisation of some monitored cracks.

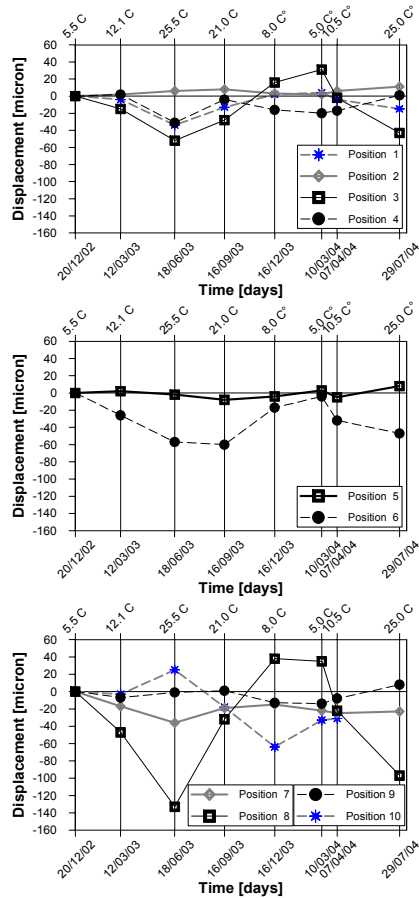
Figure 8: Monitoring of the cracks.

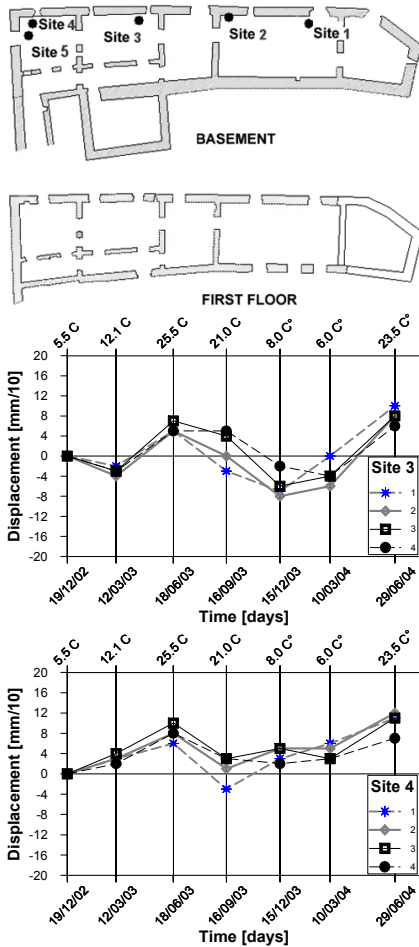
The trend is confirmed by the out of plumb measurements reported in Fig. 9. It was therefore important to collect also data on the morphology of the deformed walls.

Figure 9: Out of plumb measurements.

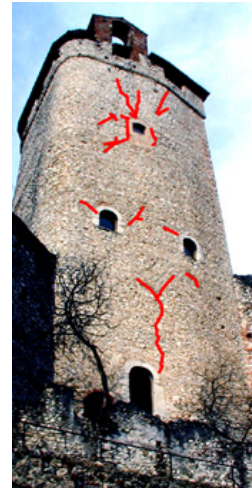
Another relevant crack pattern is easily recognised on the Mastio Tower (the oldest and tallest one), at the moment not yet monitored (Fig. 10). A remarkable crack pattern is visible on the Tower.

Figure 10: Crack pattern of the Mastio.

- The “Mastio” Tower, due to additional dead loads (e.g. a bell support and additional floors), the lack of connection and a probably multiple leaf badly connected masonry, should be also monitored and better studied.

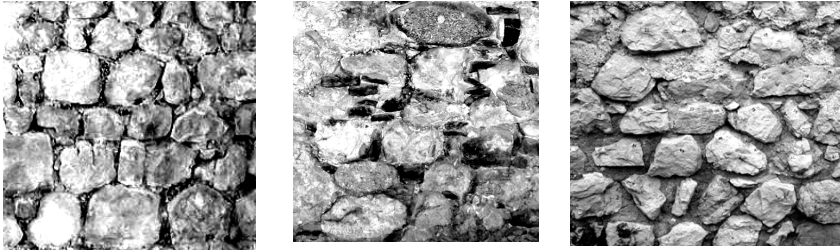
The Castle of Avio seems characterised by different masonry typologies. Fig. 10 shows the main masonry typologies of the Avio Castle. Two main masonry typologies can be distinguished: the external walls, most ancient, and the internal partition walls, in general not connected to the previous ones. The presence of cracks, in fact, stresses the discontinuity. The third masonry typology is the one of the Mastio.

Figure 11: Masonry textures of the external walls, of the partition walls and of the Mastio.

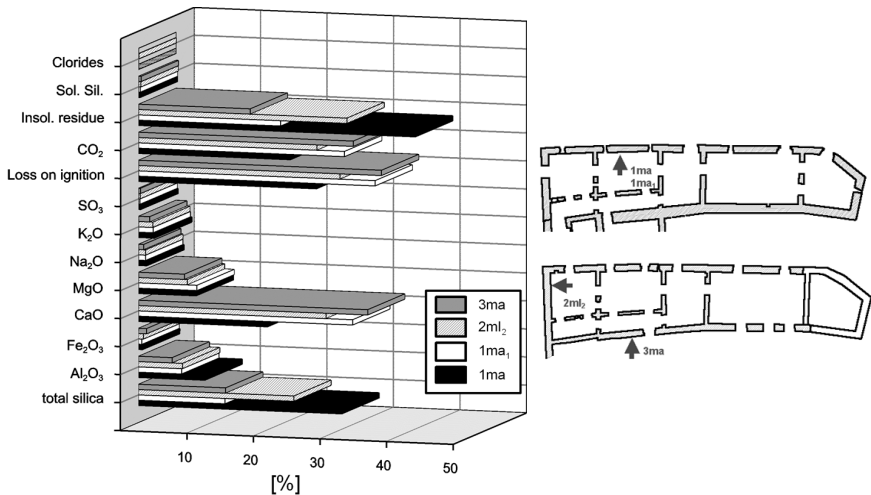
The results of the chemical analysis show similar materials, as it is possible to deduce from Fig. 12. The low value of Soluble Silica reveals the binder as lime. The aggregate origin is mainly calcareous, as revealed by the different percentage of calcium carbonate variable between 17% and 49%.

The tests also allowed one to conclude that the mortars are rather similar and made probably with local materials.

Figure 12: Chemical analysis of the mortars and localisation of the sampling.

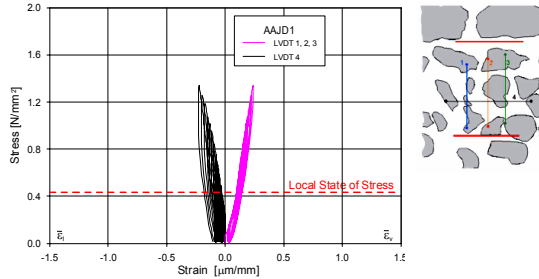
a)

**AAJ1D** Elastic Modulus (33-59%): 6524 N/mm<sup>2</sup> Local State of Stress: 0.43 N/mm<sup>2</sup>

Figure 13: Characterisation of the masonries typologies by double flat jack.

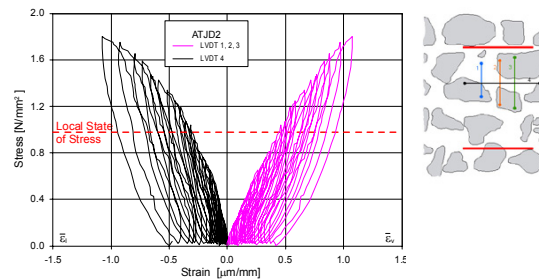
b)

Unexpectedly it seems that the “Mastio” walls are more deformable than the other walls. Due to the fact that the flat jack test is very local this results should be check by other tests.

**ATJ2D** Elastic Modulus (10-36%): 2307 N/mm<sup>2</sup> Local State of Stress: 0.97 N/mm<sup>2</sup>

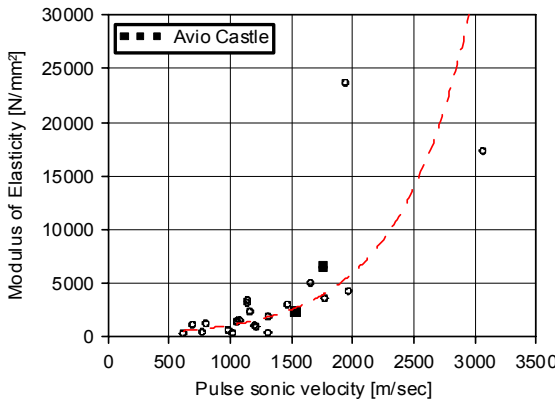
Fig. 14 shows a tentative correlation between pulse sonic tests and the modulus of elasticity by the double flat jack on a group of 25 cases. The test results seem to be aligned with the other data.

Figure 14: Correlation between pulse sonic tests and Modulus of Elasticity.

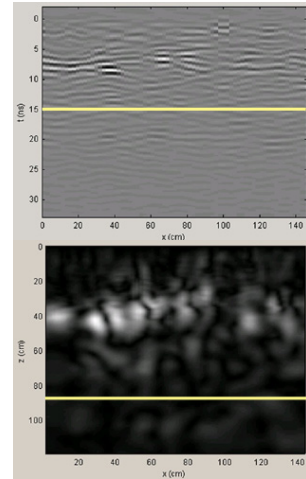
The radar inspection showed in several areas less compact materials (Fig. 15) that could be interpreted as local detachments of the two leaves of the masonry (Fig. 16). Fig. 16 shows the reconstruction of the radar profiles, enhancing the targets in a sequence of depth slices. Several voids are readable in the radargrams in correspondence of the leaves interface. This conclusion was confirmed also by direct visual inspection. The material found is very poor with weak or even locally missing mortar (Fig. 17). This can explain the appearance of bulging only on the outer surface as a detachment of the two leaves of the walls.

Figure 15: Radar profiles indicating the presence of a two leaves section.

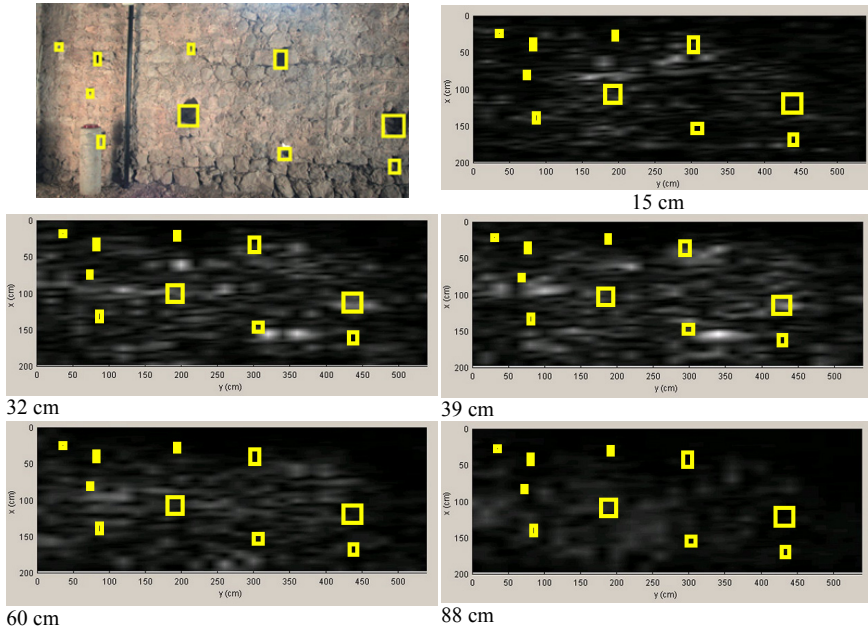
Figure 16: Reconstruction of the radargrams respectively at the depth of: 15, 32, 39, 60 and 88 cm. The elaboration enhances the presence of internal voids (white spots). White boxes identify the positions of surface cavities and missing stones.
