NDT assessment of timber structures: a case study – Villa Ivonne, Meliana

A research group at the Polytechnic University of Valencia [1] has developed a NDT method of assessment of timber structures applied to the historic heritage. “Villa Ivonne”, a traditional building located at Meliana, close to Valencia (Spain) with timber roofs. It was used as a case study in which this method of assessment was applied. Besides the NDT measurements, visual inspection was done and its building timber structure system and pathology was studied. In this paper the NDT method is presented, by using ultrasonic, micro drilling and wood hardener devices. From the conclusions of these studies, pathology causes can be identified, and the subsequent repairs can be proposed.

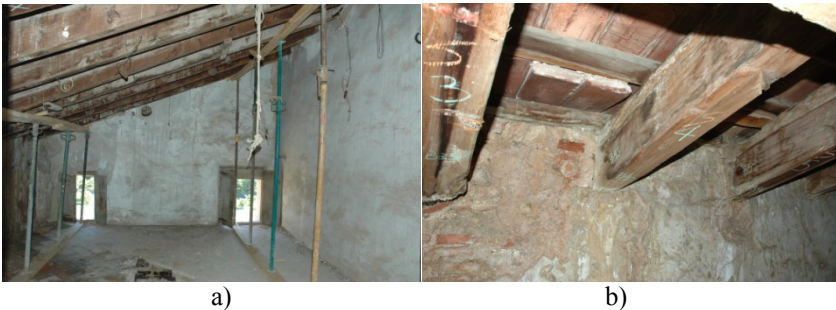
Figure 4: a) General view of the roof structure, b) a detail of the roof structure.

Its general condition is very impaired, having produced partial collapses in some areas. There has also been dismantling and uncontrolled stack of some coatings, and in some cases has suffered vandalism actions. All this has led to propose a series of studies on the building and intervention projects, which to date have not been able to be carried out. Preventive actions such as cleaning, shoring and removal of those elements that had a higher risk of collapse has been the only works done. As a conclusion of the aspects mentioned above, mortar coatings of exterior walls and carpentry are seriously damaged, and roof leaks have allowed water to reach timber elements producing wood rot and other biological attacks.

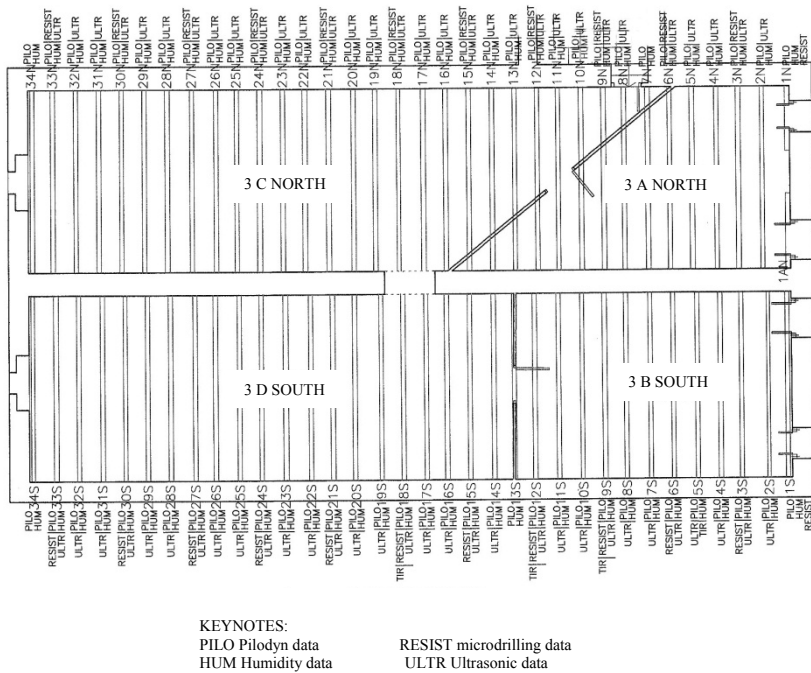
Figure 5: General plan of the roof structure, with indication of the NDT testing.

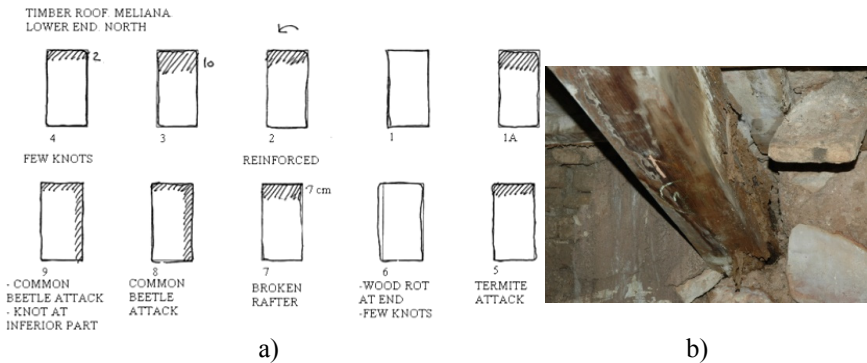
Figure 6: a) Sketches of cross section rafters 1A to 9; b) Detail of rafter 6 N.

Specie: *Pinus sylvestris* (visual identification)

- straight fibre,
- knots: \varnothing 5 cm, separation 30-40 cm
- sapwood on upper face, about 2-4 cm height

Timber structural quality: ME-2 (UNE 56544:1997), C24 group

- common beetle attack,
- longhorn beetle attack,
- wood rot at ends

As the case study belongs to a roof structure in which bearing loads are not supposed to be increased after restoration works will be done, the recommendation is to repair damaged ends by means of epoxy resins and fiber glass bars as well as broken elements by using the same technique or eventually its substitution by new elements of same wood specie. Brick board must be repaired and tiles replaced, when necessary.

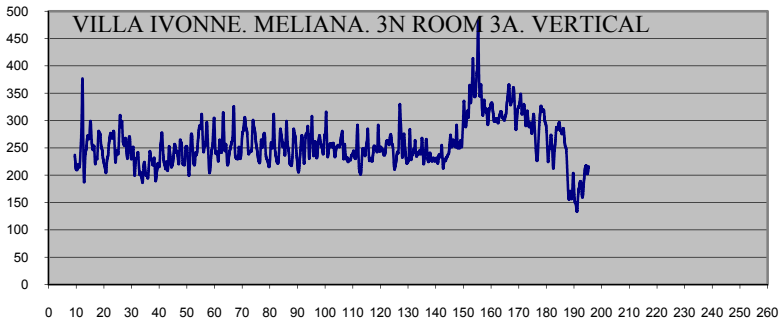
This testing allows having the internal view of the timber element. Graphs of two rafters, 3A room, are included in this paper: 3N and 6N (Figures 8 and 9 respectively). The values of vertical axis belong to the engine force to maintain the same velocity of penetration of the \varnothing 1,5 mm pin. Horizontal axis shows the position of the possible discontinuity of the rafter cross section, measured in centimeters. The first and the last centimeter of the graph should be rejected since it is due to the resistograph adjustment on the material. It is evident that on rafter 3N there is a discontinuity at about 5 cm from its upper surface, where sapwood appears to be. In rafter 6N there is no evidence of the wood rot at its

Figure 8: Microdrilling graphic of rafter 3N, vertical direction.

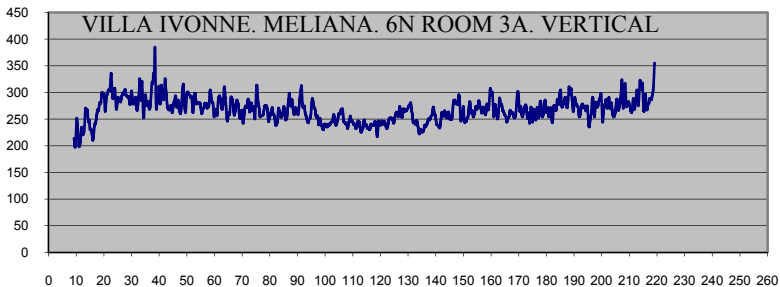
Figure 9: Microdrilling graphic of rafter 6N, vertical direction.

end, as the resistograph was positioned at 25 cm to the wall. So, this decay is only localized at its end, where wood is in contact with wall materials.
