RC frame structure strengthening by reason of insufficient concrete strength

P. Stepanek, I. Lanikova & P. Simunek
Brno University of Technology, Czech Republic

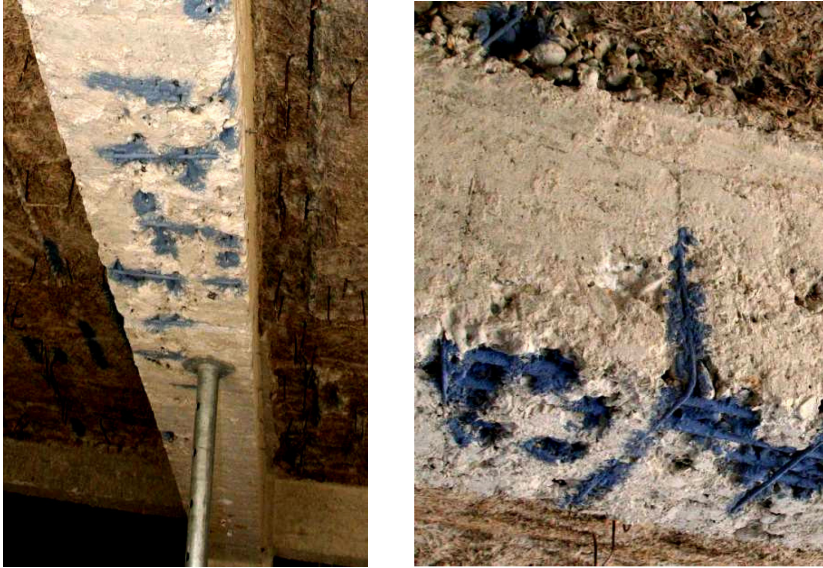
Figure 5: Local failures of a girder after plaster removal.

The load-bearing structure did not demonstrate any serious static faults (deformations, cracks) when checked visually before the removal of plaster. After the plaster was gradually removed, local failures, insufficiencies in the quality of the concrete and inexact positioning of the reinforcement were detected (Figs. 5–8).

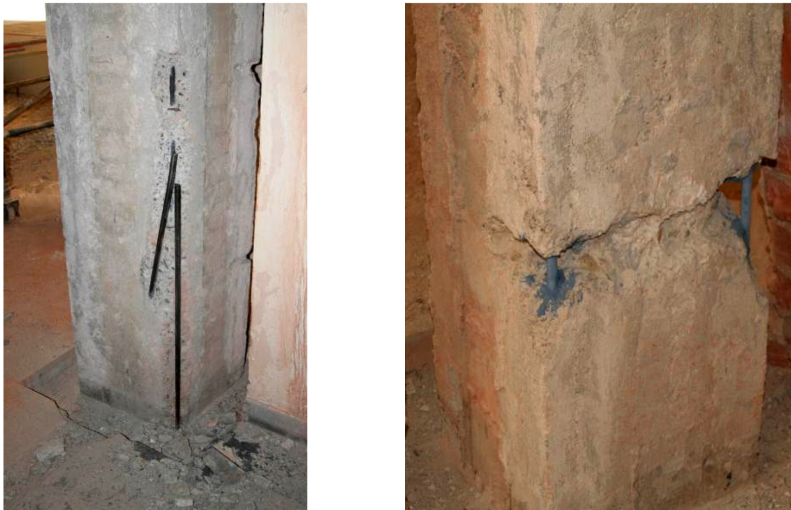
Figure 6: Local failures of a column after plaster removal.

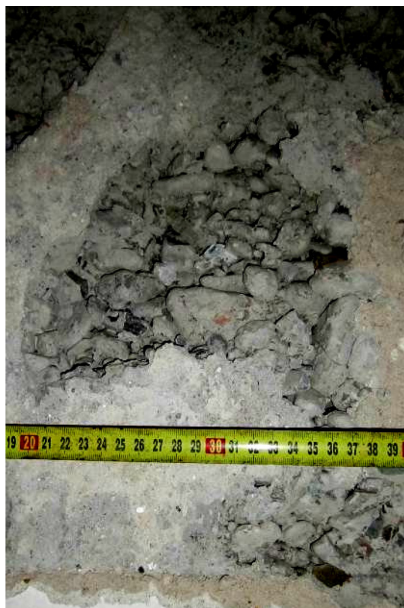
Figure 7: Faces of some columns after plaster removal.

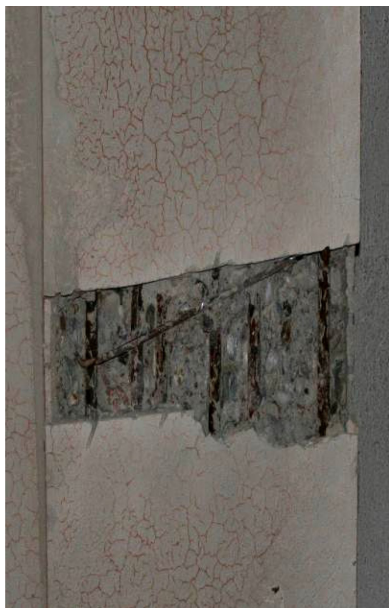
Figure 8: Checking the amount of reinforcement.

Plain steel bars were used as reinforcement, these being 10370 steel according to the original design with a design strength of 180 MPa, see standard [1]. The drawing documentation concerned with statics is incomplete. The amount and positioning of the reinforcement was verified for selected columns and girders and it more or less corresponded to the drawings (the difference was about 20%).

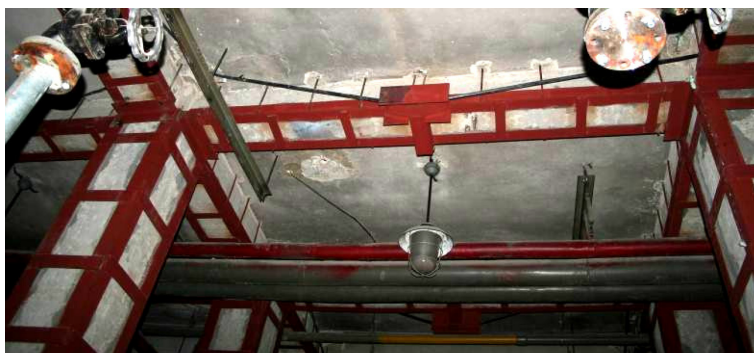
Figure 9: Column and beam bandage.

Transverse stress was applied to the columns via the incremental heating of the bandage strips by around 100°C and their welding to the corner angle sections.

After the columns had been bandaged, it was also necessary to bandage most of the girders due to the low strength of the concrete from which they are constructed. The girders' bandages were fixed to the columns' bandages.

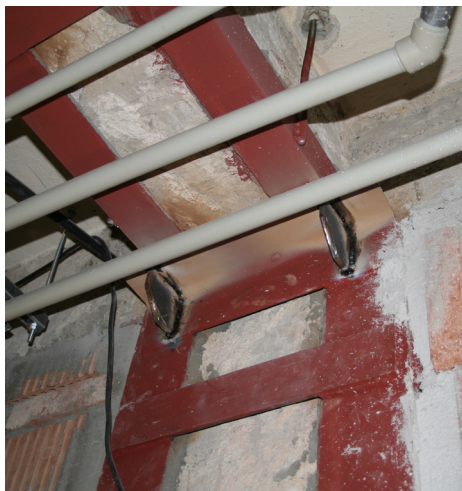
The reinforcement in the bottom part of beam is inadequate. This was compensated for via the attachment of beam bandage to the column bandage, and prestressing (Fig. 17).

Figure 17: Beam zone with positive moment, strengthening.

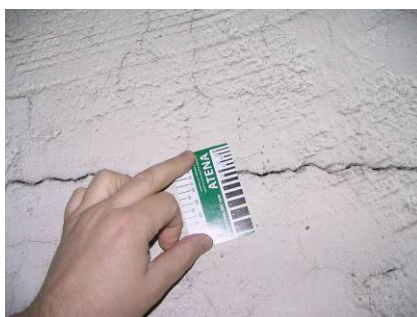
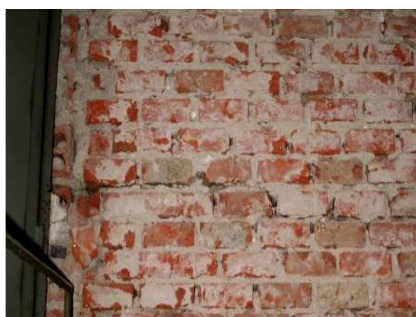
The gable wall above the primary RC beam of foyer m was cracked. The damage was caused by beam deflection (elastic, shrinkage and creep, etc.).

Figure 18: Gable wall crack.

The crack was stabilized; grouting and reinforcement stitching was an adequate solution (Figs 21 and 22).

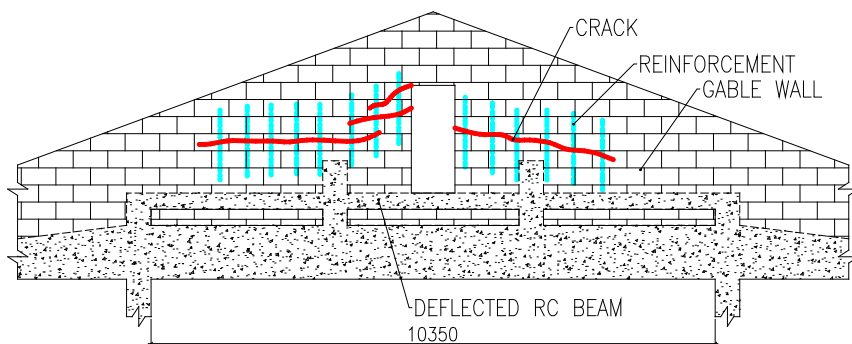
Figure 21: Gable wall, crack and repair with steel reinforcement.

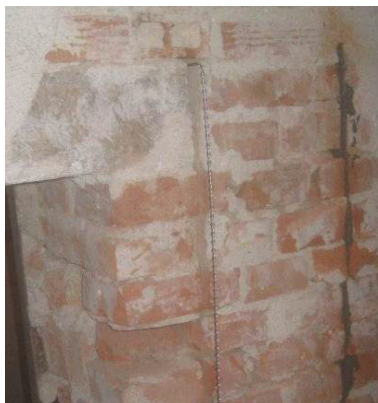
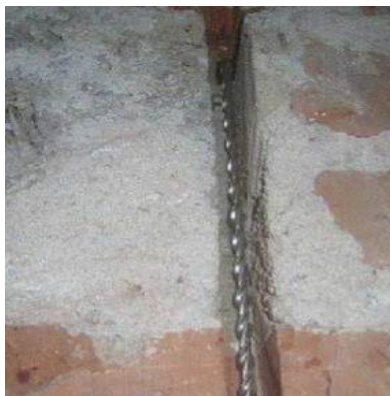
Figure 22: Gable wall, crack and repair with steel reinforcement.
