# A meaningful case of structural assessment following the collapse of a historical masonry building

F. Palmisano & A. Vitone  
*Politecnico di Bari, Italy*

The partial collapse of the so-called ‘Palazzo Edilizia’, which occurred in Salerno (Italy) on the night of June 15, 2007, is a meaningful case since it has revealed that ‘hidden’ structural defects can be the cause of ruinous and apparently unpredictable failures. The paper presents the investigations carried out by the technical consultants of the Criminal Investigate Magistrate. The purpose of the investigations was not only to determine the causes of such unexpected failure but also to give the Investigate Magistrate sufficient data in order to identify the parties responsible.

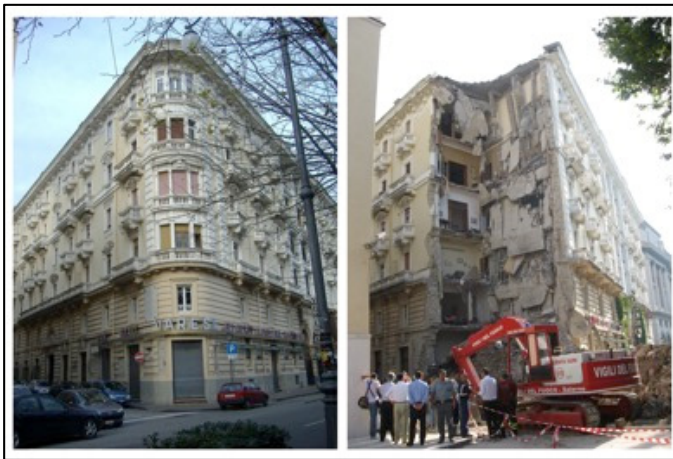
The building south-west corner, between Verdi Street and Trieste Promenade, collapsed (fig. 2) on the night of June 15, 2007, at about 3.30 a.m. On that corner, only the slab of the ground floor, the vertical structures of the underground floor and the foundations were not involved in the collapse. Just before the collapse, some creaks were heard and plaster detachments were seen.

Figure 2: Picture of the south-west corner (between Verdi Street and Trieste Promenade) before (left) and after (right) the collapse.

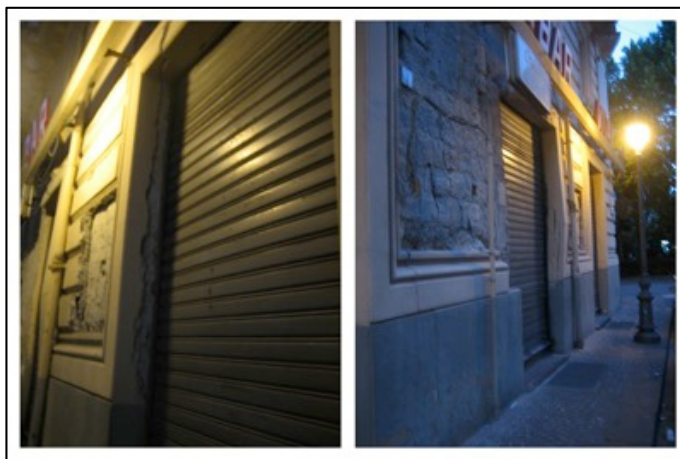
had been detected and the Condominium General Assembly planned retrofitting and monitoring intervention. Neither detailed reports on the cracks nor projects of the interventions were found in the investigations. Moreover, since the first survey (June 29, 2007), the technical consultants of the Investigate Magistrate observed many symptoms of compressive ‘over-stressing’, such as vertical cracks, also in areas very far from the collapsed corner and, hence, not attributable to the collapse.

Figure 3: Cracks around two openings of the Varese Bar (Verdi Street, June 13, 2007).

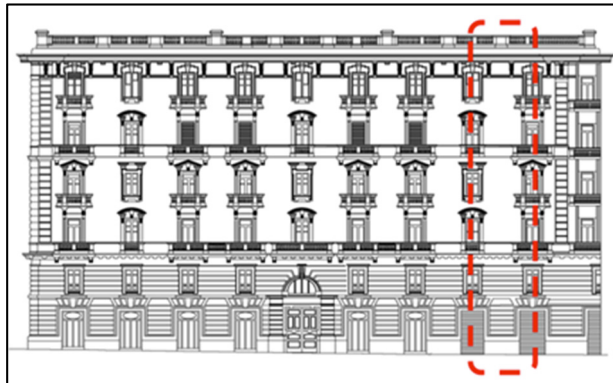
Regarding the collapse, the most important critical aspects of the structural conceptual design are the following: very few vertical diaphragms, weakening of the collapsed corner due to the presence of large openings, lack of tying systems [3], eccentric width reduction of the masonry walls from the lower to the upper floor, ground floor masonry piers narrower than those of the other floors (because of the larger openings at the ground floor; fig. 4).

Figure 4: CAD reconstruction of the Verdi Street façade with the indication of the masonry pier of the numerical analyses.

- The collapse was originated in the masonry pier in fig. 4.
- At the moment of the collapse the demand of axial resistance due to gravitational loads was sensibly higher than the capacity of the masonry pier in fig. 4. This is the primary cause of the collapse.

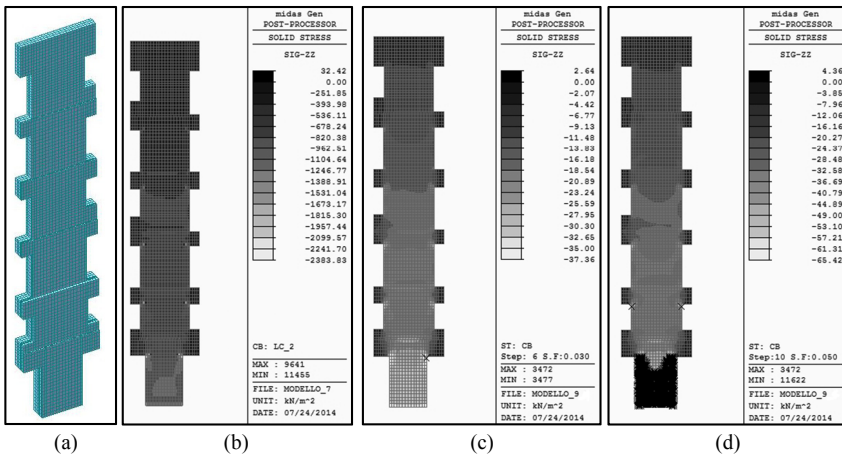
The linear finite element analysis has permitted to evaluate the stress peaks due to the deviations of loads because of the architectural characteristics of the wall (fig. 5(b)). These peaks are not negligible and they determine an important reduction (from 0.56 to 0.26) of the global safety factor evaluated by the simplified analysis, increasing, from a numerical point of view, the structural risk of that wall before the collapse.

Figure 5: Models of the FEAs: axonometric view of Models 7 and 9 (a), axial vertical stresses of Model 7 (b), yielding points of Model 9 at 3% of ULS load (c), yielding points of Model 9 at 5% of ULS load (d).

The results of the nonlinear analysis (figs 5(c) and (d)) show that the first yielding points are at the intersection of the wall with the lintel of the opening at the ground floor (3% of the ultimate limit state design load). Then the yielding points immediately spread all over the ground floor panel (ultimate load equal to the 5% of the ultimate limit state design load). This means that the masonry under study has no capacity to redistribute the internal stresses.
