Static restoration of San Domenico's church at Ruvo di Puglia (BA)

SUMMARY

The construction of San Domenico's Church at Ruvo di Puglia—a town in the province of Bari, (Italy)—was begun in 1560 and continued intermittently until the 19th century when it was finally completed.

To investigate causes of the discontinuities, the site was excavated and drilled, special interventions were planned, some of which have already been completed while others are still in progress or are nearing completion. Essentially the work involves in consolidating the whole structure starting from the foundations on calcareous rock strengthened with cement-water injections and micropiles.

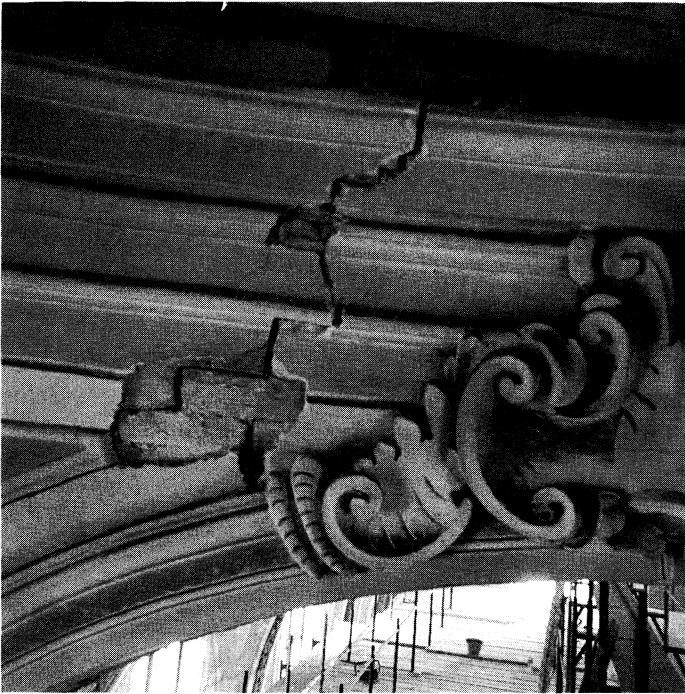
The cracking of greatest concern inside the Church is that to the four arches that support the dome, positioned at the intersection of the central nave and the transept have become visibly damaged, particularly the keystones, with gaps of the order of several centimetres. With time this has brought a variation in the static functions of the load bearing structures of the building from the original pillar-arch system with the load being transmitted to the foundations to one of semiarches and pillars acting as brackets (fig.1).

The cracking seems to be basically symmetrical, with reference to the four pillars examined, even though the external plumb line of the first pillar on the right is more marked than the other three.

FIG. 1 : Damaged arche before intervention.

- Stitching of the arches with injection of epoxy resin and relevant reinforcement with inox-steel bolts carried out in such a manner as to constitute a suitable " space-lattice " in thath it gives back continuity to the same and absorb the residual cracking phenomena.

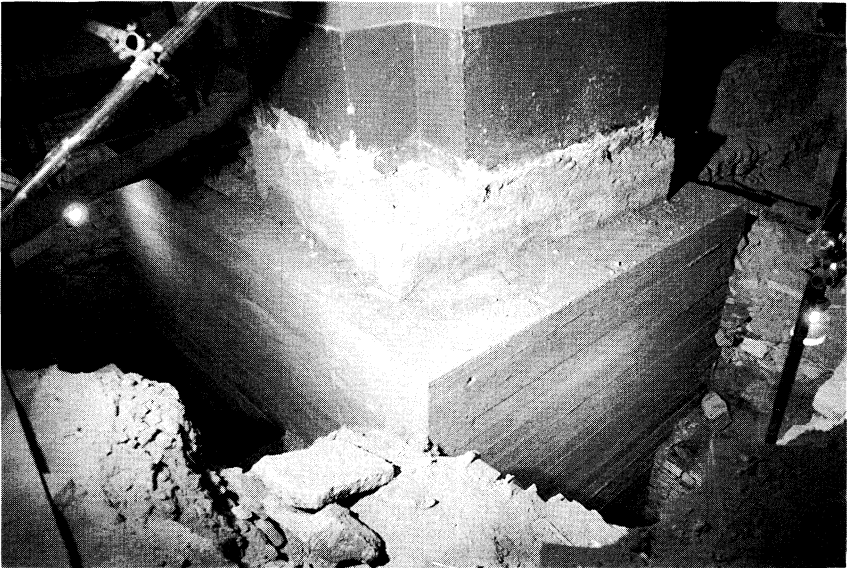
FIG. 2 : Foudation of pillar with a reinforced concrete wall.

The first phase consisted of the stitching of the walled structure of the foundations using 30 mm bores reinforced with 12 mm steel rods of improved adherence and successive injections of water-cement mixture at high pressure. In addition the work was carried out so as to bind the foundations with reinforced concrete walls, in which case the direct observation of their consistency became necessary. (Fig. 2).
