Restoration of thin shell brick domes: the chapel of the 'Hospital de la Caridad'

P. Valcárcel, Jr.^a, F. Escrig^b, S. Muñiz^a

Abstract

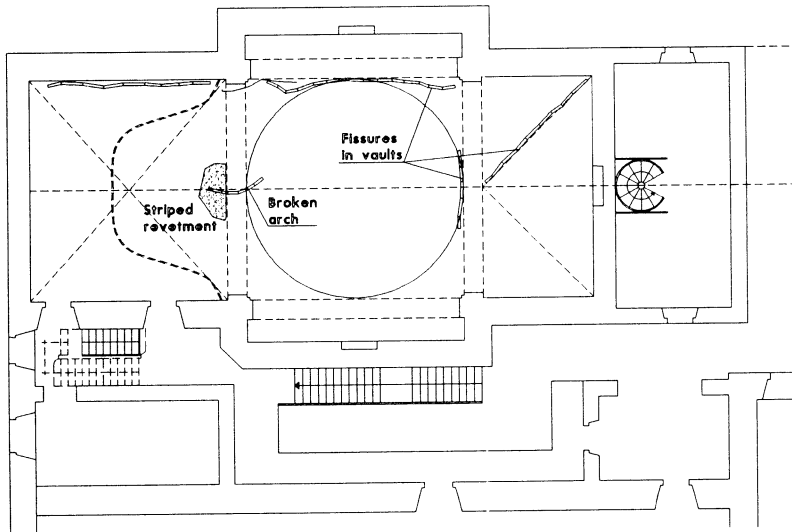
Fig. 3.- Crack damage on chapel

Instead of the low-quality of the used materials, the building in 1979 was in satisfactory condition, specially after a well-conceived restoration to transform it into a cultural centre. However, in the adjoining building, 5 m from the chapel, works to build a big block of houses with five basements for a parking place started. For that, it was performed a basement wall anchored to the ground under the chapel of the hospital. As it is often in this kind of excavations, there was a landslide that made the nearest of the chapel turn in such a way that broke the group of vaults. In consequence, vaults fissured reaching values up to 5 cm wide of fissure and threatening the stability of the

whole seriously. In the fig 3, the pathology that presented the chapel can be seen and the fig 4 and 5 show two aspects of them.

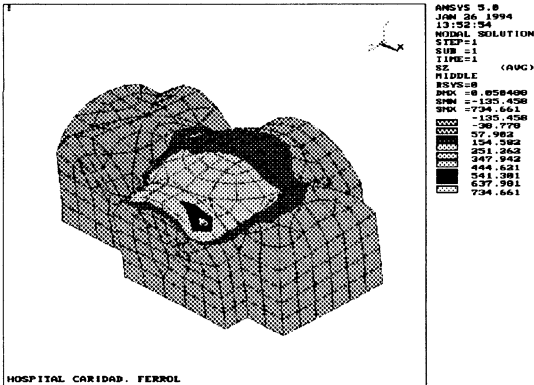
Fig 7.- Horizontal stresses after displacements by settlement

A first study considering the situation of chapel after displacements by settlement was made. The whole was modelized introducing displacements similar to real ones. Fig 7 shows the horizontal stresses in vaults. It is noteworthy that the tension stresses appear in the joint between the central dome and the former arch. These stresses are up to 50 Kp/cm² and could be 73.4 Kp/cm². The domes made with low-quality brick are not strong enough and in fact is the area fissured as it was described in the pathology.

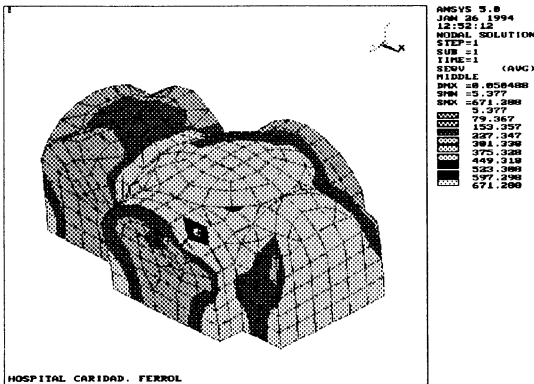
Fig 8.- Equiv. stresses after displacements by settlement

Fig 8 shows the equivalent stresses on a perspective of chapel model. Fig 9 shows the same in plan and fig 10 in frontal view.

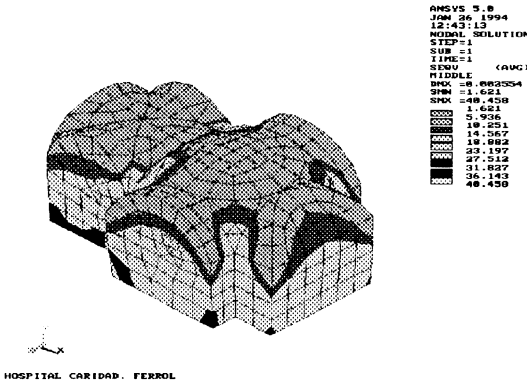
Fig 11.- Stresses under gravitational load

In order to check the stability of vaults after repair it was necessary to study the situation of the chapel considering fissures closed with mortar of epoxy. The fig 11 shows the equivalent stresses in perspective, the fig 12 in plant and the fig 13 in frontal view.

The executed hooped is indicate in the fig 11, 12 and 13. First, sections of hoop corresponding to lateral walls were made and later transversal ones were tensed. They were tensed the first day, afterwards they rested and were tensed again 24 hours later. At the end of one week they were tensed again and the hoop was covered of concrete.

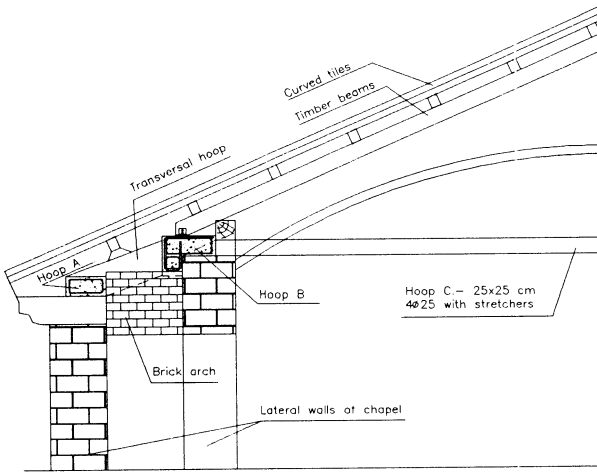
hooped with several timber beams that we believe were decisive in order to limit the opening of fissures. Anyway the building was in rather precarious condition and in fact during the initial phase of reinforcement, the chapel continued opening instead of the fact the lateral walls

Fig 14.- Reinforcement by prestressed hoops

All of this made us decide to do the hooped with a slight prestressed. It was a question of preventing the enlargement of steel bars when receive the load producing new fissures in the group of vaults. It was also a question of recovering as far as possible the initial condition, closing fissures as the resistance of walls allowed it.

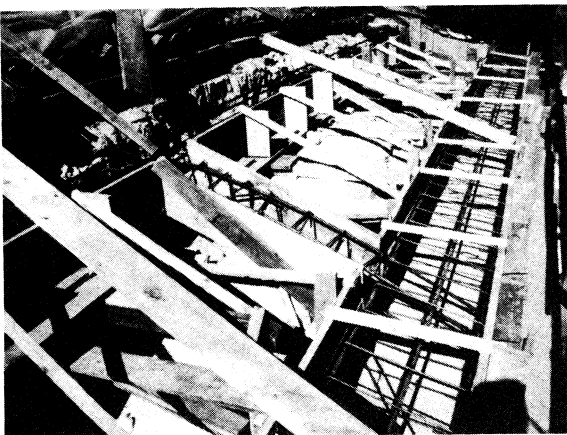
Fig 15.- Construction of hoops

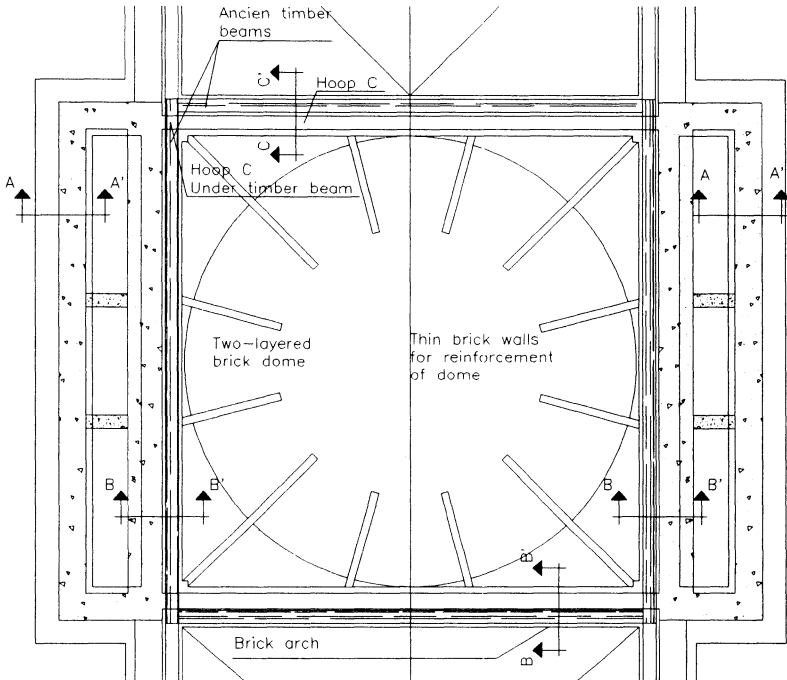
Fig 16.- Design of reinforcement

The group of hoops served as support to the new timber trusses of covering. The roof was made in curved tiles, respecting the initial form of the building. This phase lasted three months approximately and when it was concluded, fissures were injected with mortar of epoxy, finishing then the work of reinforcement.
