# **The Berlin “Neues Museum” – structural analysis, stabilization and structural design for restoration**

J. Seiler & G. Eisele

*Ingenieurgruppe Bauen, Karlsruhe – Mannheim – Berlin, 10999 Berlin, Leuschnerdamm 13, Germany*

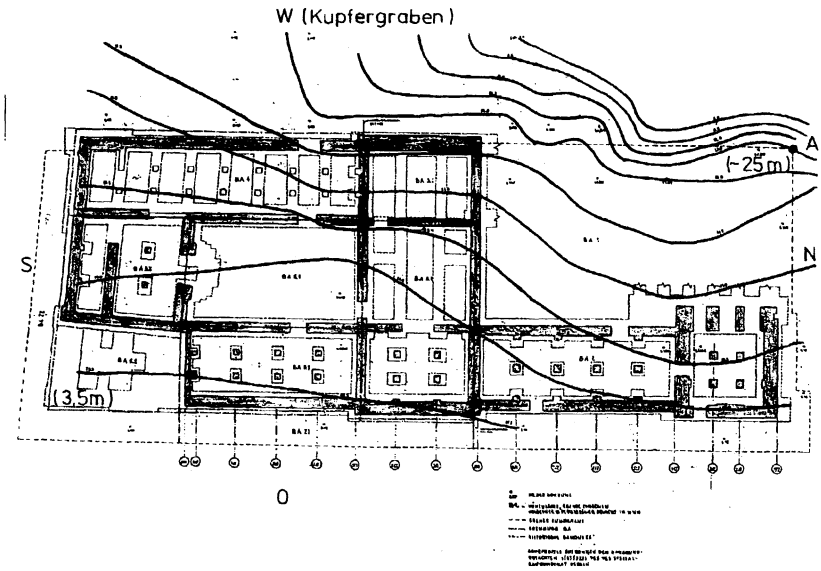
Figure 1: Contour lines of the firm subsoil layer

Thus we are dealing with crater-like sheer drops throughout the firm bearing stratum. Of all the buildings on the Museum Island, the Neues Museum is the one most negatively effected by this type of inhomogeneity. From the southeast corner to the northwest corner, the level of the firm soil layer falls to almost 25 meters below the undersurface of the building's foundation.

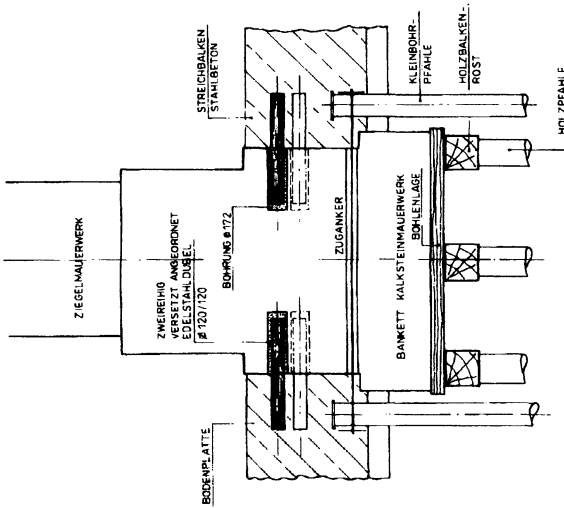
Figure 3: Load-transfer structures prior to German reunification

Our first task was to inspect the previously built load-transfer structures as to the effectiveness of load transfer from the walls to the newly built-in pilings/underpinings. The builders in the former German Democratic Republic had chosen to use „high-tech“ construction methods with stainless steel pegs and tie rods of prestressing steel. These structures, however, put

heavy strain on the historical masonry. (Figure 3). We countered with „robust“ construction (Figure 4), which meant less overall drilling into the historical building substance, which called for only general purpose constructional steel and which caused less strain on the historical masonry.

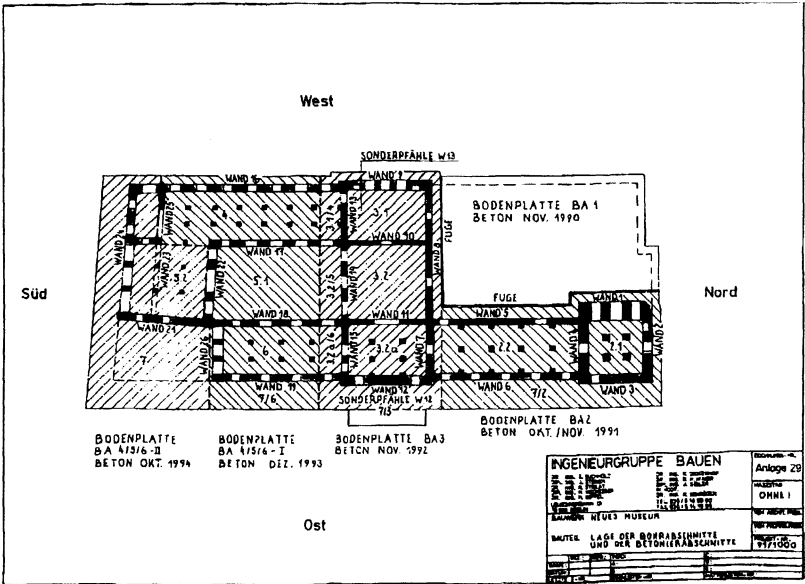
Figure 5: Ground plan of the remaining cellar walls Construction divisions

- Drilling stresses considerably increased settlements (Figure 5).
- These are settlements which would also have occurred without drilling stress, although in that case these settlements would not have happened within such a short period of time.
- Periods of drilling further revealed a clear picture of the mechanisms of movement which were already inherent to the edifice and which stem from damage caused by the inhomogenous foundation situation. The data gathered thereby provided the basis for decisions regarding appropriate superstructure stabilization measures. (Figure 7)
- Upon completion of the piled bearing plate, the results of wall testing and the results of tests conducted on the piled bearing plate proved to be identical, thus demonstrating the efficacy of the load transfer structures.

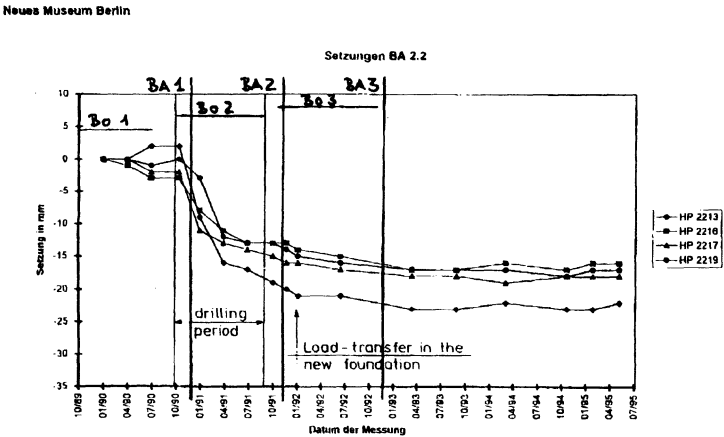
Figure 6: Evaluation of the surveys and tests for settlements (exemplary)

- The secondary settlements which have taken place since the piled bearing plate has hardened are insignificant. The uneven settlements of neighboring points, which were to be expected, are acceptable and can be handled by the superstructure (Figure 6).
- It must be assured that this uniformity in terms of displacements and deformation is not lost when the superstructure is rebuilt.
- Some localized damage may result from uneven settlements.
