New disaster management system in Turkey: a case study of the 2011 Van earthquake

F. Oktay, C. Tetik, O. Gokce & G. Cebi

Disaster and Emergency Management Presidency, Turkey

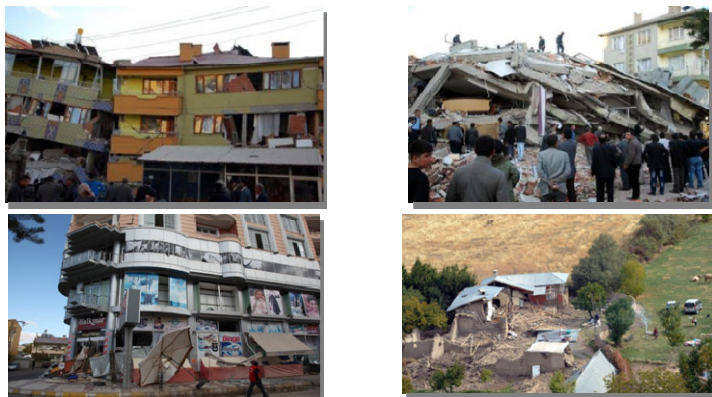
The earthquake resulted in heavy damage to buildings and significant casualties in this province, particularly in Erciş district. A number of 5–7-story RC buildings collapsed particularly in Erciş and Van centre. The major causes of the heavy damage to reinforced concrete buildings were basically similar to the observations in previous earthquakes such as poor quality of construction materials, lack of implementation of design codes, the existence of soft floors (weak floors), pounding, lack of ductility, poor integrity of RC frames with in-fill walls, poor quality of workmanship and poor ground conditions (Fig. 4).

Figure 4: Photos showing destroyed and damaged urban and rural buildings.

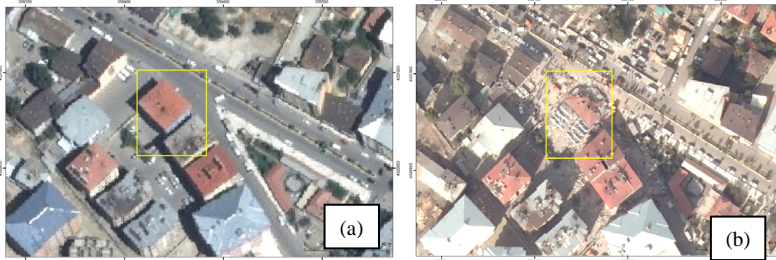
Figure 5: Manual determination of collapsed building in Erciş district by high resolution orthophotos ((a) before earthquake image, (b) after earthquake image).
