Successful rehabilitation of a sand dune system

J. S. Antunes do Carmo¹, C. S. Reis², & H. Freitas²

¹*IMAR, Institute of Marine Research, Department of Civil Engineering, Coimbra University, Coimbra, Portugal*

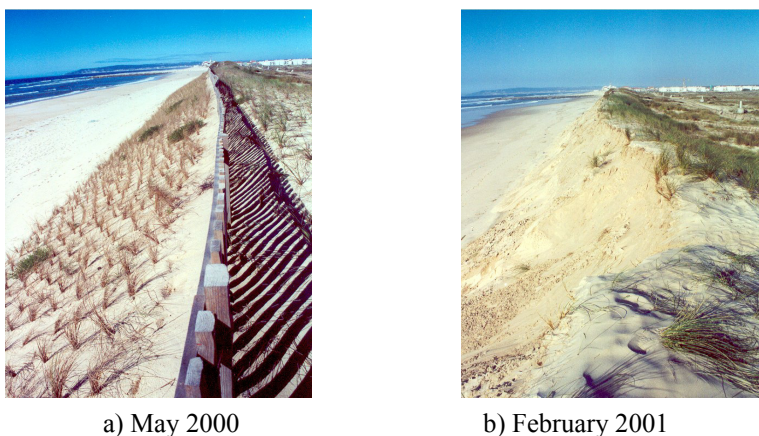
Figure 1: Reconstructed sand dune system, in May 2000, and its destruction due to a winter storm in early 2001 (Antunes do Carmo [2]).

A monthly monitoring plan was set up to see how the rehabilitated sand dune developed. After only a few months, several dune species started to colonize the area, meaning that the system was beginning to stabilize. However, in February 2001, during a storm that struck all of central Portugal, especially the coast, the oceanic front of the Leirosa dune system was destroyed. After this breakdown, the monitoring plan was kept up on in the continental side of the dune, and the results were rewarding since in only a little more than a year a stable dune was formed, with the colonization of about 25 plant species and a significant increase of the percentage of plant cover (Reis and Freitas [1]). The situation on the ocean side was different, however, since after the storm, and with the loss of all the plant cover and a considerable amount of sand, the erosion was intensified on this part of the dune, as shown in Figure 1.

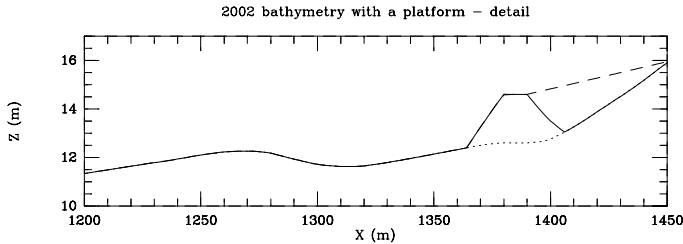
Figure 2: Detail of the bathymetry with a platform installed (continuous line) 60-70 m before the existing sand dune base (Reis *et al.* [7]).

presented in detail in Reis *et al.* [7]. These conditions represent characteristic situations of calms and storms over an installed submerged breakwater, followed by a platform (see Figure 2), and with the crest level situated 2.0 m above the zero hydrographic level (ZH).

As shown in Reis *et al.* [7], all these situations lead to a significant reduction of wave amplitude and also, as a consequence, its energy potential, after the generalized wave breaking process over the platform, approximately 60 m to 70 m away from the sand dune base and a 2.0% to 2.5% slope.

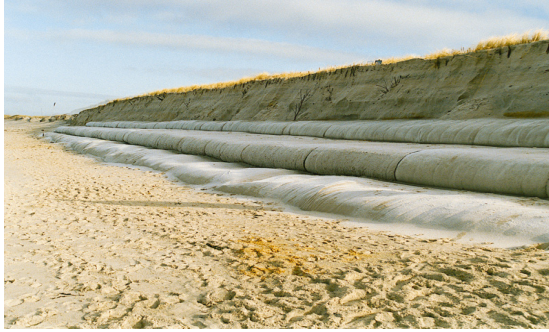
Figure 3: Application of geotextiles in coastal protection.

The solution implemented to stabilize the Leirosa sand dune system consisted of placing geotextile containers filled with sand. Figure 3 illustrates the technique and placement of the sand containers in layers. Once the sand containers were in place, this protection “barrier” was covered by a 1.0 m layer of sand which was planted with dune vegetation, turning this area into an attractive and safe coastal dune system. This technique, in particular the design and the different construction phases, which were completed between April and June 2005, are also explained in detail in Reis *et al.* [7].

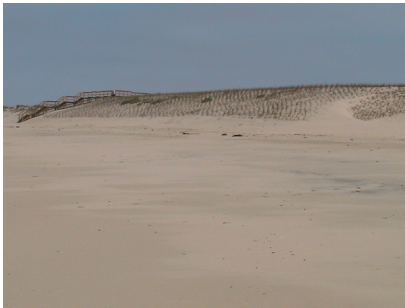
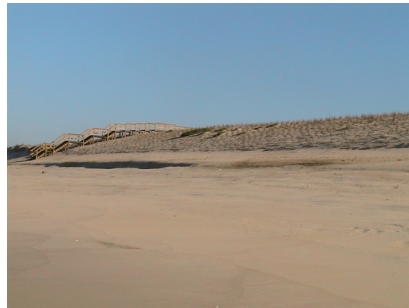
a) September 2005 (before winter).

b) February 2006.

Figure 4: Leirosa sand dune system: two different states of the intervention area.

Figure 4 shows two different configurations of the intervention: a) Dune system state before winter (September 2005), and b) Present configuration (February 2006).

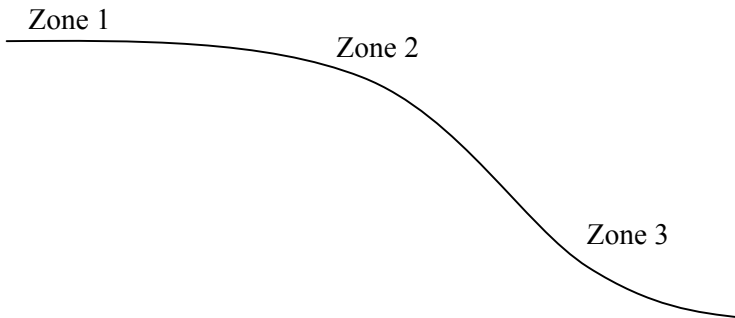
Figure 5: The sand mobility posts’ distribution.

The monitoring of the sand mobility was another important aspect that was covered in this study. For this, 24 graduated wooden posts were distributed along the restored dune system. Eight transects, about 15 m apart and perpendicular to the coastline were delineated. Three graduated wooden posts were placed in the sand, in each transect: the first one on the top of the dune, on the landward side; the second one on the top of the dune towards the ocean side, and the third one at the base of the ocean side (Figure 5).

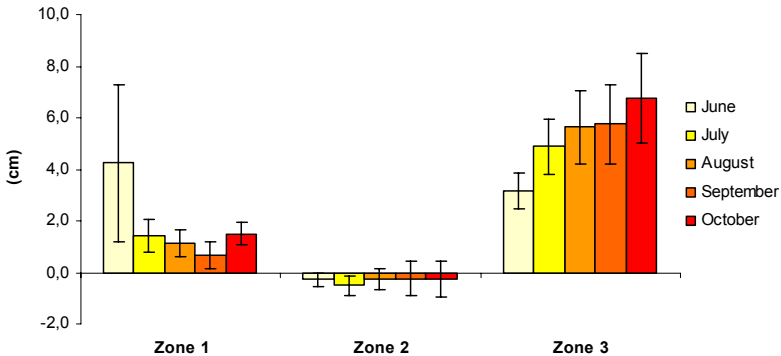
Figure 6: Sand mobility measured by the graduated posts placed along the restored dune system (Mean ± SE).

All posts were placed at zero level in the first month of the monitoring work, and every month the sand mobility was measured (Figure 6). After six months there is a clear distinction between the three defined zones.

A pronounced reduction on the sand level of the zone 1 was registered between June and September, which might explain the loss of two posts from this zone, one of them probably due to the enormous amount of sand that accumulated on the extreme north side of the dune.

Zone 2 is the only one where some erosion was noticed, although in a very small quantity and very stable over the period. Constant sand accumulation was registered over the six month monitoring period in zone 3, where the highest values of sand accretion were also registered.

This is important since zone 3 corresponds to the base of the restored dune closer to the beach area, which works as the first defense in a storm.
