The debris flow in Log pod Mangartom, NW Slovenia

M. Zorn & B. Komac

Abstract

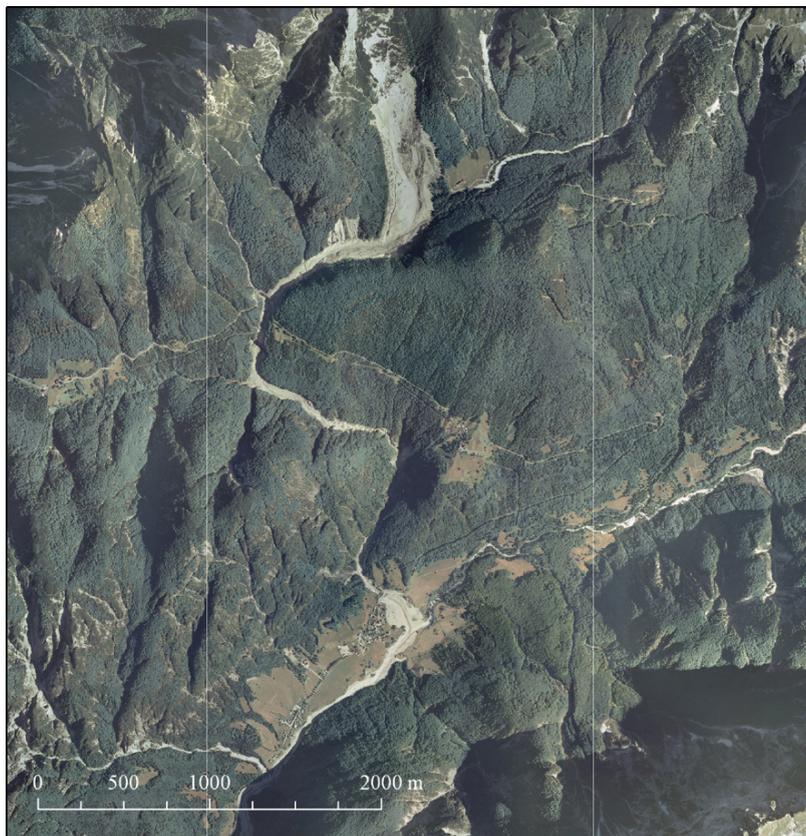
Figure 1: Aerial photograph of the event. (Source: Orthophotographic image, © Geodetic Survey of Slovenia, 2005.)

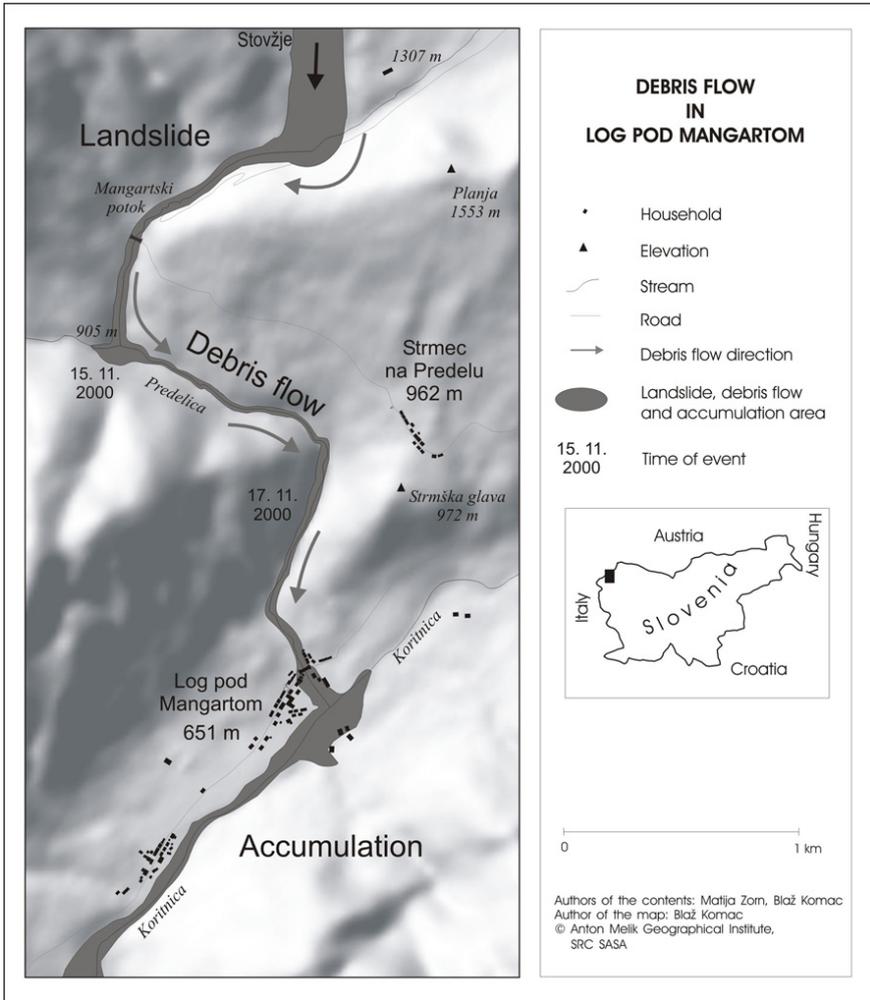
Figure 2: Map of the Log pod Mangartom landslide and debris flow.

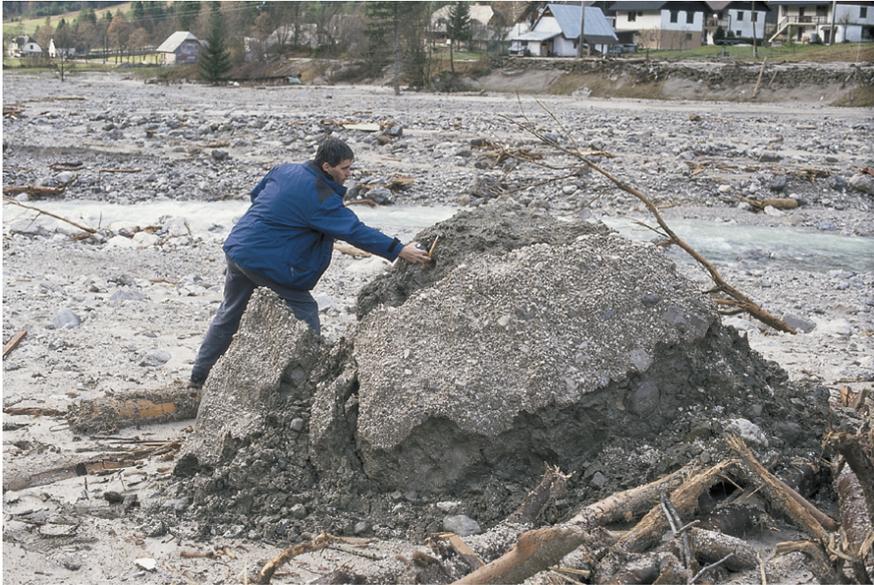
Figure 3: “Rubble-clay bomb” (Photograph: Blaž Komac, November 30, 2000).

Mud flows formed in the deposited sediment to form a lake that threatened the Mangartska Planina mountain lodge. Similar “clay bombs” (Figure 3) could also be found in the Koritnica Valley, where they gradually deteriorated into characteristic conical mounds [2].

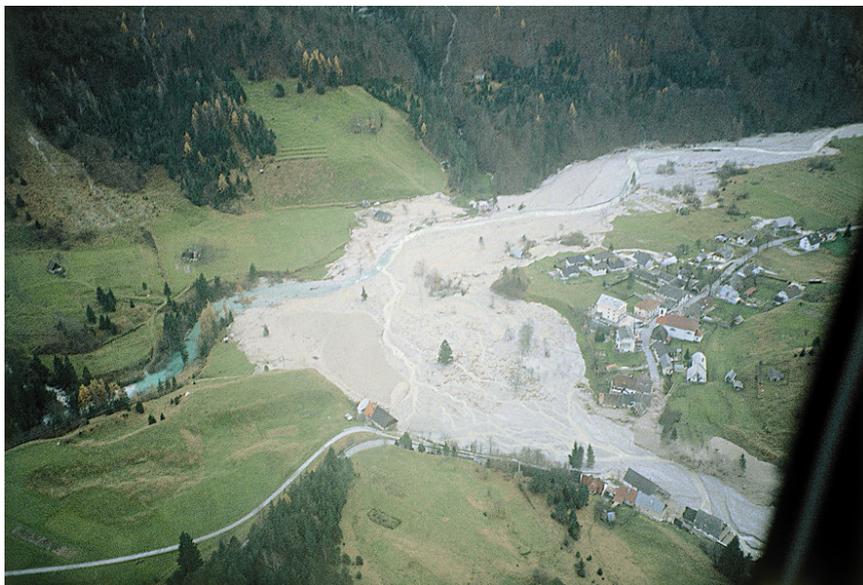
Figure 4: Debris flow fan at the confluence of the Predelica (right) and Koritnica (left) streams in Log pod Mangartom (Photograph: Blaž Komac, November 19, 2000).

During the debris flow in 2000, a total of 1.5 million cubic meters of material moved. Part of the material was deposited in the bed of the Predelica stream, and more than a million cubic meters was deposited over an area of fifteen hectares in the Koritnica Valley (Figure 4). For almost three kilometers, the valley floor was covered with a layer of alluvium several meters thick.

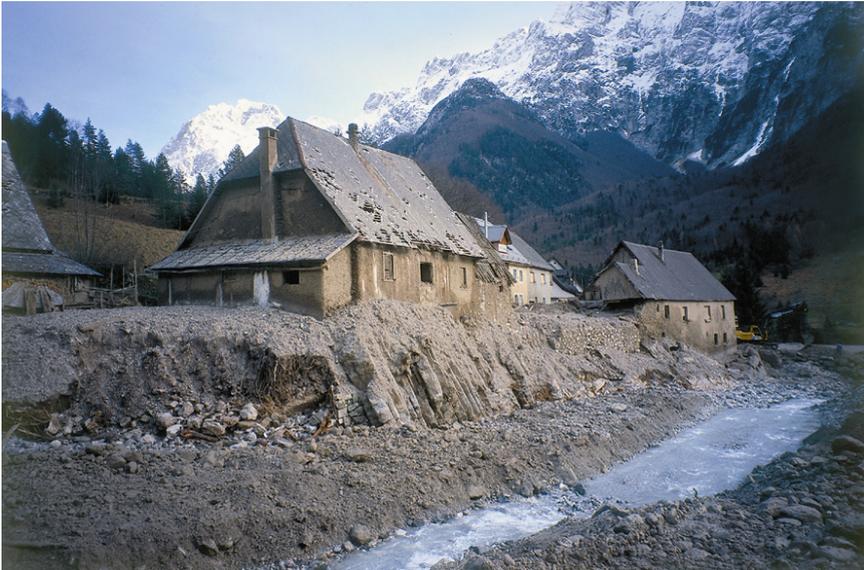
Figure 5: The debris flow destroyed or damaged 18 houses and 8 outbuildings (Photograph: Matija Zorn, November 30, 2000).

The natural disaster in Log pod Mangartom claimed seven lives and demolished or damaged eighteen houses and eight outbuildings. Two bridges were destroyed on the Predel Pass road that links Bovec in Slovenia with Tarvisio in Italy. The damage amounted to 31 million euros [16].

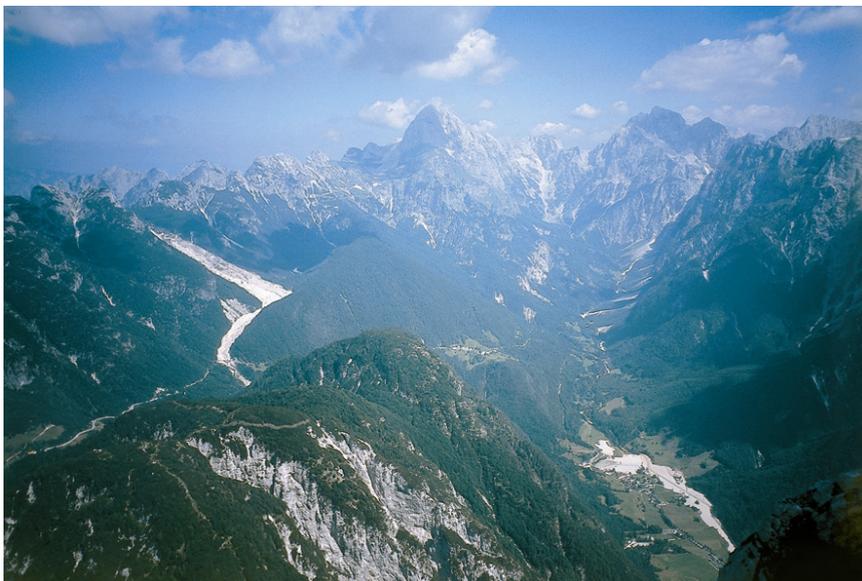
Figure 6: Mount Mangart (in the middle behind; 2,679 m) with landslide on the left and debris flow fan in Log pod Mangartom on the right (Photograph: Matija Zorn, August 25, 2001).
