Conservation of defence heritage structures using corrosion protection techniques

R. Brueckner & P. Lambert

Mott MacDonald, Materials and Corrosion Engineering, UK

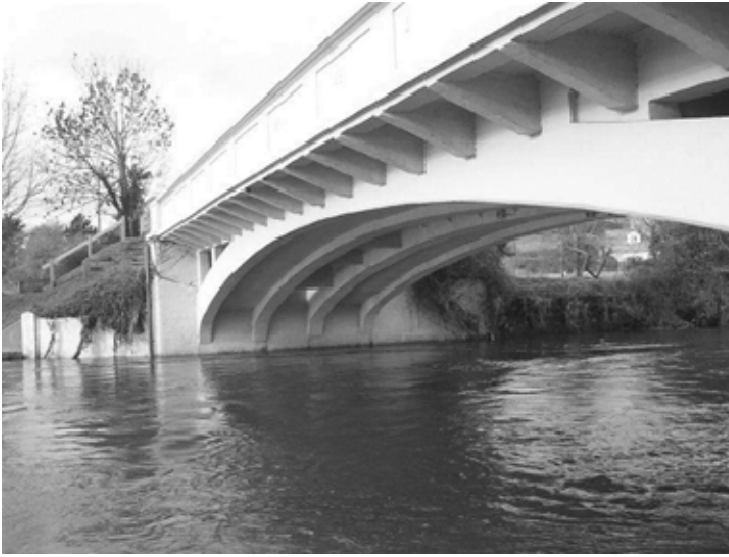
Thorverton Bridge is a good example of the approach required to apply CP to an historic reinforced concrete structure, Figure 2. This bridge is the main access to a small village in Devon in the south west of England. It dates from 1908 and is the oldest reinforced concrete bridge in Devon. In this case there were two requirements for the structure. Significant corrosion was identified due to carbonation of the concrete. Little chloride contamination was found in spite of the fact the structure had been regularly treated with chloride based de-icing salts. In addition to this the structure had been identified as understrength under the 40 tonne assessment programme and required bringing up to strength.

Figure 2: Thorveton Bridge.

The solution developed was based on casting additional concrete arches between the existing arches. A cathodic protection system was installed to ensure durability. The cathodic protection was based on discrete anodes comprising a coated titanium rod inserted into a carbonaceous gel. The anodes were up to 0.5m long and were interlinked using titanium wire back to a central power and control unit. The monitoring system was routed back to a remote system that could be monitored and adjusted via modem.

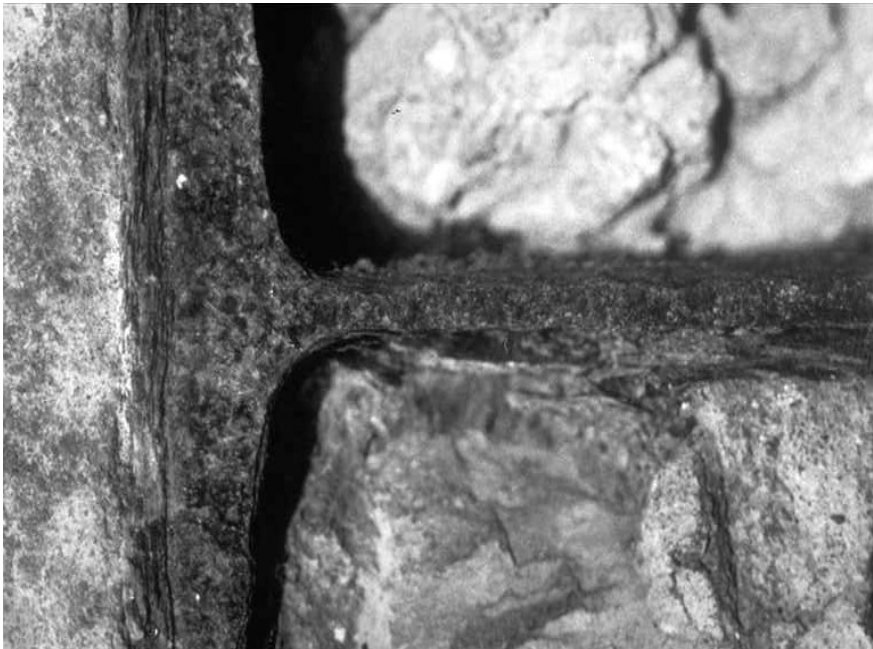
Over the last 75 to 100 years since construction of steel framed masonry clad buildings, the protection offered by the surrounding masonry has broken down and the steel has corroded resulting in cracking and displacement of cladding as higher volume corrosion has filled up the gaps, as shown in Figure 3. In extreme cases,

Figure 3: Corrosion of a masonry encased wrought iron beam.

the steel members have lost sufficient section to impair their structural capacity, requiring the inclusion of new or additional steel.

Traditional methods of repair require the displaced masonry to be removed and the corroded frame to be cleaned and recoated prior to reinstating the cladding. This is not only disruptive and expensive, but generally leaves large areas of corrosion where no displacement of the masonry has occurred untreated and the level of damage to the masonry will commonly require new material to be employed in the reconstruction, thereby undermining the authenticity of the structure.

CP of such structures, introduced toward the end of the last century, has provided a technically feasible and commercially viable alternative to the repair and maintenance of such structures and continues to gain favour in such applications. Details of such systems have been described in detail elsewhere [8].

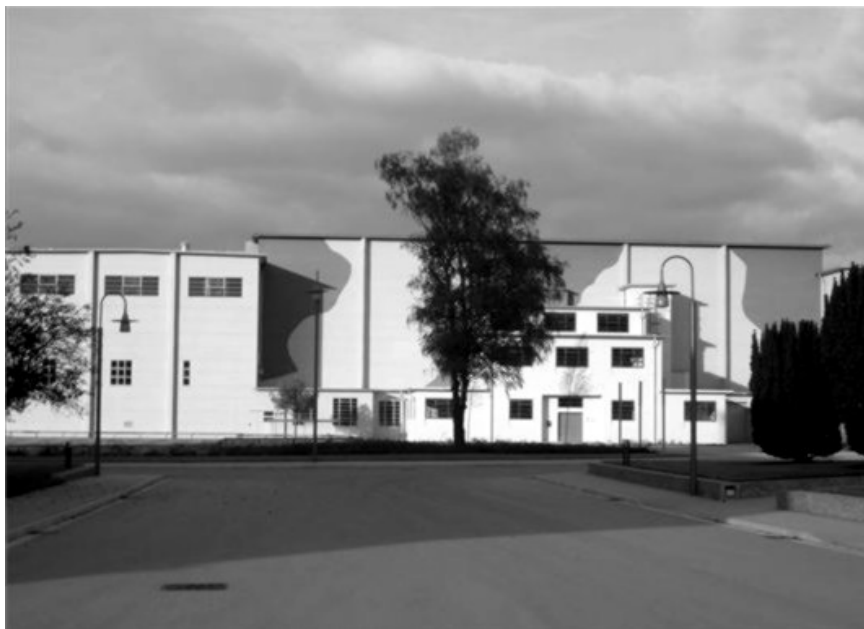
Figure 4: Wind tunnel buildings at RAE Farnborough, partly protected by inhibitors [10].

Because the surface of the porous material to which they are applied is unaltered, they allow the protection of embedded metals without altering the appearance of the structure. The service life of the inhibitor, typically several years, is dependent upon the porosity of the material and severity of the environment but can be easily reapplied. Figure 4 shows a Grade 1 listed structure at the former Royal Aircraft Establishment in Farnborough, UK where corrosion inhibitors were employed to protect the reinforcement while retaining the original weathered appearance of the concrete [10]. Other recent applications for corrosion inhibitors have included cramps and wall ties and the protection of historically important industrial sites with wax-based corrosion inhibiting coatings.

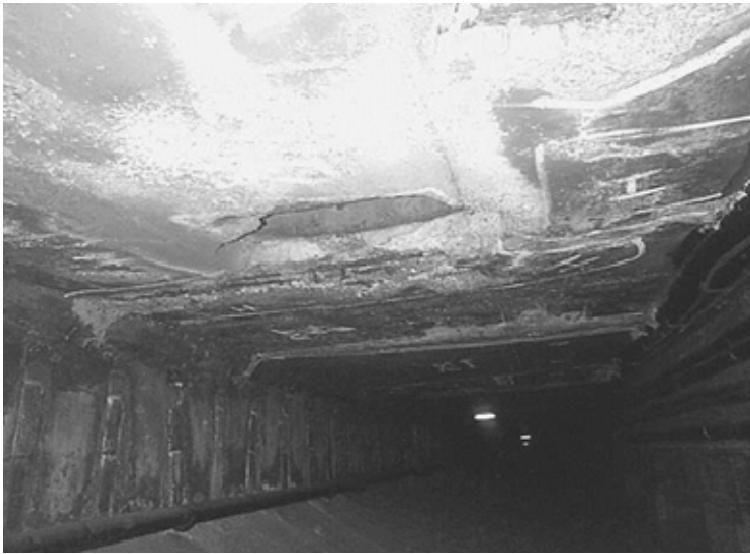
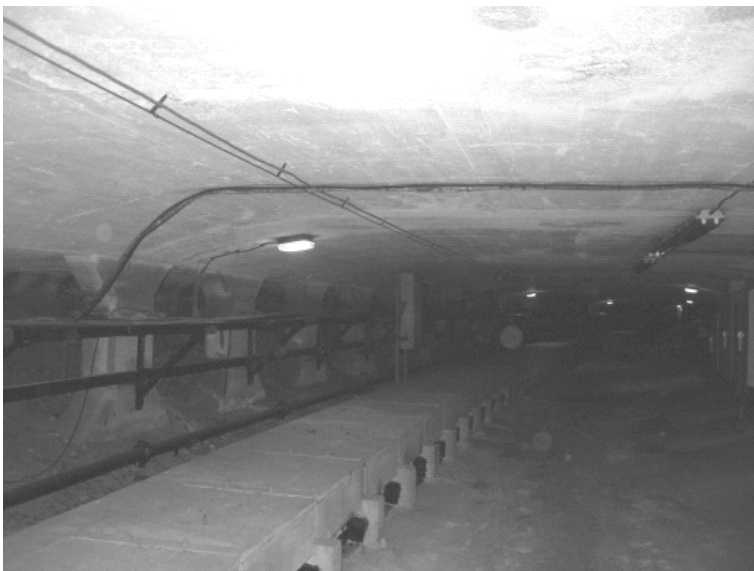
After a routine inspection significant corrosion of the deck soffit was identified. This was due to carbonation, accelerated by the dry air being constantly blown over the surface of the concrete. Chloride testing was undertaken on the top of the deck and significant chloride was identified throughout the tunnel, despite the fact

that the tunnel had never been de-iced. This was attributed to vehicular traffic tracking chlorides in from the surrounding area.

Figure 5: Queensway Tunnel Deck Soffit – prior to repair, approximately 60 years old (top) and 20 years after repairs were completed (bottom).

The repair procedure was complicated by the access. Whilst there was plenty of room under the main bore, in order to get to this area access was via limited access passages, Figure 5. Based on the difficulties in accessing the job the repair

process was developed using ultra high water pressure jetting to remove all loose and delaminated concrete, and dry sprayed concrete to reinstate the removed concrete. All spoil had to be removed and all materials had to be brought to the area of work via the same limited access points.

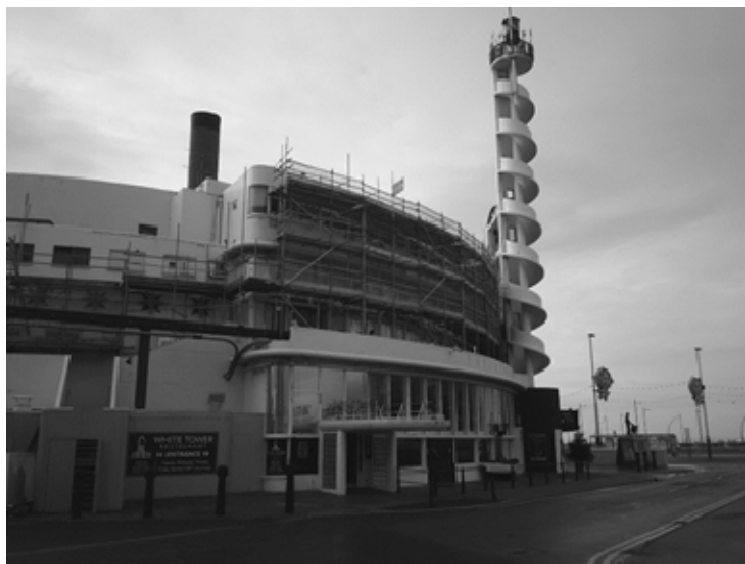
The White Tower building in Blackpool is a fine example of Art Deco style, Figure 6. The building was constructed in 1939. The external envelope was original made up of white Portland cement with a quartz aggregate. Over the years it had succumbed to extensive chloride contamination. In addition it had been coated and patch repaired many times. In 2005 a £500,000 repair project was undertaken. Due to the extent of degradation and previous repairs it was not possible to restore the original finish to the structure as little of it remained.

Figure 6: The White Building, Blackpool, during refurbishment.

One further problem was that in some of the larger elements areas the exterior façade was made up using permanent formwork to achieve the high quality finish. The reinforcement was placed in the formwork and backfilled with conventional concrete, in a procedure similar to that used by Frank Lloyd Wright. This gives the initial impression of a high quality finish, however the concrete behind the façade is of poor quality, heavily voided and rapidly degrades.

The repair procedure involved the removal of all loose and delaminated concrete and reinstatement with appropriate repair materials. In spite of the benefits that cathodic protection normally provides in minimising the extent of breakout, it was not appropriate for this structure as the façade was made up of many individual precast elements. This would have required a very complex CP

system which would have precluded the repair contract. Once the repairs were completed the whole structure was recoated. The structure owner has introduced a rolling programme of inspections to enable the maintenance of the building to be better planned and more closely controlled.
