# New techniques for the rapid repair of levee breaches

S. J. Boc, D. T. Resio & E. C. Burg  
*US Army Corps of Engineers,  
Engineer Research and Development Center,  
Coastal and Hydraulics Laboratory, USA*

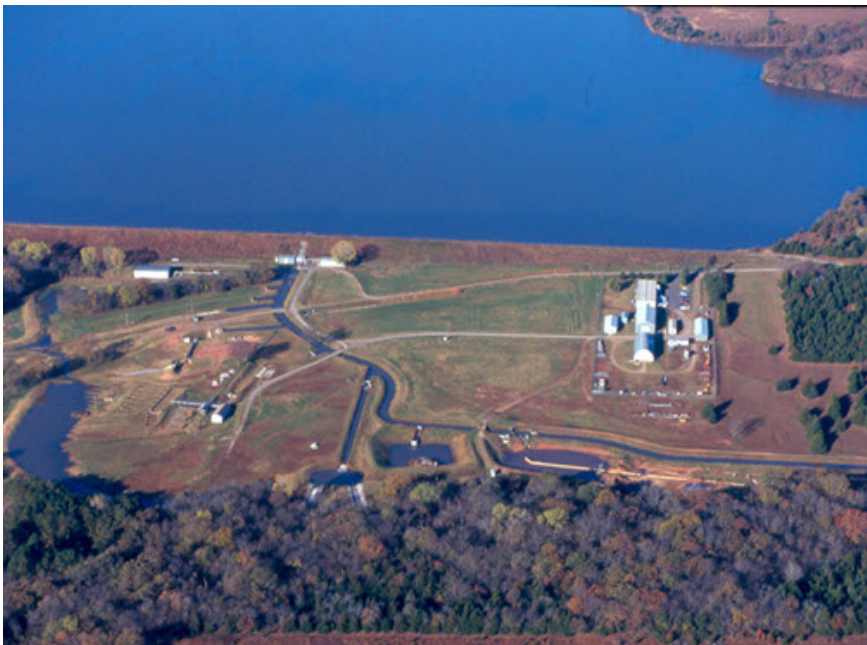
Figure 1: Aerial photo of facility at ARS-HERU facility in Stillwater, Oklahoma.

A review of available facilities which can generate large flow rates suggested that the optimal site for testing concepts at a large scale was the Hydraulic Engineering Research Unit (HERU) of the Agricultural Research Service in Stillwater, Oklahoma (Figure 1). This facility can maintain a flow rate of 125 cubic feet per second for prolonged periods of time.

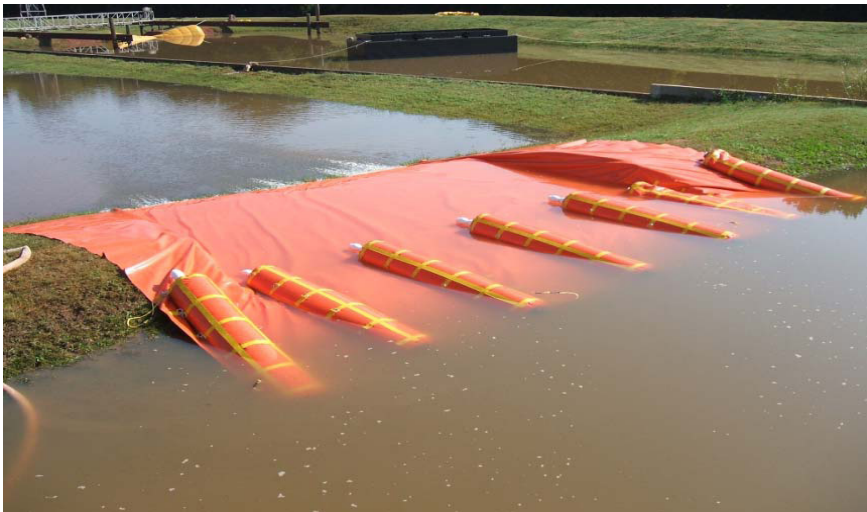
Figure 2: Demonstration of REPEL system with 0.5-ft of water passing over the top of the breach.

is approximately 1 foot above the surface. The performance of this system was clearly a success in terms of both its ease of deployment, ability to maintain its position, and its ability to prevent erosion of the underlying cover.

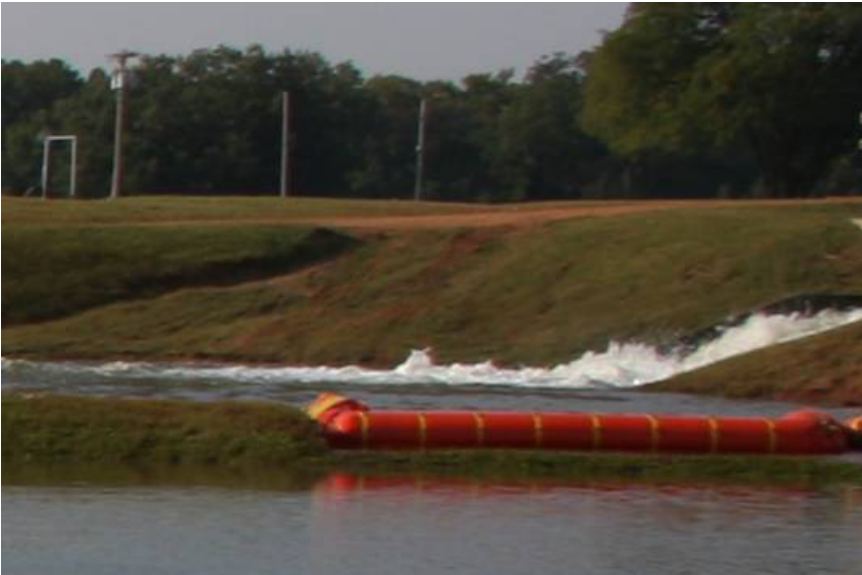
Figure 3: Demonstration of shallow, wide breach closure system.

The ability of this system to prevent flow through a wide, shallow breach could be very important in many applications throughout the world. It should be recognized that such a system could be pre-positioned along low lying areas or deployed in a situation such as occurred at Braithwaite, Louisiana during Hurricanes Gustav and Ike (Figures 5 and 6). In both of these situations, weather conditions would have permitted the deployment of a water-filled fabric system, such as that demonstrated here. Another interesting aspect of this class of system is that, by placing individual systems next to each other, very long reaches of exposed levee might be protected.

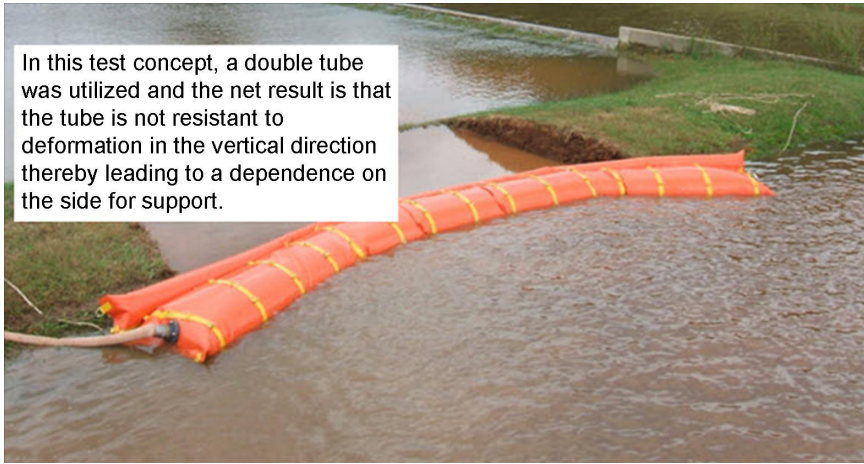
Figure 4: Example of wide, shallow test at Stillwater for a system which was not resistant to deformation in the vertical dimension.

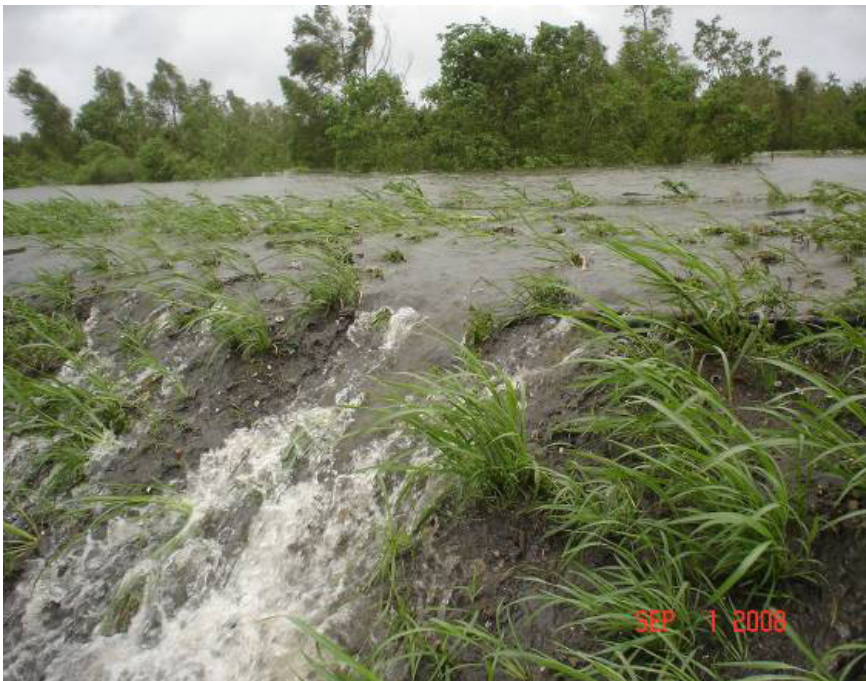
Figure 5: Close-up photograph of levee overtopping in Braithwaite, Louisiana during Hurricane Gustav.

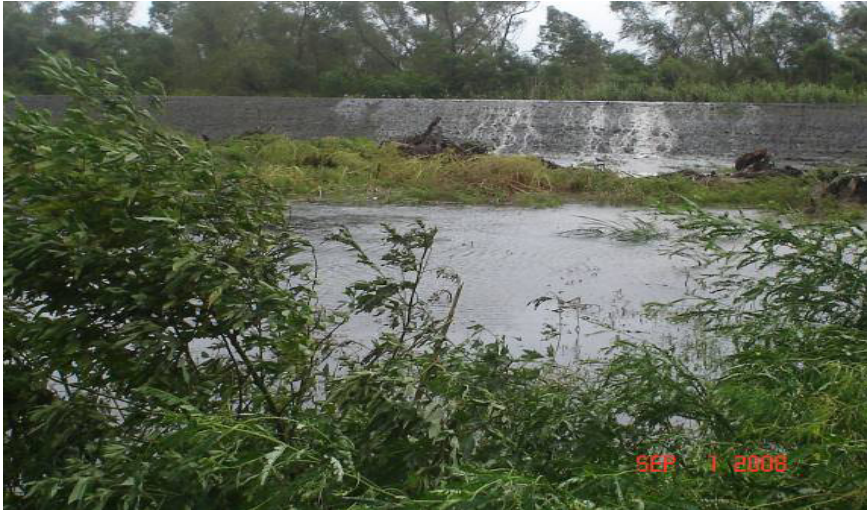
Figure 6: Wider perspective of this flow from Figure 5.

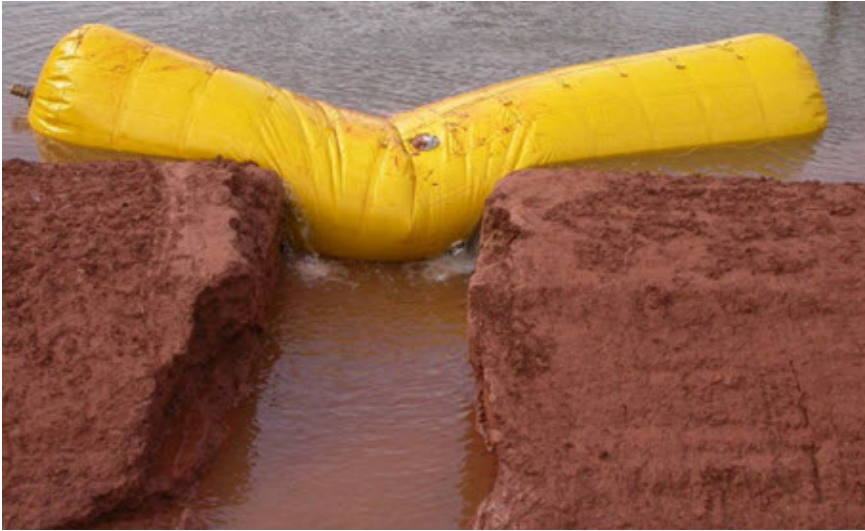
Figure 7: Sample deployment of deep-breach closure system, with a small residual flow still persisting along the upper edges of the breach opening.

Figure 7 shows the tube in its final location from one of the dozens of large-scale tests conducted. Consistent with the performance of this system concept in 1:16 scale testing, the PLUG blocked almost all of the flow in these tests. In some of the tests a small residual flow was observed at locations along the periphery of the breach, typically either at the top outside edges of the breach or the lower outside edges of the breach. However, these flows were usually very small (less than 1 cubic foot per second). As shown in Figure 8, the addition of two small tubes on either side of the breach opening usually provided a very effective seal for all flow.

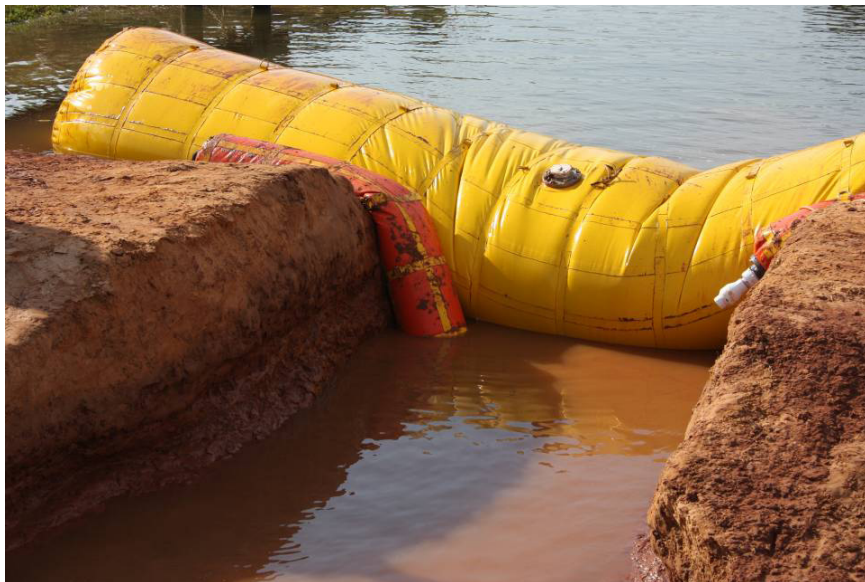
Figure 8: Sample deployment of deep-breach closure system including the addition of two small tubes along the upper edges of the breach opening which produced essentially zero-flow conditions through the breach.
