Modeling a real backdraft incident fire

A. Tinaburri¹ & M. Mazzaro²

Abstract

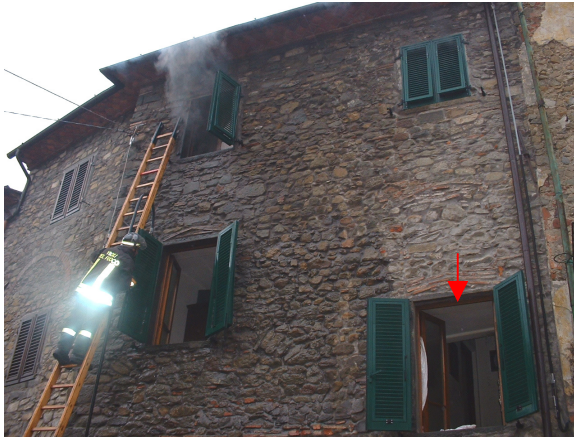
Figure 1: External view of the 2nd floor room originating the fire and of the window that vented out the backdraft flame (pointed by the arrow). All the pictures have been taken about one hour later the fire event.

As in the fire incident, the bedroom window and door were kept closed during the simulation, till the firefighters opened them. The front window on the second floor was kept closed while the one located on the first floor, where the backdraft was vented out (see Figure 1), remained opened during the entire simulation. For the FDS simulation, a specified heat flux from the wall adjacent to the wardrobe was used to start the fire growth as the ignition source. Starting the simulation with a flaming ignition enabled fire development to be modeled within a reasonable computational time. The actual fire may have taken several hours to develop to the flaming stage, if eventually reached. As the simulated fire spreads from the ignition source, and then to other items in the room, it depletes its supply of oxygen for combustion. When a fire occurs in a closed room where the only ventilation is due to leakage, it can become limited by the available oxygen and produce large amounts of unburned fuel. If the leakage rate is low enough

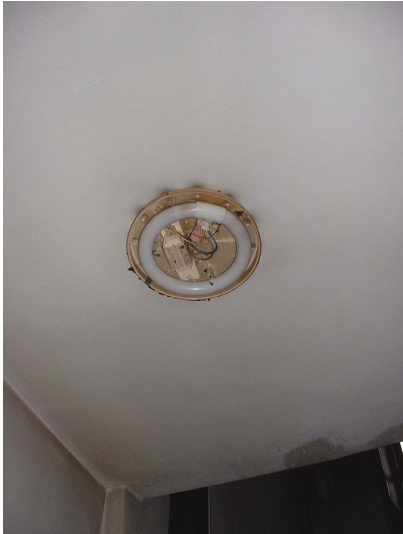
Figure 2: Detail of the 2nd floor stairway lamp showing cover destruction.

The stairway from the first to the second floor showed only few appreciable effect of the backdraft flame impingement on the ceiling and walls except for the destruction of the lamp cover located on the second floor ceiling (Figure 2), the partial melting of the light switch located on the left side, near the bedroom doorway (Figure 3). The ladder shown in Figure 3 was used by the firefighters to access the wooden roof structure, after extinguishing the fire, to verify that no fire propagation and smoldering combustion had occurred.

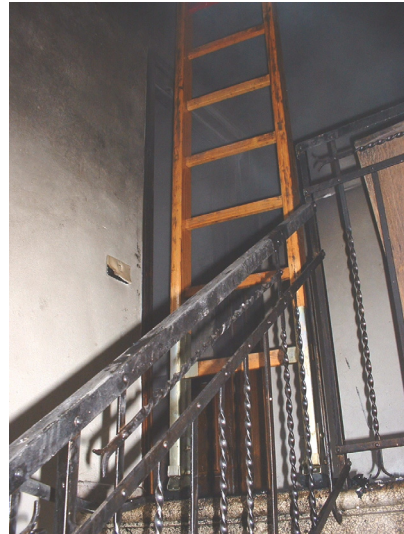
Figure 3: 2nd floor stairway. The room originating the fire is on the left side.

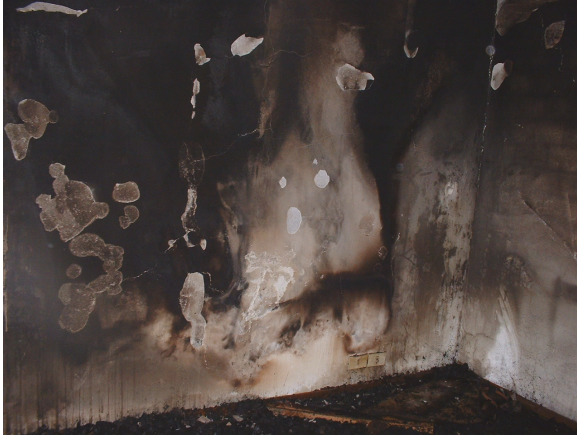
Figure 4: Detail of one wall in the room originating the fire. The wardrobe gone completely destroyed was located near this wall.

The bedroom had significant deposits of soot throughout, with limited thermal damage. The gypsum board walls and ceiling remained intact. A wardrobe and some furniture located adjacently two walls were completely destroyed by the fire (Figures 4, 5 and 6).

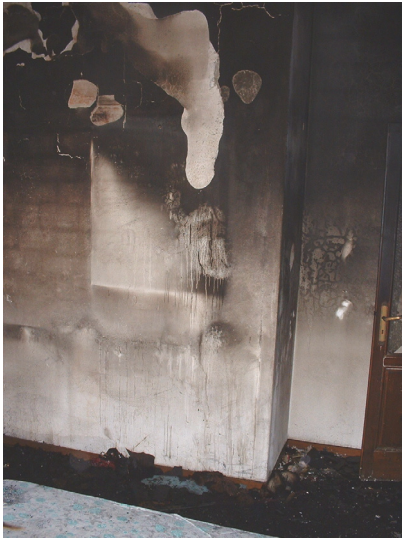
Figure 5: Detail of one room wall (next to Figure 4).

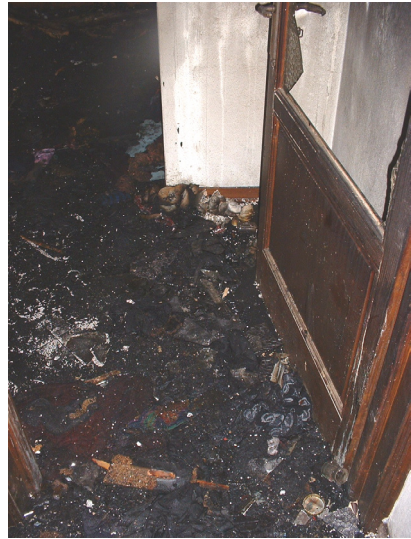
Figure 6: Detail of the bedroom door (next to Figure 5).

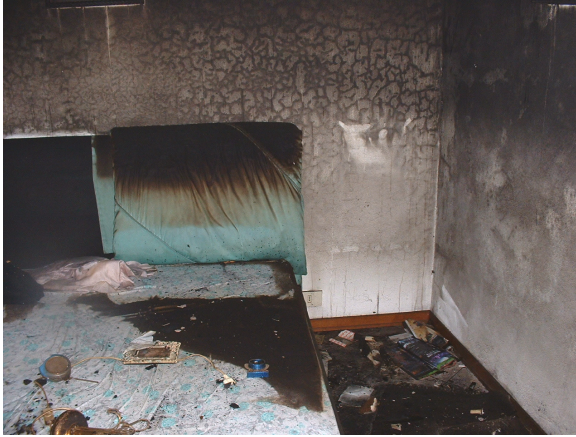
The bed showed signs of pyrolysis and limited burning on the upper portions of the back cushions (Figure 7). The triangular shape of the combusted part was attributed to the fire propagation from adjacent furniture, gone completely carbonized.

Figure 7: Detail of the bed.
