Seismic risk assessment of reinforced concrete buildings

C. S. Dragomir^{1,2} & A. S. Tronac¹

In this context, investigation focused on building B of the University of Agronomic Sciences and Veterinary Medicine of Bucharest. The building consists of five stories (basement, ground floor, two floors and an attic) and was proposed for strengthening by the Technical Report developed in 2012.

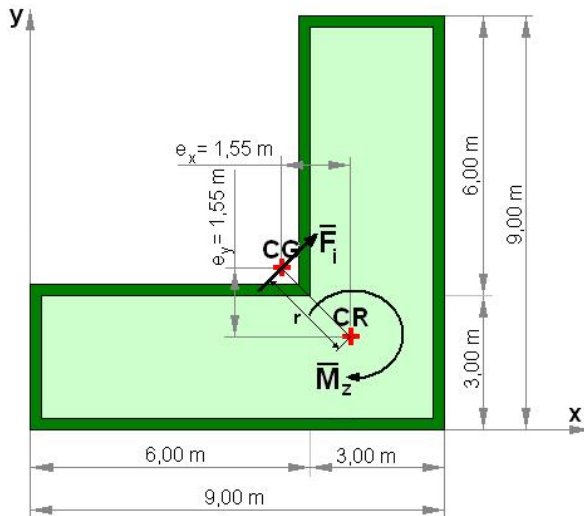
Figure 1: Representation of inertial force.

In the case of an L shaped-plan, as presented in Figure 1, equation (1) becomes:

$$S_{\text{envelope}} - S_{\text{floor}} = 108,00m^2 > 15\% S_{\text{floor}} \quad (2)$$

It was noted that the L shaped-plan with the dimensions shown in Figure 1 did not satisfy any of the conditions in accordance with the regular rules. The conclusion was that the chosen construction type had no regularity in the plan.

From the viewpoint of the simplified calculation scheme, the inertia force F_i was applied to the gravity centre CG of the cross section. Hence, the expression of the global torsion moment was:

Further on, the solution for mitigation of the global torsion moment consisted in sectioning the L-shaped structure by a seismic joint.

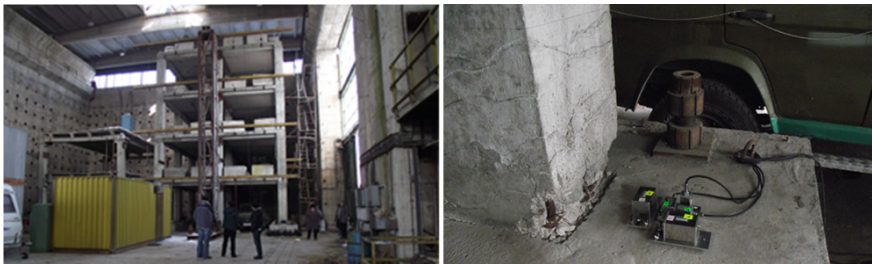
Figure 2: Experimental model and sensor disposition on foundation model.

The structural model presented in Figure 2 was based on a modular square grid 3.90 x 3.90 m and a floor height of 2.75 m, consisting of two openings and two bays, which comprised a single structural wall.

Following the above steps, microseismic measurements were made on the experimental model by using two sensor placement schemes: one on the horizontal and the other on the vertical direction. Measurements were made both by applying shocks in the centre of the 2nd floor and the microseismic movement on the site.

According to the Fourier spectra analysis, the dynamic characteristics of the model were evaluated as 0.60 s on direction X and 0.32 s on direction Y.

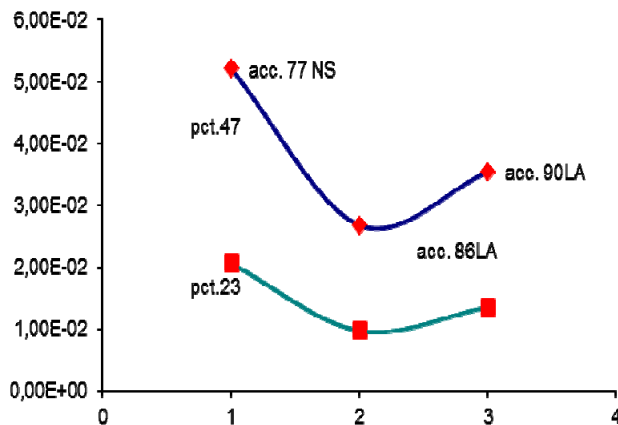
Figure 3: Maximum values of building displacements.

The linear modal time-history analysis provided the results for the structural system studied as movement variations in a node located at the top level and at the basis of the structure. The maximum values of displacements, corresponding to nodes 47 (at the top of the building) and 23 (at the basis of the building) under major Romanian earthquakes, are presented in Figure 3.

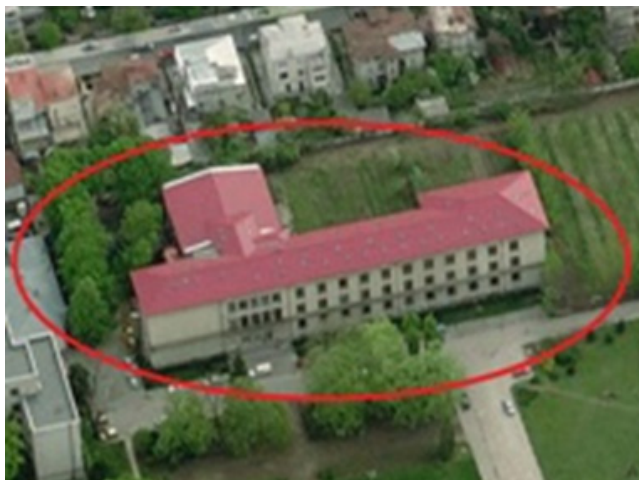
Figure 4: General view of faculty building.

The case study presents the applicability of building performance assessment on the Bucharest educational building presented in Figure 4.

Taking into account the shape and size of the building plan, the building was divided into two distinct wings through an expansion joint of 2.00 cm. The section of the main entrance and lecture hall area was named B_1 , and the other one was called B_2 .

The building has an irregular shape in plan and elevation, and the expansion joint is damaged, which means that the two buildings clashed in the earthquakes that occurred over the past 60 years. Therefore, the expansion joint has failed to fulfil the function of seismic joint.

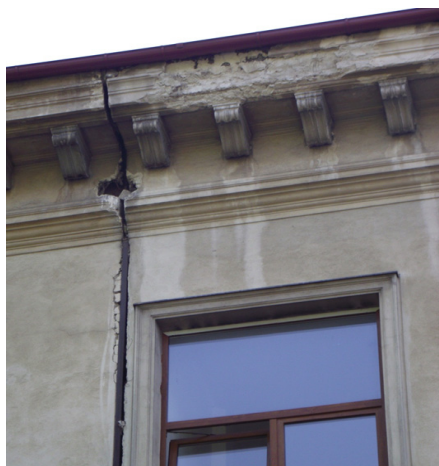
Figure 5: General view of faculty building.

Figure 5 shows that the 2.00 cm expansion joint played no role as a seismic joint since the two wings pounded with each other, probably owing to their different rigidity since the two wings have large heights (Dragomir *et al.* [5]).

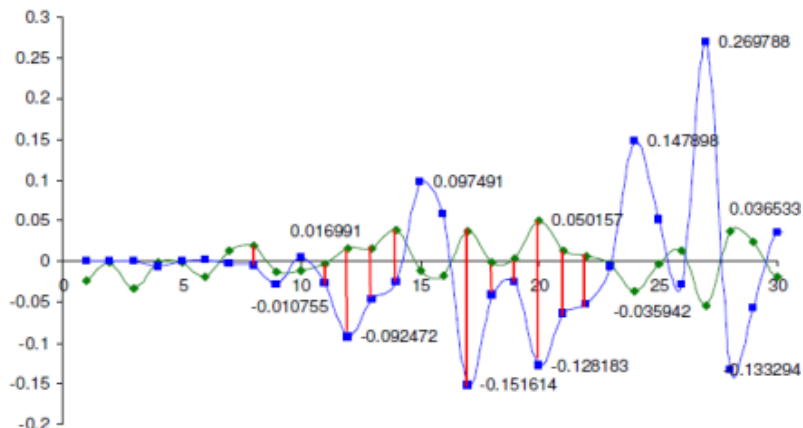
Figure 7: Modal displacements of the two bodies of faculty building.

To emphasize the pounding situations when the condition was satisfied, some modal displacements for two points at the top of each body were represented in Figure 7, according to the vibration modes.

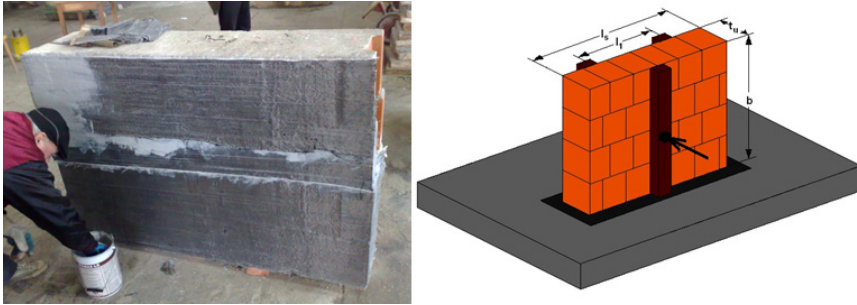
Figure 8: Strengthening solution with bending test setup.

One of the modern solutions used today for strengthening the RC frame buildings with masonry infill walls consists in strengthening the masonry panels with carbon fibre fabric. The aim of the study was to test for bending four models of masonry made of ceramic blocks, with the same plan dimensions, 1.50 x 1.00 m, but with different thickness: 2 models with 30 cm thickness (M30) and 2 models with 38 cm thickness (M38).

The two models were strengthened on the side in tension with carbon fibre fabric. Epoxy resin was used for applying the fabric.

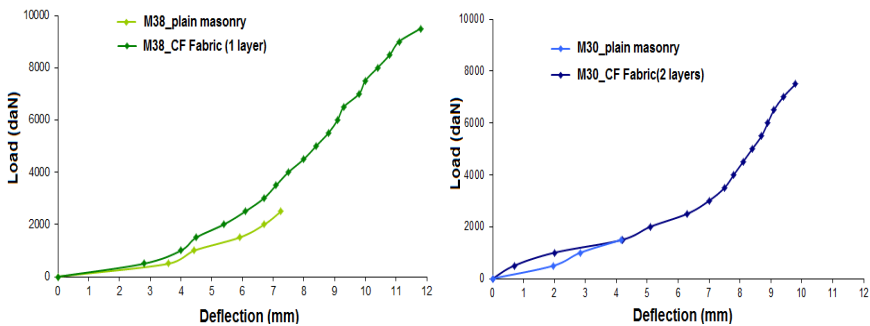
Figure 9: Force-arrow diagrams for M30 and M38 models.

Figure 9 presents a comparison between the force-arrow diagrams for the two versions of the M30 and M38 models, i.e. plain and strengthened.

The failure of the two modules led to the conclusion that masonry had exceeded its compressive resistance.

Under the conditions of the tests, the contribution of the block size to rigidity was greater than the contribution provided by applying a double number of carbon fibre layers; a single layer of fabric was sufficient as the advantage of an increased number of layers could not be exploited.
