CASE STUDIES OF ENVIRONMENTAL THE QUALITY OF BUILDINGS DAMAGED BY EARTHQUAKES, PRIOR TO ADAPTIVE RECONSTRUCTION: PALAZZO MOSCARDELLI IN OFENA AND EX-COLONIA IX MAGGIO AT MONTELUCCO DI ROIO, L'AQUILA, ITALY

ANGELA LOMBARDI¹, JOHN MURPHY JR¹, ANTONELLA IANNARELLI²,
SIMONETTA CIRANNA³, PATRIZIA MONTUORI³ & ELSA G. DE LEON¹

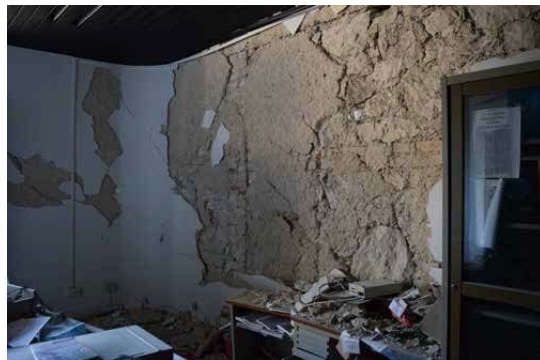
Figure 2: Office inside Colonia IX Maggio, abandoned after 2009 earthquake. (Source: E.G. De Leon.)

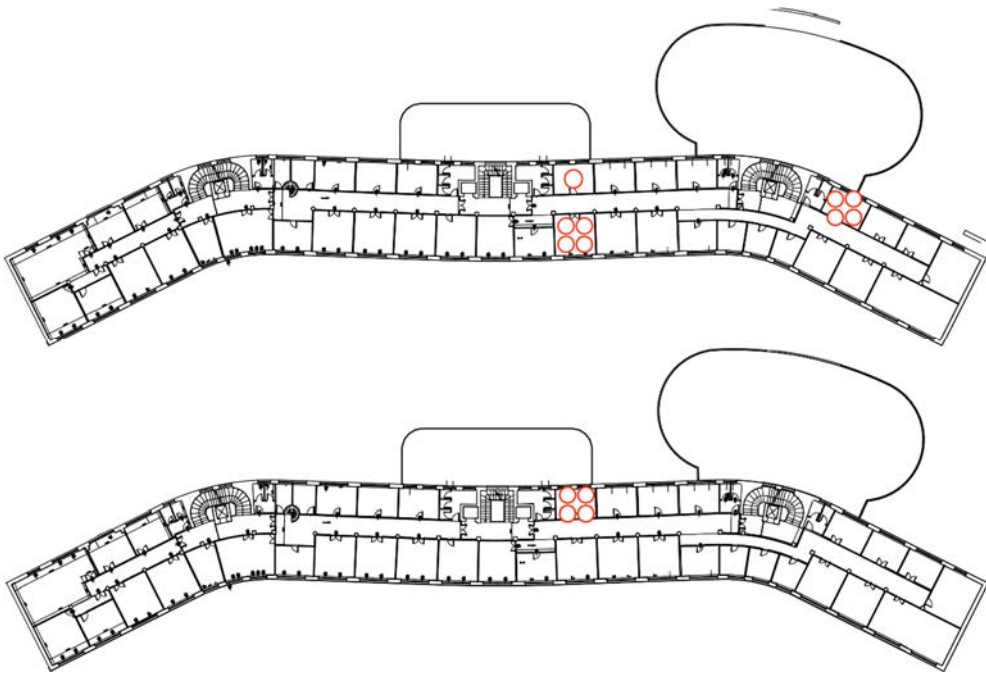
Figure 3: Floor sampling locations, Colonia building.

Samples for gas emissions, air particulate counts, bio-aerosols, humidity/temperature and total VOCs were taken on each of the historic structures analyzed using these instruments in 3–5 different locations and various rooms. The selection of rooms depended on the observed conditions of each, as well as the apparent “worst” conditions to create a concept of worse-case scenario. For example, locations were sought with visual confirmation of mold, high humidity, structural damage, the condition of location, and past uses. Any obvious changes of rooms since occupant departure were noted. During the instrumental survey, three out of five instruments provided us automatic results. These results are related to weather and airborne particulate counts. However, the typology of particulate samples was not ascertained. The bio-aerosol and VOC samples were captured and sent for analysis to a laboratory under the administration of ARTA Abruzzo. Figs 1–3 illustrate the sample location strategies. Researchers were unable to sample or analyze radon gas occurrence levels at either subject building. However, regional data regarding radon gas emissions are available for consideration, collected by ARTA Abruzzo [7].

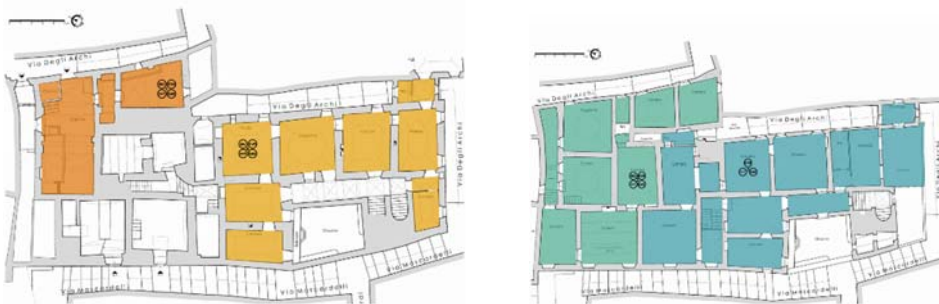
Figure 4: 1st floor sampling locations, Palazzo Moscardelli. Figure 5: 2nd floor sampling locations, Palazzo Moscardelli.

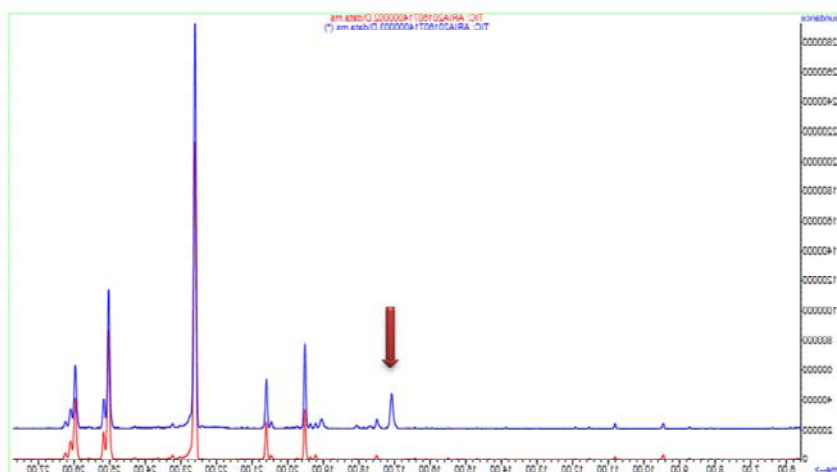
Figure 6: Colonia building – overlay of the gas chromatographic profiles related to base line (red) and to one sample inside building (blue).

As Figs 5 and 6 indicate, the base line, taken outside the building, shows that outdoor air is rich in VOCs, both of natural and anthropic origin; therefore, its gas chromatic profile graph is characterized by a multitude of peaks.

A useful overlay of interior and exterior gas chromatic profile graphs emphasizes that no presence of substances directly attributable to the building’s internal sources can be identified. This is a typical condition of places with abundant air exchange and with no emissive sources. The Colonia’s building, damaged by the earthquake, has doors and windows in bad conditions, sometimes even missing; cracks in the exterior walls are also clearly visible. These conditions prevent the building from being considered for ‘confined spaces’.

The only peak present in the sample gas chromatic profile graph, highlighted with a red arrow in Fig. 6, is an Alkane. Alkanes are known for applications as solvents and as important components of crude oil, diesel, and gasoline [9]. Presumably, it can be concluded that the source of Alkane compounds is directly tied to the parking lot usage by combustion vehicles, as well as the asphalt paving materials used for the surface of the parking lot. This supports the gas meter results discussed earlier.

As the results indicate, there are some low levels of Alkane in existence in one of the sample buildings. By investigation, it would appear that this is related to the proximity to the external parking lot facilities. Suggested mitigation is to relocate the parking facility to limit the potential of these Alkane compounds infiltrating into the indoor environment, and affecting the intact environmental context. Particulate count (exterior ambient air sample) and CO gas existence at the same location substantiate the need for such mitigation.
