Re-use of historic wooden verandas in Sopot, Poland

J. Poplatek & J. Bąkowski

Faculty of Architecture, Gdansk University of Technology, Poland

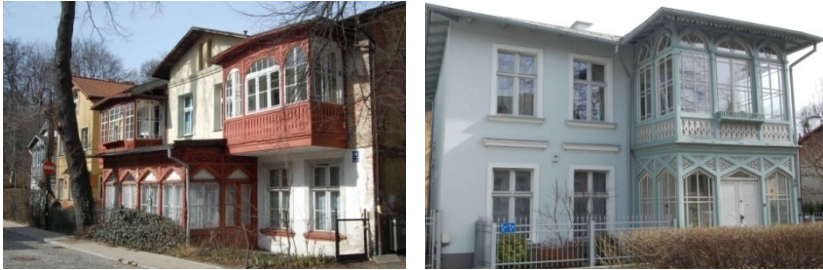
two-storey extensions without cellars, built on a rectangular or, less often, on a polygonal base (foundation wall). It is also possible to find examples of buildings where a veranda was a kind of a bay window suspended over the ground floor on the floor beams protruding from the wall (figure 1).

Figure 1: Wooden verandas as a dominant element of the façade composition; verandas in Majkowskiego Street (left) and Haffnera Street (right).

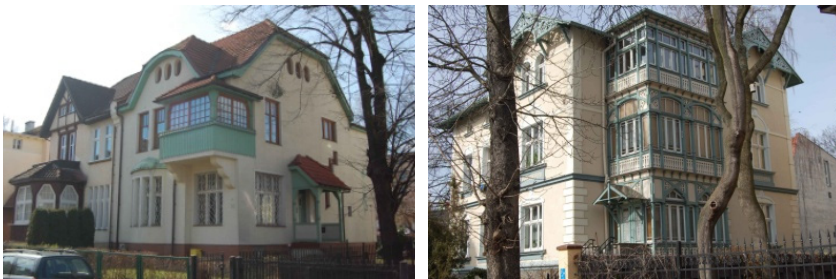
The verandas and wooden structures were placed in a different way on representative residential tenement houses. Those were three-storey or higher buildings with interesting structure and rich in architectural detail, with sculptural roofs covered with ceramic tiles. The tenement houses represented a combination of various styles (Classicism, Eclecticism, Art Nouveau and even modernism) joined in a free, rather random way, which gave each of the residential districts a diverse and picturesque character. With regard to these buildings, the verandas were only an element supplementing the form and detail, and played the role similar to that of other architectural elements, such as turrets, balconies, bay windows (built of brick or wood) and dormers. The verandas were not symmetrically placed. Just like the whole structure and the façades of the buildings, they were designed without retaining one symmetrical axis. Also, there was more freedom as far as the shape of the verandas was concerned – they were not constructed following a typical design, which was usual in the case of boarding houses (figure 2).

Figure 2: Verandas and wooden structures on the façades of tenement houses; tenement house in Parkowa Street (left) and Mokwy Street (right).

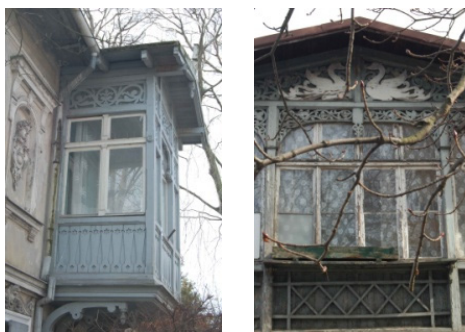
The common feature of all Sopot verandas was the material – wood. The spandrel-beam construction of verandas was wooden, with decorative boards and windows mounted in the birdsmouths of the spandrel-beam construction. The under-sill spaces were richly decorated with intricately carved rows of wooden boards, inspired by the patterns of Swiss and Tyrolean balustrades. The ornaments on openwork window frames were dominated by symmetrical geometrical or plant motifs. Those openwork forms, resembling lace curtains, were used as the decorative elements for the upper part of the windows. The veranda cornices were finished with profiled boards beams and slats. The wooden architectonic details of individual Sopot verandas did not significantly differ from each other and were based on ready-made patterns elaborated by designers. However, the use of catalogue, repetitive motifs did not negatively affect the quality of the detail. In fact, it was quite the opposite – the lacy patterns and ornaments, precisely cut in wood with a jigsaw, made Sopot verandas even more attractive to look at (figure 3).

Figure 3: Wooden verandas and their architectural detail; verandas in Mokwy Street (left) and Haffnera Street (right).

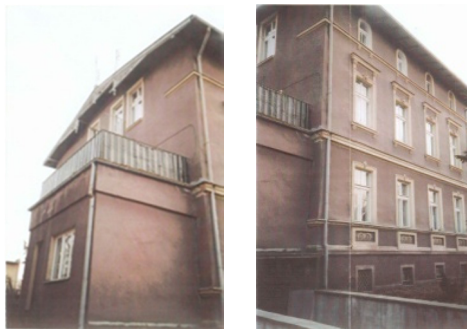
At the beginning of the modernization, there was a plan to demolish the brick lean-to, which does not have any aesthetic value. The composition of the side façade was random and required some design works. The proportions of the whole building were also irregular, hence a decision was made to apply 3D form in the side façade. It would be justified to recreate the historic veranda, yet as it was impossible without any iconographic materials, the only remaining solution was a historicizing stylization, a creation (figure 4).

Figure 4: Façades before modernization with the brick lean-to.

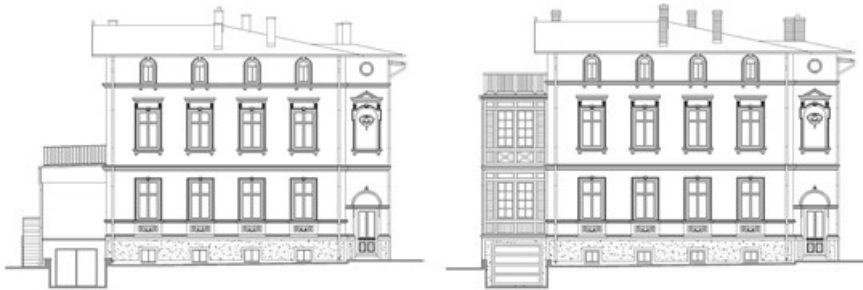
be appropriate with regard to architectural and urban context of the city. As a result, a two-storey wooden veranda was designed, whose scale and articulation of divisions was characteristic for historic verandas. A terrace with a wooden balustrade, functionally connected with the flat in the attic, was designed for the top of the veranda. The conservation creation should not copy historic patterns, hence the façades of the veranda had a shape characteristic for Sopot verandas, yet without copying the historic forms. Similarly, the applied architectonic detail was significantly simplified in comparison with the historic originals. It should be remembered that the above considerations on form, composition and detail may be used in creation, not in reconstruction (figure 5).

Figure 5: Front façade before modernization (left) and after modernization (right).

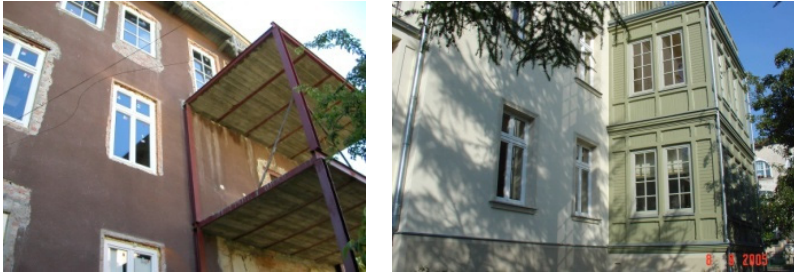
Acoustic insulation, which prevents sound spreading, was applied in the mezzanine floor. Wooden, self-supporting external walls of the veranda were designed as shell walls with the use of spandrel-beam construction. The thermal insulation was designed from the interior side, choosing its thickness so as to obtain the “U” heat transfer coefficient, which would comply with the norms currently binding in Poland. Their ventilation was ensured (between the thermal insulation and external boarding), to prevent out-dropping inside the partition. The interior was finished with plaster boards (figure 6).

Figure 6: Veranda under construction (left) and veranda at present (right).

Rectangular or polygonal historic verandas had a wooden construction and were connected with wooden floors of the buildings. Their spandrel-beam construction consisted of square or rectangular pinewood squared timber (mainly of 12–14 cm cross section) connected by tenons or wooden pins. Wooden floors were laid on wooden beams. The floor beams were not covered from the bottom or they were finished only with plywood headlining. Nowadays, such arrangement of floor layers does not meet the requirements of fire protection, acoustics and thermal insulation. Similarly, the external wooden walls without thermal insulation or single-pane windows do not fulfil the requirements of thermal insulation and energy efficiency. In the case described here, it was decided to use a modern design solution, i.e. a steel frame structure with wet cast reinforced concrete floors.

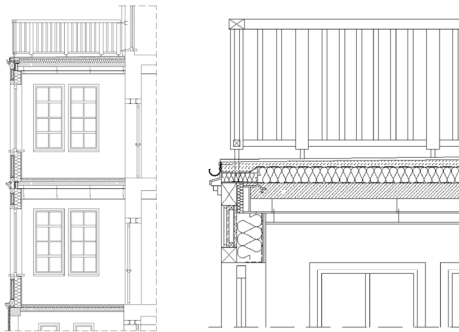
The obtained results allowed for providing proper comfort for users in line with current requirements, ensured fire protection of walls and floors and decreased energy consumption, while maintaining the historicizing detail and form integrated into the architectonic context, as well as into the historic and cultural image of the city (figure 7).

Figure 7: Veranda section (left) and detail of the terrace on the top (right).
