URBAN TRANSPORT INFRASTRUCTURE FOR PEOPLE WITH DISABILITIES IN THE CITY OF TSHWANE, SOUTH AFRICA: AN OBSERVATION AUDIT

BABRA DURI* & ROSE LUKE†

Department of Transport and Supply Chain Management, University of Johannesburg, South Africa

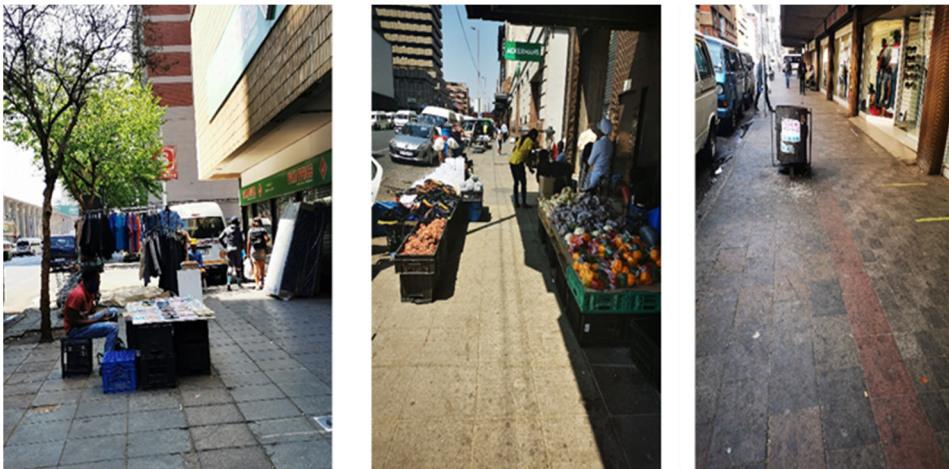
Figure 1: Pavement obstructions.

It was observed that mini-bus taxis, vendors, shop products and bins were obstructing free flow of traffic. The width of some pavements was reduced by street vendors, minibus taxis and shop products which would make it difficult for people with vision and mobility disability to manoeuvre.

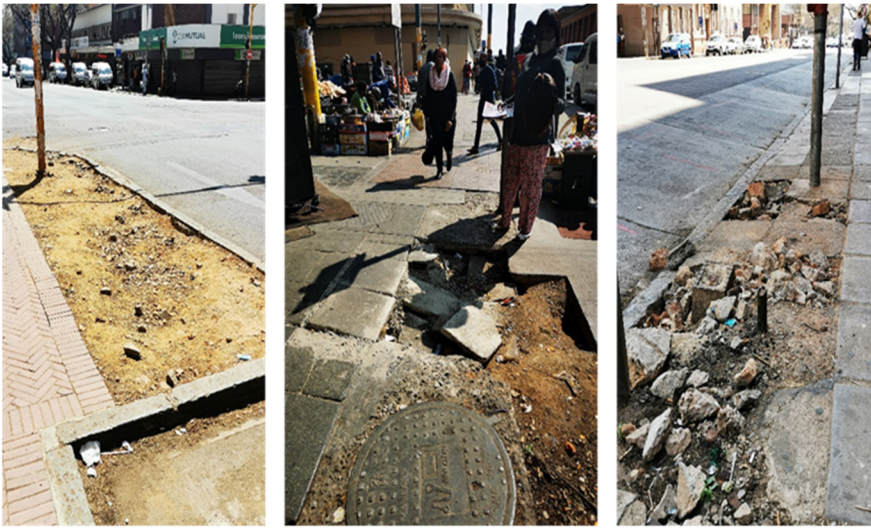
Fig. 2 shows broken pavements and incomplete construction of pavements. From the observations it was found that some broken pavements have been in that state for a long time, while some newly constructed pavements were incomplete. Fig. 3 shows the state of tactile surfaces in some areas around the CBD of Tshwane. The findings show that the tactile surfaces around the CBD were mostly in poor condition and lack maintenance. To a large extent, tactile surfaces are not functionally existent around the CBD.

Figure 2: Maintenance of pavements.

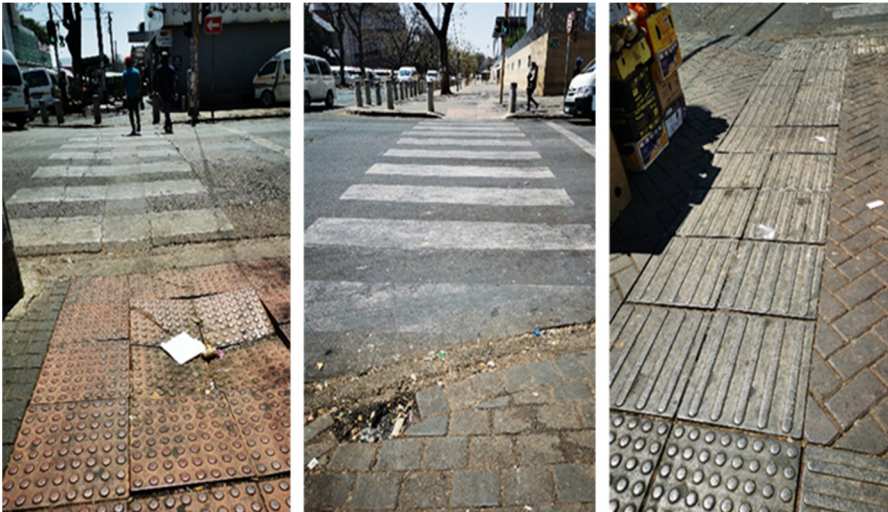
Figure 3: Tactile surface.

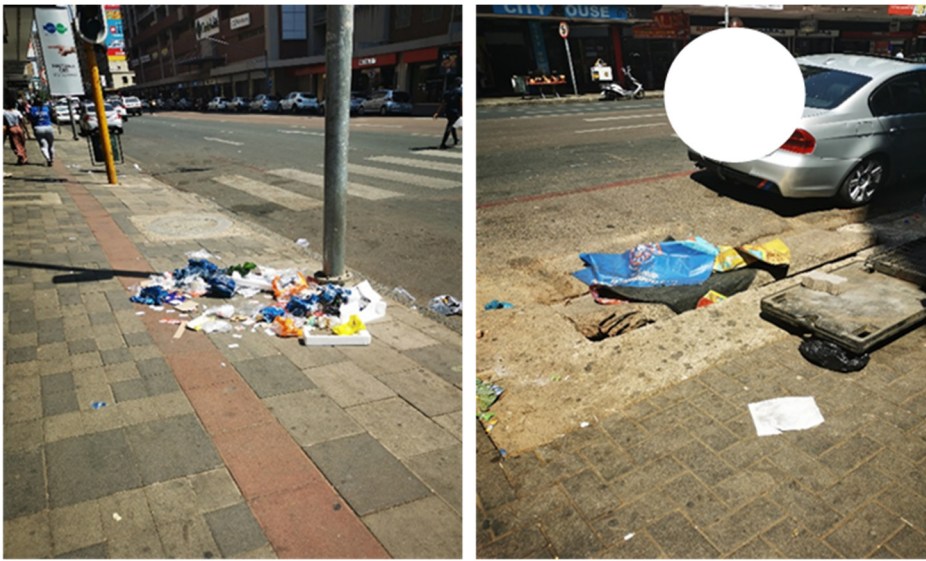
It was observed that some pavements are not kept clean as shown in Fig. 4. The findings also revealed poor spacing of bins around Tshwane CBD. Fig. 5 shows the state of some of the signage around Tshwane CBD. The signage board in Fig. 5 is damaged. From observation, the damaged signage board was in that state for a long time which shows lack of maintenance of infrastructure. The findings also revealed that some signboards are obstructed by street light poles and traffic light poles.

Figure 4: Cleanliness of pavements.

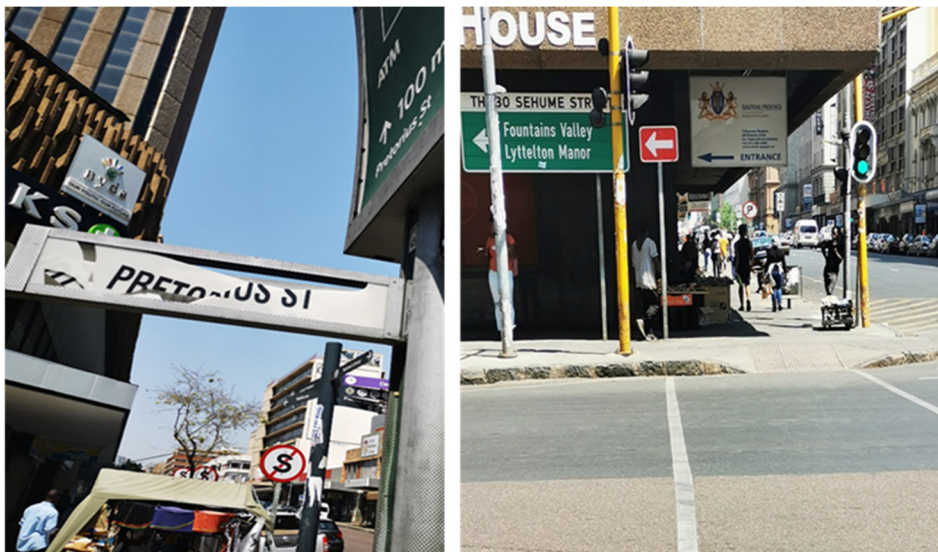
Figure 5: Signage.

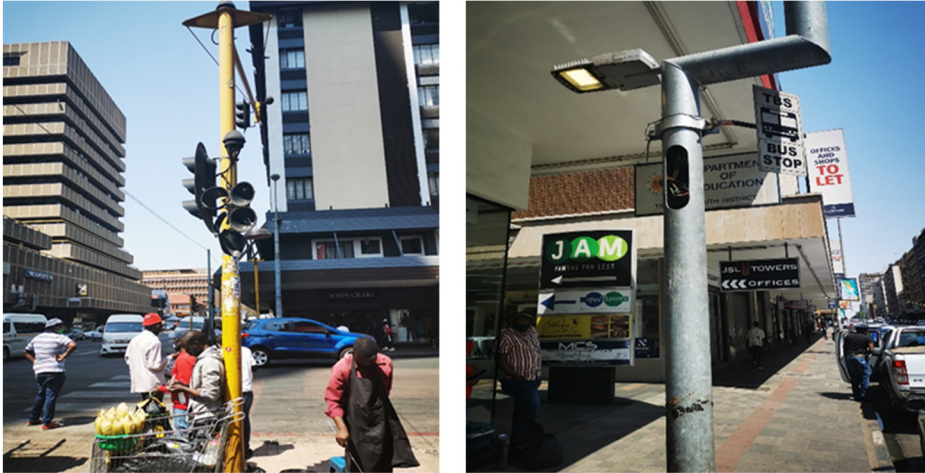
around the CBD. The traffic lights around the CBD of Tshwane did not have countdown signals and a few had push buttons that were not functional.

Figure 6: Traffic light and street light.

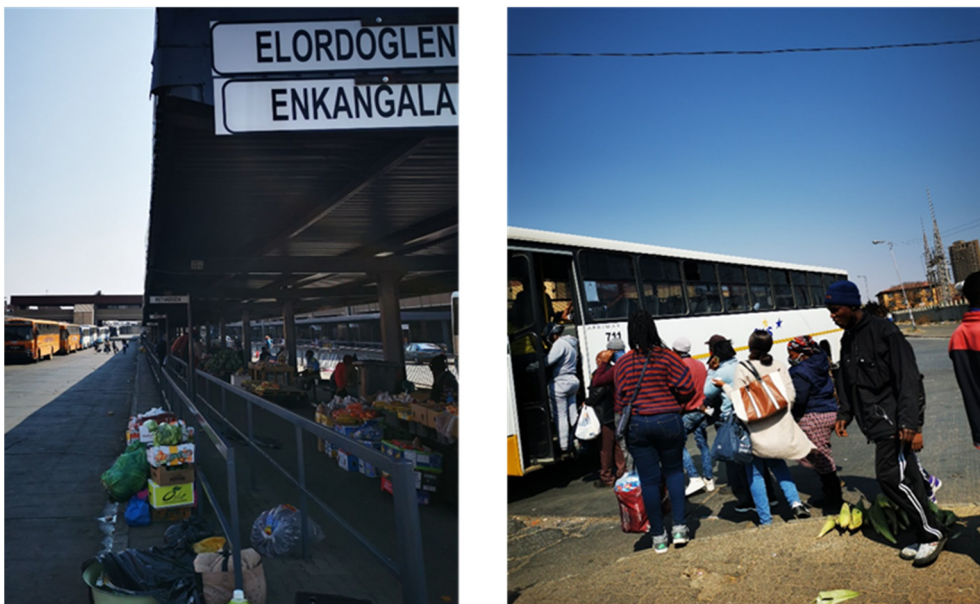
Figure 8: Marabastad bus station.

did not have ramps and some buses were loading in the middle of a road. Luggage was obstructing the free flow of passengers. There were no ticket counters at Marabastad bus station that were identified.

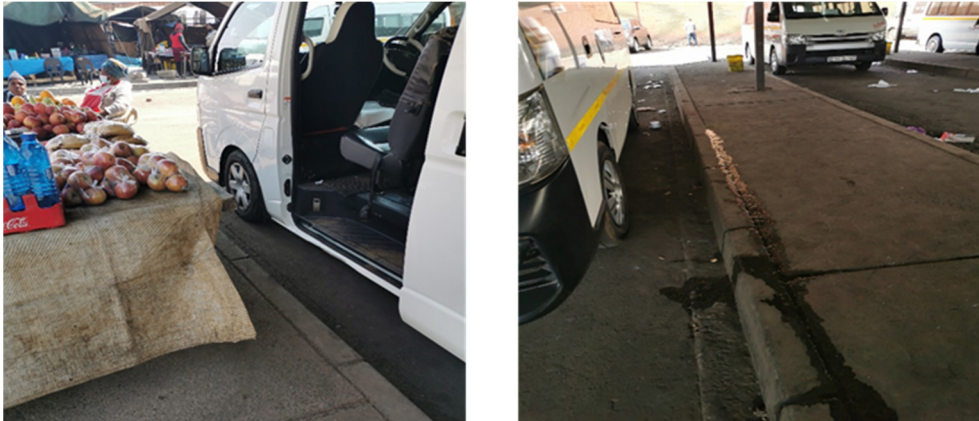
The two types of taxi ranks for mini-buses around Tshwane CBD are off-street and on-street taxi ranks. It was observed that some of the off-street taxi ranks did not have pavements and other amenities such as toilets and shopping facilities. Off-street taxi ranks had uneven gravel surfaces which was not ideal for people using wheelchairs. One of the basement off-street taxi ranks did not have good lighting and ventilation. Fig. 9 shows a taxi loading zone.

Figure 9: Taxi loading zone.

It was observed that street vendors obstruct taxi entrances which was not ideal for people using wheelchairs and people who have visual disability. The vendors' tables were next to the taxi entrance as shown in Fig. 9. The findings also revealed a lack of transport information and signage.
