The impact of the rail welds geometry on the noise in urban zones

S. Lakusic

University of Zagreb, Faculty of Civil Engineering, Croatia

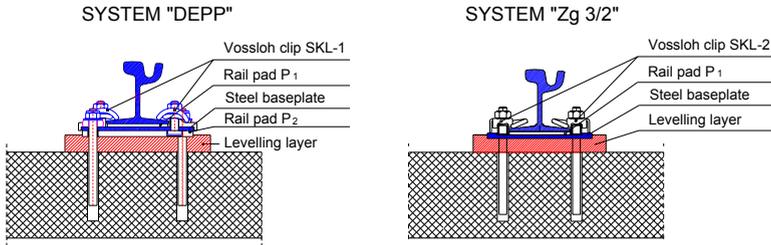
Figure 1: Fastening systems of tram tracks in Zagreb.

Figure 2: Cross section of tram track in Zagreb.

The study of the impact of rail weld geometry was conducted on three streets in the City of Zagreb, Ilica Street (Location A), Maksimirska Street (Location B) and Savska Street (Location C). Ilica Street and Maksimirska Street represent the most important links between the western and eastern part of the city, until Savska Street represent the most important link between the north and south part of the city in terms of tram traffic. Reconstruction of the tram tracks was conducted in 1996 (Location A and Location B) and in 2002 (Location C). At all locations, tram tracks have been placed on continues concrete base. The fastening of the rails to the base was conducted with a direct elastic fastening system "Zg 3/2" on Location A and Location B and with an indirect double elastic fastening system "DEPP" on Location C, fig. 1. The closure of the rails was carried out with reinforced concrete slabs on all locations, fig. 2.

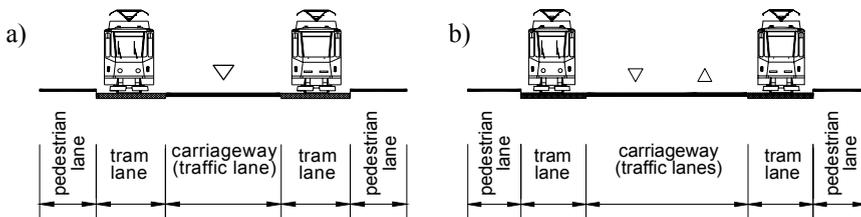
Figure 3: Cross section: a) Location A; b) Locations B and C.

The traffic volume of the tram tracks at Location A totals 14 to 17 million gross tons per annum (MGT). Ilica Street is open to tram traffic and pedestrian traffic and for delivery vehicles in the morning hours, on the part near the centre of Zagreb. On other part, Ilica Street is open to both tram and vehicular traffic, primarily cars. A cross-section of Location A is shown in figure 3a. The traffic volume of the tram track in Maksimirska Street and Savska Street totals approximately 12 million gross tons per annum (MGT), according the data of Zagreb Streetcar Company, [1]. Unlike Location A, Maksimirska Street and Savska Street are subject to heavy tram traffic as well as a heavy traffic volume of road traffic (cars, trucks, buses). A higher tram speed than Location A, are also present here. Maksimirska Street and Savska Street are four lane roads, two lanes for each direction. The tram tracks are situated on the sides of the road and are an integral part of the road lanes. A cross section is shown in figure 3b.

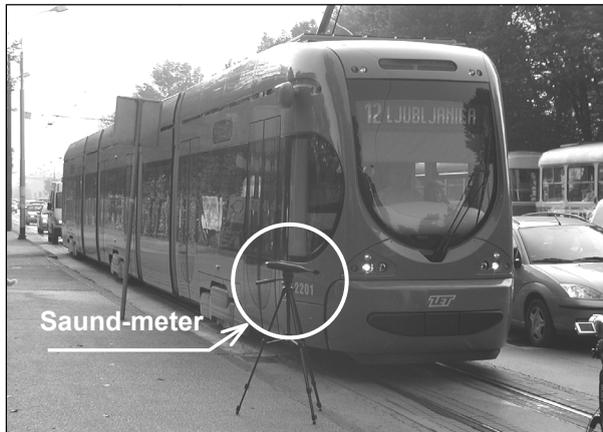
Figure 11: Position of instruments during measuring.

The software EVALUATOR 7820 by the same manufacturer was used for analysis of measurements. At each site, noise level was measured for a minimum of five passages of each type of tram vehicle. By measuring the interval of the passage of trams between two fixed points, tram driving speed was determined. Noise levels were measured one metre from the tram vehicles, at a height of 1.2 metres above the running surface of the rail (fig. 11). Noise level measurements were conducted in two phases: the first phase included noise measurements on tracks with irregularities at the welds, while the second phase included measurements of noise levels at the same locations following repairs to the irregularities of the rail running surfaces.

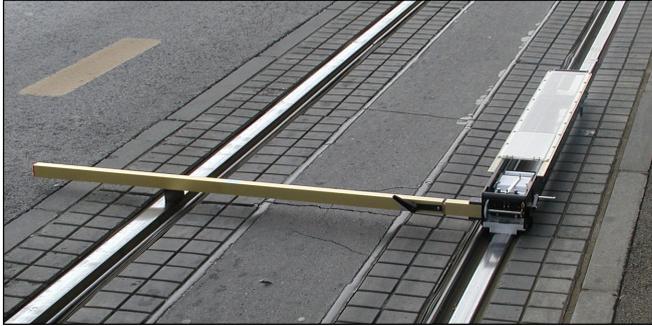
Figure 12: The profilograph – brand name CEMAFER.

Prior to measuring noise levels, the geometry of the rail running surface at rail welds was measured. This measurement was conducted with a profilograph (device for measuring rail unevenness), fig. 12. This device has the capacity of measuring rail running surface irregularities at distances of 18, 23 and 33mm from the running edge of the rail. Considering that the subject of this study are tracks which have been in exploitation for 10 to 12 years, the measurement of unevenness was conducted at a distance of 23mm from the rail edge, fig. 13. The reason for selecting this measuring position is based on earlier studies conducted by the Faculty of Civil Engineering of the University of Zagreb, [2]. The differences between the uneven geometries measured at the same measurement location but from varying distances from the rail edge were analysed. It was established that for tracks which are in use for a certain period of time, the differences between recorded unevenness at 23mm and 33mm were virtually negligible. The positions of the measurement line of the geometry of the rail

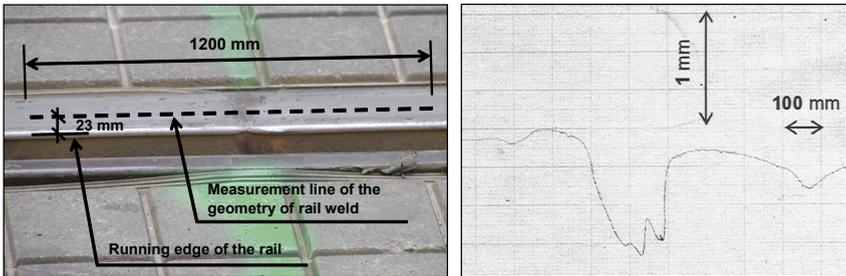
Figure 13: Picture of weld and vertical weld geometry – Location A.

running surface in the weld zone (600 mm to the left and right of the weld) are seen in figure 13. The weld measurement scale was 1:10 in length and 30:1 vertically, while the instrument error is 0.05mm, [3]. Photographs of a weld on the Zagreb tram track and the recorded running surface are seen in fig. 13 (Location A) and fig. 14 (Location B).

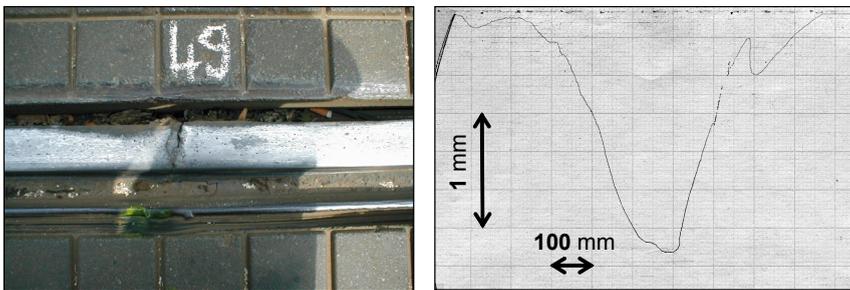
Figure 14: Photographs of weld and recorded weld geometry – Location B.

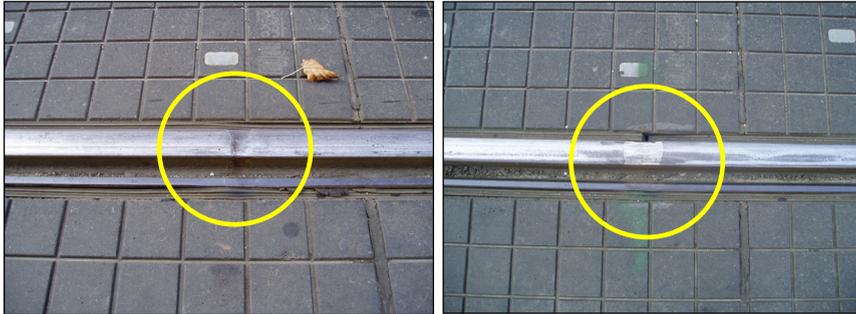
Figure 15: Unrepaired and repaired rail weld.

Following measurement of the unevenness geometry, an initial measurement of noise was conducted in the case with unevenness at the running surface and following repairs to the unevenness (fig. 15), noise level measurements were repeated.

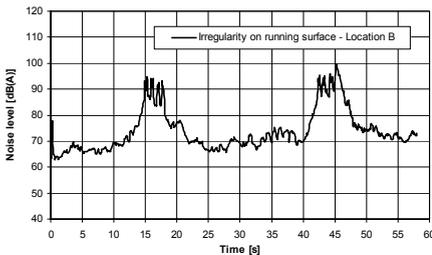
Figure 16: Characteristic depiction of change in noise level.

Noise levels were measured during tram passby, for a period of 20 to 40 seconds (depending on the tram driving speed). A characteristic depiction of the changes in noise levels over time are shown in fig. 16. The diagram shows the measurement noise levels at the time of passage of two tram vehicles over the irregularity in the rail weld. This diagram clearly shows the passage of each axle of the vehicle over the rail surface irregularity. The maximum noise levels (peaks) appeared during the passage of tram vehicles. Where irregularities on the rail surface are smaller, noise levels during tram passage are also smaller. The results of measurements taken at Location A with the presence of irregularity in the rail surface and following repairs to the rail surface are shown on fig. 17.

The increased noise levels (peaks shown in figures) are clearly seen in the characteristic depiction of noise levels over time in figures 16 and 17. Following repairs to the irregularities, the sudden jumps in the noise level diagrams disappear and the maximum noise levels are thereby decreased (fig. 17).

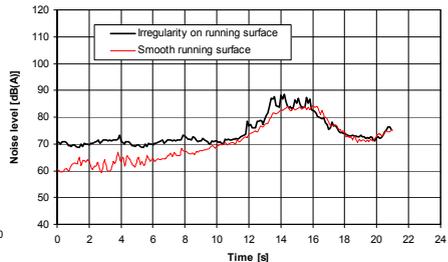
Figure 17: Noise levels prior to and following weld repairs.

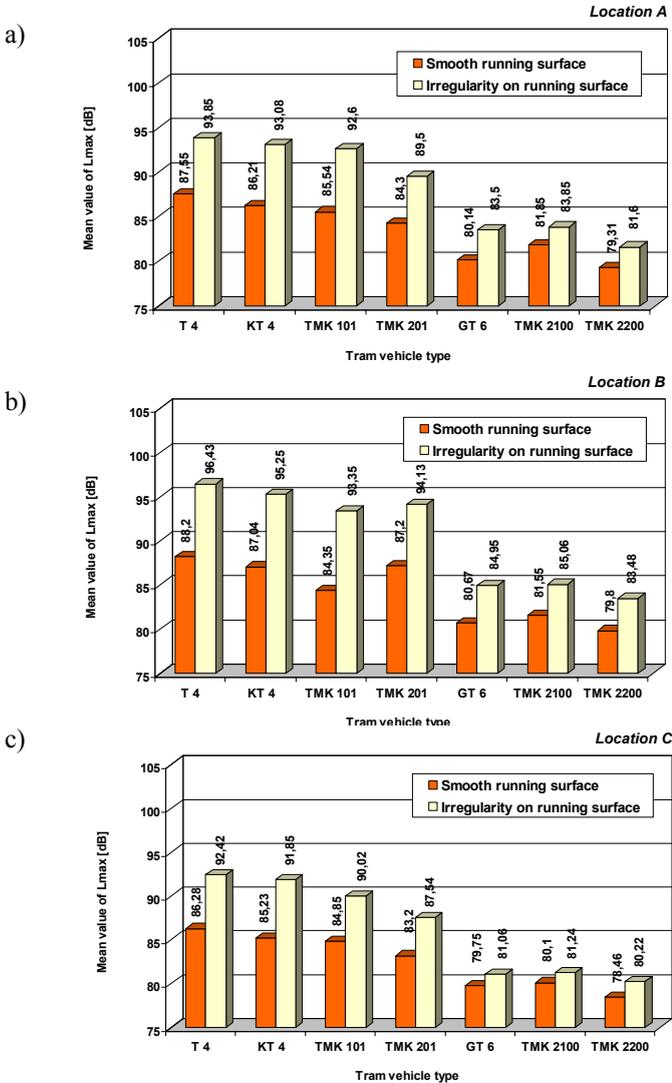
Figure 18: The maximal noise levels depending on tram and geometry of running surface.

In addition to comparing noise levels prior to and following repairs to weld irregularities, a comparison was also conducted of the mean values of noise level peaks dependent upon the type of tram. Tram vehicles which passed over the rails which were the subject of this study were investigated, as noted in point 2. The mean values of noise level peaks dependent upon tram type is shown in figure 18a) for the measurement site at Location A, in figure 18b) for the measurement site at Location B and in figure 18c) for the measurement site at Location C.

The mean value of maximal noise levels following repairs are 6 to 8dB lower than measurements taken with the presence of rail surface irregularities (at the same location). Comparison of results of measurements prior to and following rail weld repairs at Locations A, B and C, it is clear that the level of noise at Location C is about 5-10dB less (prior to weld repairs) and about 3-6dB less (following weld repairs). The increased noise levels at Locations A and B are due partially to a greater tram speed and partially to greater geometric irregularities. At Location A, dents in the weld were 1.2mm deep, while the same were 2.3mm deep at Location B and 0.6mm at Location C. The greater depth of irregularities is caused by the strong impact of the vehicle wheel at the moment the vehicle passes over the irregularity and results in a significant increase in noise levels. Comparison of the mean values for the maximal noise levels shows that the passage of the trams of the type T4, KT4, TMK 101 and TMK 201 causes larger increase of the noise levels (up to 7 dB) as compared to the case where uneven driving surfaces exist. The trams of the GT6, TMK 2100 and TMK 2200 types had shown better results.
