REJUVENATING THE SHOPHOUSE: CONSERVATION OF HISTORICAL BUILDINGS IN PENANG'S UNESCO WORLD HERITAGE SITE

ZAHARI ZUBIR, KOH JING HAO, NOR HAYATI HUSSAIN & PRINCE FAVIS ISIP
School of Architecture, Building and Design, Taylor's University, Malaysia.

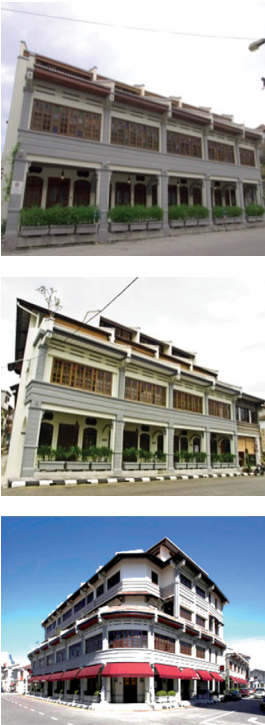
<ul style="list-style-type: none"> • Mix of the Late Straits Eclectic Style and Art Deco • The Art Deco elements can be seen at the banded first floor spandrel beams and banded column surfaces • Architectural features include U-shaped terracotta roof tiles • On the upper floor, wooden louvered shutter windows • On the lower floor, butterfly-shaped Chinese air vents, timber windows with iron bars, curved timber ventilated door and brick wall terracotta floor tiles • The newly added second and third floors matched the existing lower floors
