Masonry block construction in Haiti

Abstract

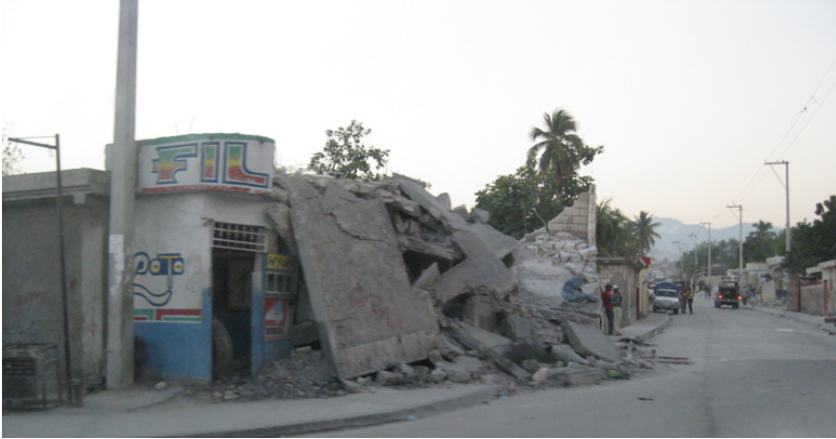
Figure 1: Typical buildings in Port-au-Prince, Haiti shown following the earthquake.

reinforced concrete slab roofs and floors (Figure 1). After the earthquake it is obvious upon inspection that these buildings were constructed with little steel reinforcement and poor connection details.

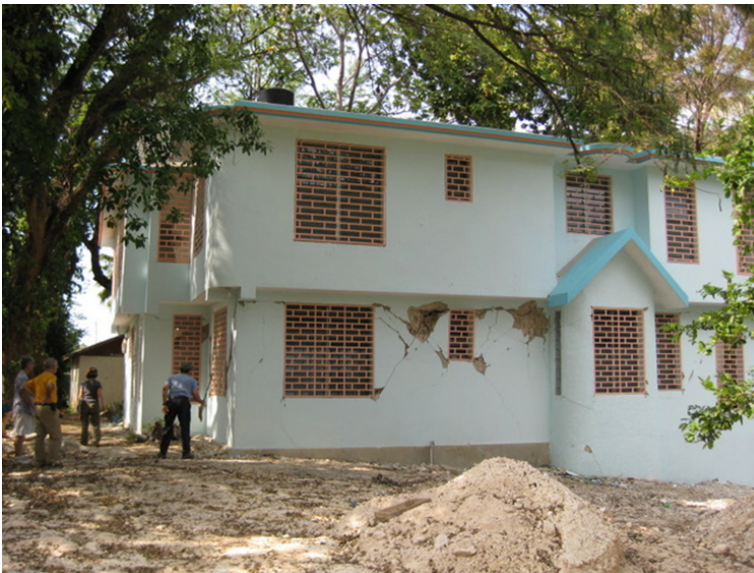
Most of the buildings constructed using CMU were a hybrid of reinforced concrete frames and CMU walls. The reinforced concrete frames are built with little attention to detailing at beam-column connections which results in low moment capacity of the frames [1]. Because of these low moment capacity frame connections, the building relies heavily on the CMU walls to resist lateral loads [2]. Additionally, as seen in Figure 2, it is very common for the second story to cantilever over the first story. This creates a structural irregularity in the perimeter wall system where a great deal of the lateral load resisting system is located.

Figure 2: Newly constructed building which is a hybrid of reinforced concrete and CMU block.

Samples from several CMU block buildings were tested at the Donald G. Fears Structural Engineering Laboratory at the University of Oklahoma [3–7]. The first set of samples was taken from the buildings damaged during the earthquake. The results from the compression tests of these samples are shown in Table 1. In the case of the building shown in Figures 2 and 3, the mortar coating the blocks had a higher compressive strength than the blocks themselves.

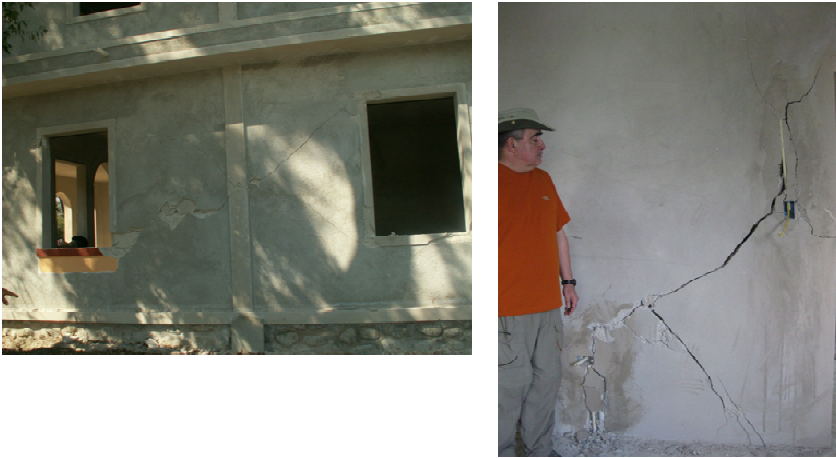
There were seven hybrid buildings at Christainville and of these seven buildings, four were two-story buildings which all collapsed or were damaged beyond repair. The three one-story hybrid system buildings performed better. Only one collapsed, one was severely damaged, and one remained undamaged. It is worth noting that the undamaged building had a lightweight steel roof. Several of these hybrid buildings that failed were newly constructed buildings where the CMU block performed poorly as a shear wall (figures 4-6).

Figure 3: Wall shear failure in newly constructed hybrid reinforced concrete and CMU block (left outside view, right inside view).

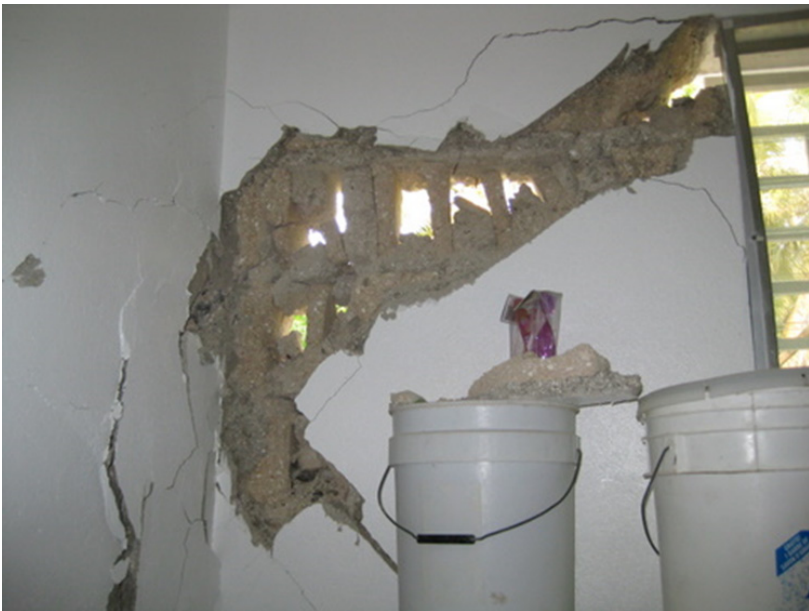
Figure 4: Newly constructed building with a hybrid system of reinforced concrete with CMU block.

Sample description	Compressive strength (psi)
Block samples from the building shown in Figure 4	
Sample 1	745
Sample 2	545
Sample 3	1135
Block samples from the building shown in Figures 2 and 3	
Sample 1	890
Sample 2	555
Samples from an older building (hybrid structural system)	
Sample 1	655
Sample 2 (interior mortar coating)	1908
Samples of Haitian locally purchased CMU block	
Sample 1 (made of local Marl aggregate)	470
Sample 2 (made of river rock aggregate)	493
Sample 3	1538
Sample 4	1282

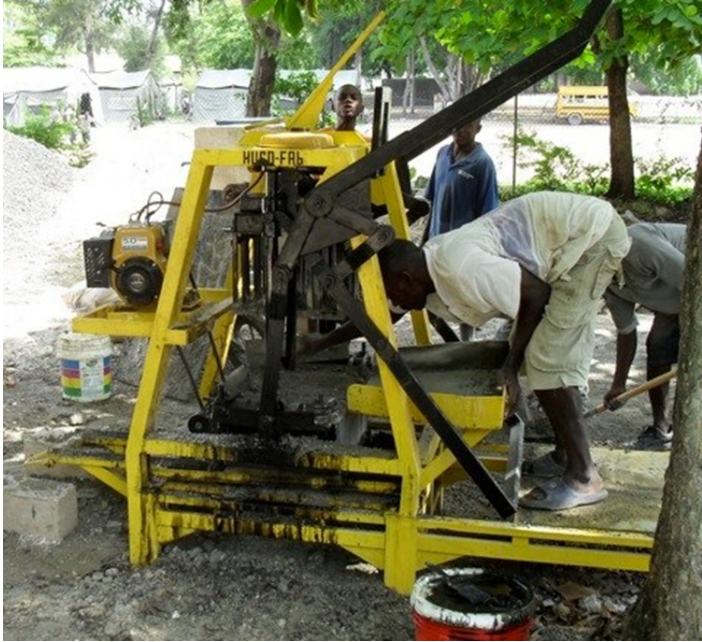
CMU blocks used in building construction in Haiti are made locally. They are often made with hand operated mechanical presses as shown in Figure 5. They

Figure 5: Machine used to make CMU block in Haiti.

After confirming the poor strength of the blocks purchased in Haiti, Christianville officials decided to begin making their own block to have greater control over the quality of block used to rebuild. Christianville purchased a block maker (figure 5) and researchers at OU advised the officials on CMU block making. The amount of Portland cement was increased to 1/6th by volume. The sand and/or small aggregate used in the mix was not smooth river

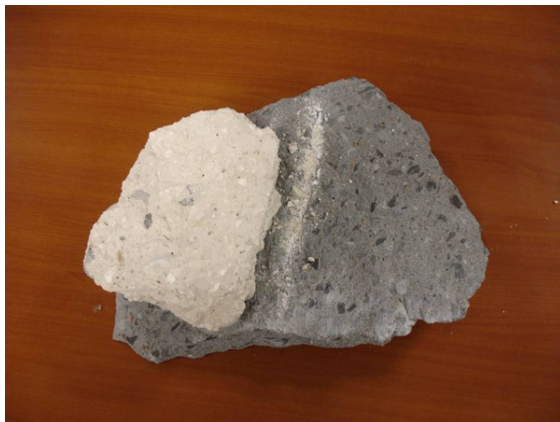
Figure 6: Sample of Haitian concrete (left) and a typical US concrete sample (right). Note the Haitian concrete is loose and chalky and able to leave a chalk line with very little pressure.

are made with local sand and gravel. These ingredients are often of poor quality. The sand may contain salt and the gravel is typically smooth shaped rather than jagged in shape so the bond to the cement paste is not as strong as it could be. The Portland cement, which is the only imported ingredient, is often of poor quality and visual inspection indicated (by a gritty texture of the powder) that it

was partially hydrated. Workers interviewed said the mix for the block consisted of mostly sand and gravel with as little as 1/30th Portland cement. Rather than having a characteristic gray color found in a properly produced CMU, these blocks have so little Portland cement they are white or yellow in color. The newly constructed blocks are placed (uncovered) in the sun to dry and with no attention to typical curing processes such as controlled humidity. Blocks are not steamed during curing and often formed under little or no pressure. Figure 6 shows a sample of Haitian concrete next to a typical US sample of concrete. Blocks are sometimes so weak that workers must lift blocks with two hands or else blocks fall apart. Visual inspections indicate the block is of poor quality and testing verified this.

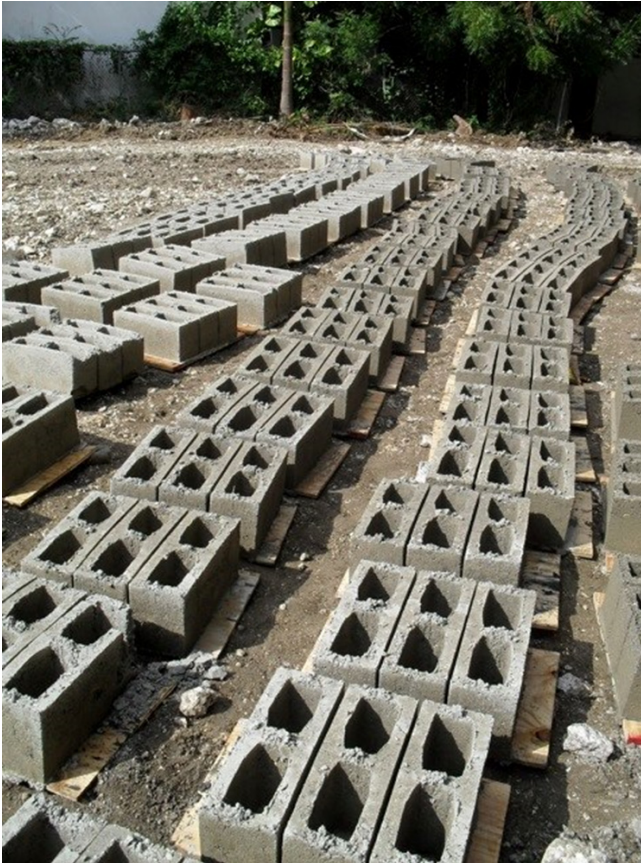
Figure 7: Newly constructed CMU blocks made in Haiti with an improved mix and curing techniques. Note: The improved CMU blocks are now grey in color.

sand and the blocks were moistened during curing. Christianville officials found it difficult to keep the block moist during the entire 28 days of curing, but did moisten the blocks several times a day. Samples of the improved blocks were tested and the results are shown in Table 2. Visual inspection of the samples indicated there is still a portion of the Portland cement that is not activated and therefore there is still room for improvement in the curing process, but overall the compressive strength was improved.

Sample description	Compressive strength (psi)
Sample 1	1198
Sample 2	1937
