# **The Doppler-Fiseau effect on the damage distribution during the Kobe earthquake (Japan)**

E. Lekkas, H. Kranis

## **Abstract**

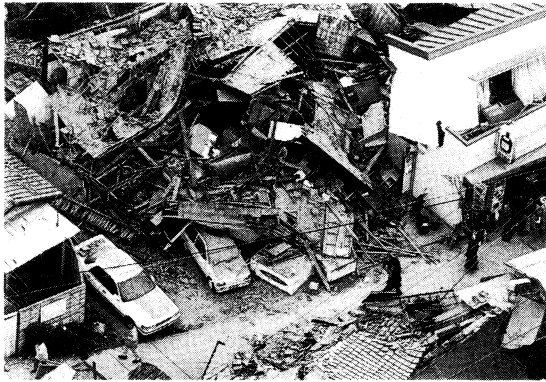
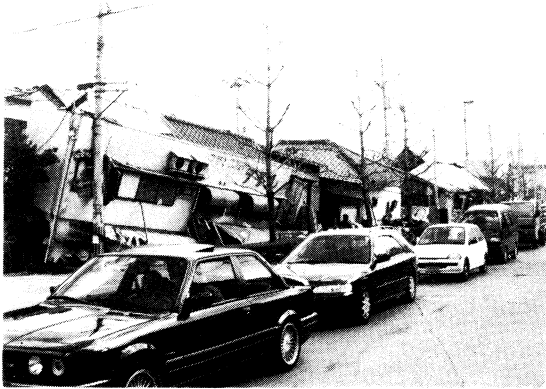
Figure 6. Destroyed wooden houses in Kobe.

Apart from the observation that there was a discrepancy in the maximum intensities between Kobe and Awajishima, there is also another fact that deserves attention, and has to do with the extent and magnitude of damage in buildings of the same type. That is to say, as for the wooden structures (and generally one- or two-storey houses), there was significant differentiation in the destruction: such structures in Kobe collapsed, totally or partially, or suffered severe damage, with only a small percentage suffering light or no damage. According to the official data, 80% of these structures fall into the first category and only 20% in the second. On the other hand, the corresponding percentages were 40% and 60%, respectively (Fig. 6).
