PERFORMANCE OF WOOD-FRAMED RESIDENTIAL STRUCTURES UNDER EXTREME WIND LOADS

SARAH A. STEVENSON¹, GREGORY A. KOPP¹ & AYMAN M. EL ANSARY²

¹Boundary Layer Wind Tunnel Laboratory, University of Western Ontario, Canada

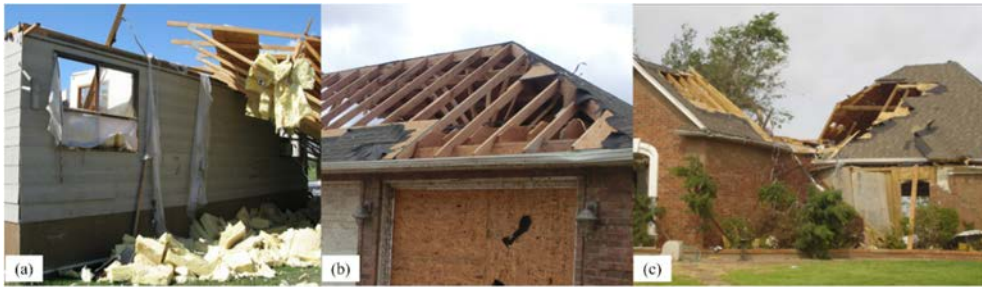
Figure 1: Residential (FR12) roof failure modes. (a) Roof-to-wall connection (RTWC) failure; (b) Sheathing loss; (c) Framing failure. (Source: Authors and Dr. D.O. Prevatt, University of Florida.)

Research to mitigate residential losses during tornadoes focuses primarily on the damage described under DOD4 and DOD6 in the EF-Scale, corresponding to roof sheathing failure and loss of large sections of the roof structure, respectively. Assessment of hurricane damage does not utilize the EF-Scale and the tornado wind speed estimates cannot be related directly to hurricane wind speeds; however, the wind-induced failure modes are similar in both types of storm. Roofs of wood-framed houses are known to be particularly vulnerable to high winds, with sheathing failure often resulting in loss of the entire building and contents due to rain entry, and failure of the RTWC resulting in rain entry and higher likelihood of wall collapse due to loss of lateral support. Images of the two common failure modes, as well as a new mode of DOD6 appearing to occur in the roof framing structure, are shown in Fig. 1. Framing failures such as that shown in Fig. 1(c) have not been studied previously.

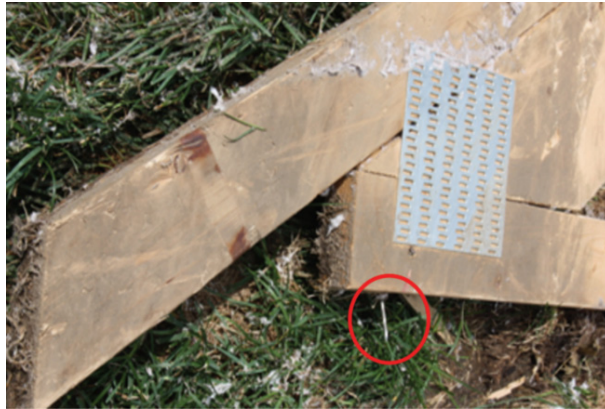
Figure 2: Failed RTWC with a single toe-nail, rather than three as required by the NBCC [10]. (Source: Kopp et al. [12].)

In another study, Kopp et al. [12] developed fragility curves for failure of RTWCs with varying numbers of nails. This study was based on damage observations following an EF2 tornado in Angus, Ontario in June 2014. The number of toenails in the RTWCs was varied to understand the effect of construction quality on the failure wind speeds. Considering toenailed RTWCs with three nails to be “perfect” connections, in accordance with the NBCC, connections with three, two, and one toe-nail were analyzed. Inadequate RTWCs were observed in the majority of failed roofs following the Angus tornado; in some cases, there was no sign of any nails at the RTWC, while many others had only one or two nails as shown in Fig. 2. The results of the fragility analysis indicate that for gable roofs, the wind speed at the 50% failure probability is reduced from 200 km/h to 160–170 km/h when two nails are missing from every RTWC. The reduced wind speed at the median probability of failure is in the EF1 wind speed range. For hip roofs, the reduction was from 250 km/h to 180–200 km/h.

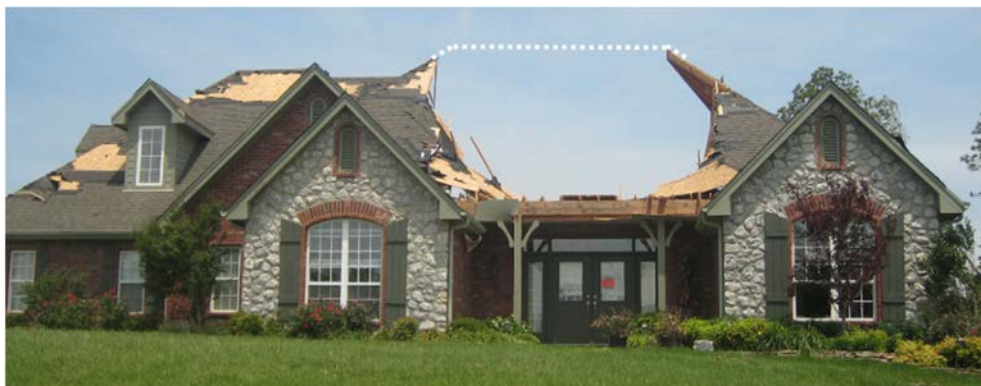
Figure 3: Failure of steep-sloping, stick-frame hip roof including removal of the largest faces. (Source: Stevenson [14] and Dr. D.O. Prevatt.)

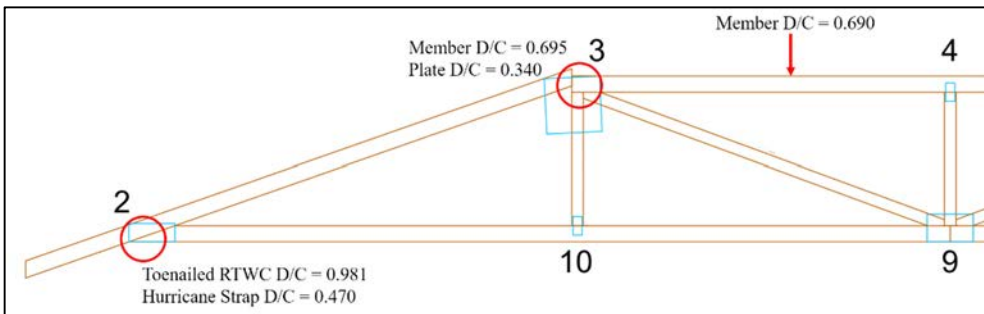
Figure 4: Diagram of modeled MPC truss showing critical demand-to-capacity ratios.

data – or accurate estimates – for every component of the structure. Such information is not available for MPC trusses, and it is limited for stick-frame roofs. For the present work, it is considered sufficient to model the roof structure in a simplified way, then compare the estimated forces to hand-calculated strength values. The weak links in the roof structure are identified by comparing the Demand-to-Capacity (D/C) ratios for every element in the roof. An image showing significant results for the trussed structure are shown in Fig. 4, and those for the stick-frame section are shown in Fig. 5.

The results of the D/C comparison for the MPC truss verify that the toe-nailed RTWC has the lowest relative strength by a 40% difference. The RTWC has a D/C ratio of 0.981, while the next highest ratio is 0.695 in the top chord member at Joint 3. Variations in the element capacity, joint configuration, or load path due to area-varying pressures could shift the results in any of the D/C ratios. However, since the analysis was based on comparison of the extreme force and capacity values, it is unlikely that the location of the weak link will shift; it is expected that toe-nailed RTWC's will almost always fail first in a trussed roof. Fig. 4 also shows the relative strength of a RTWC which uses a hurricane strap instead of toe-nails. In this case, the D/C ratio of the hurricane strap is 0.470, showing that application of the most

basic hurricane strap would shift failure into the connections within the truss. This is important because MPC joints are not currently designed for in-plane moment, which was the governing load effect at this location.

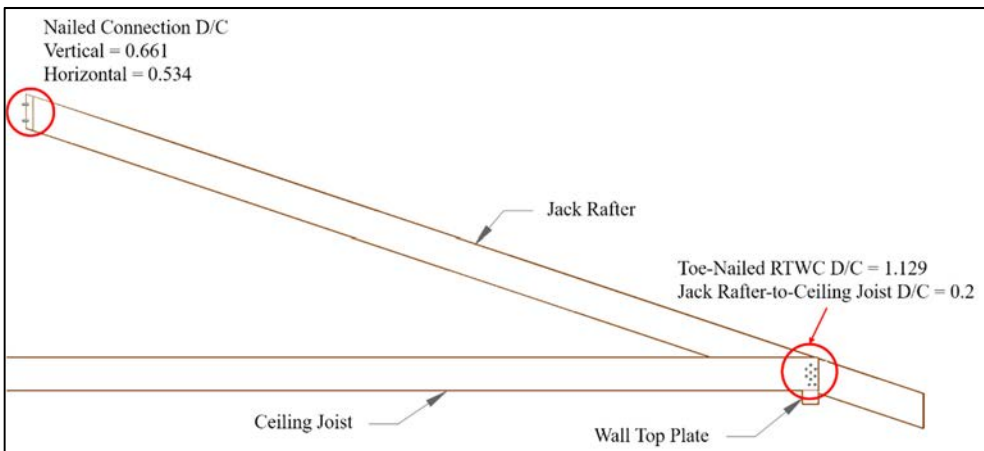
Figure 5: Diagram of modeled stick-frame section showing critical demand-to-capacity ratios.

The results of a similar D/C analysis for the stick-frame section, subjected to the same uplift as the truss, are shown in Fig. 5. Similar to the truss results, analysis of the jack rafters at the center of the roof face found that it is most vulnerable at the toe-nailed RTWC. The D/C ratio for a case including a hurricane strap was not calculated. However, introduction of a strap is expected to shift failure to the ridge joint due to the relatively high D/C ratios in this location. As with trussed roofs, variations in material behavior may make it even more likely that framing failures will take place. This is especially probable when construction errors and flaws are considered.

Another notable result, which will be discussed in the following section, relates to the second-weakest connection at the base of the roof. In a stick-frame roof, the jack rafter is fastened to the ceiling joist using seven nails, and this connection is secured to the wall as a unit by the RTWC. Significant force would be required for the structure to fail at the rafter-to-joist connection. More details of the analytical work are provided in [14], [15]. Sophisticated, three-dimensional finite element models will be required for fragility models or failure simulations to be developed in the future. Experimental studies on the failure behavior of common connections will be carried out to allow for models to be developed using accurate material properties.

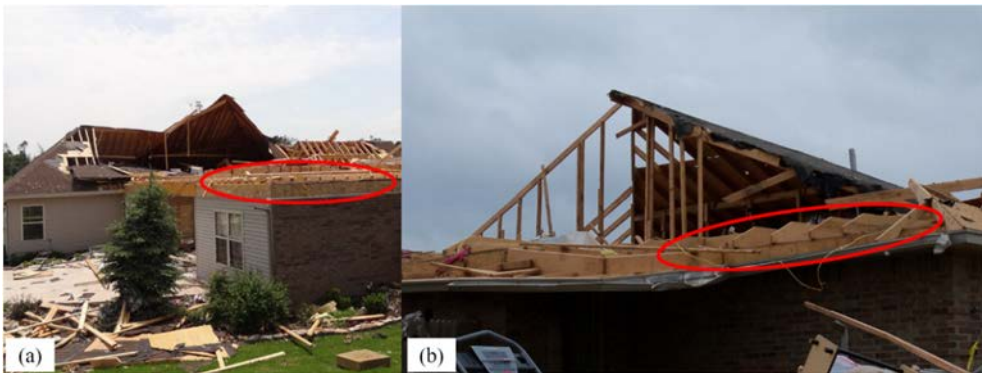
Figure 6: Framing failures in stick-frame hip roofs with intact ceiling joists. (Source: Dr. D.O. Prevatt.)

In addition to understanding the occurrence of different roof failure modes across residential neighborhoods, the available damage survey data was used to study important details in the failures of specific houses [14], [15]. In the damage photos, a group of houses was identified that fails in a way that disagrees with the results of the D/C analysis for the stick-framed roof. As shown in Fig. 6, several roofs appeared to have lost their outer faces and jack rafters, while the ceiling joists remained in place. Based on the D/C results and wind speed conversion, this failure should not occur due to the 7–nail connection joining the jack rafters to the ceiling joists. The RTWC and the connection at the ridge of the roof appear to be much more vulnerable in analysis.

Reasons for the unexpected failure of the jack rafters shown in Fig. 6 are likely related to improper or insufficient joint construction, or old building design to outdated standards. Considering system effects, a single flaw in the structure can lead to progressive, cascading

failure of the entire roof face, although a 7–nail joint would have prohibited this. Close inspection of the damage photos suggest poor construction in many of the failed roofs. In some cases, there were nails at the jack rafter-to-ceiling joist connections, but not more than a few. In others, the jack rafters and ceiling joists were separately toe-nailed to the wall top plate, without even being in contact with one another. Fig. 7 shows the intact stick-frame structure of a roof in the same neighborhood and of the same construction style as that shown in Fig. 6(b). The circle on the figure highlights a visible space between the jack rafter and the ceiling joist.

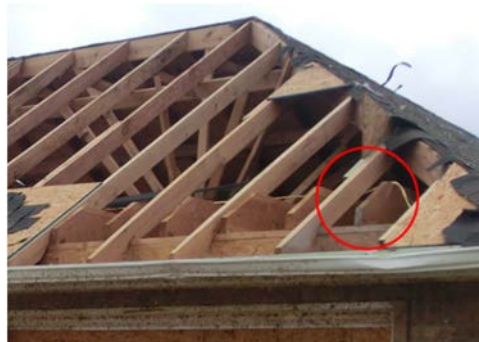
Figure 7: Intact stick-frame structure showing lack of connection between the jack rafter and ceiling joist. (Source: Dr. D.O. Prevatt.)
