Straw bale fire test on cement plaster mixes

G. Garas, M. Allam & K. Mamdouh

Civil Eng. Dept., National Research Center, Cairo, Egypt

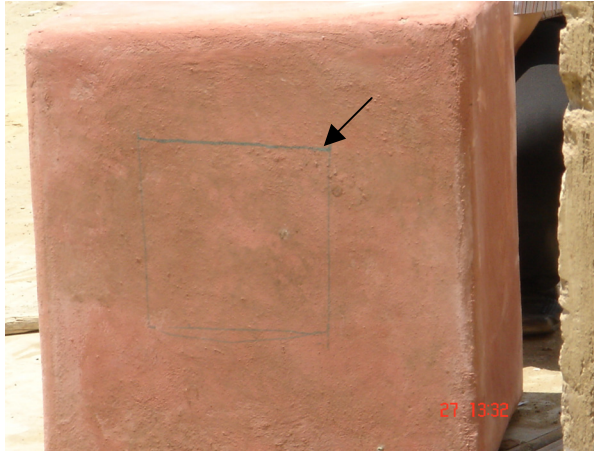
- First the area of the plastered samples that was subjected to the flame was identified by a square with dimension 20 cm × 20 cm at the center of which the nozzle of the fire source was directed, (Figure 1).

Figure 1: Area subjected to flame.

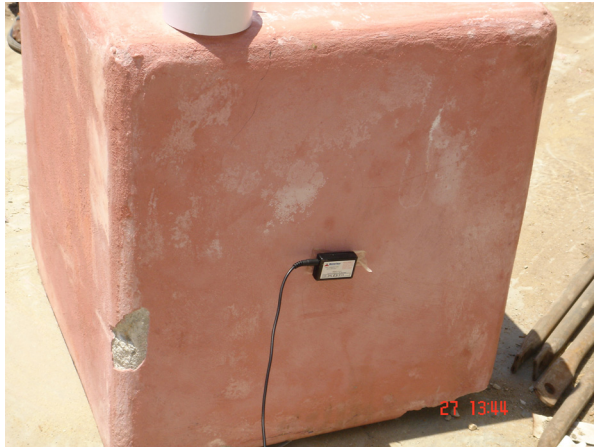
- The test continued for 2 hours after which the flame was removed.
- A sensor of sensitivity ranging from -40 °C to 80 °C was installed on the opposite surface of the flame facing the center of the marked square, (Figure 2).

Figure 2: Opposite side attached to the sensor.

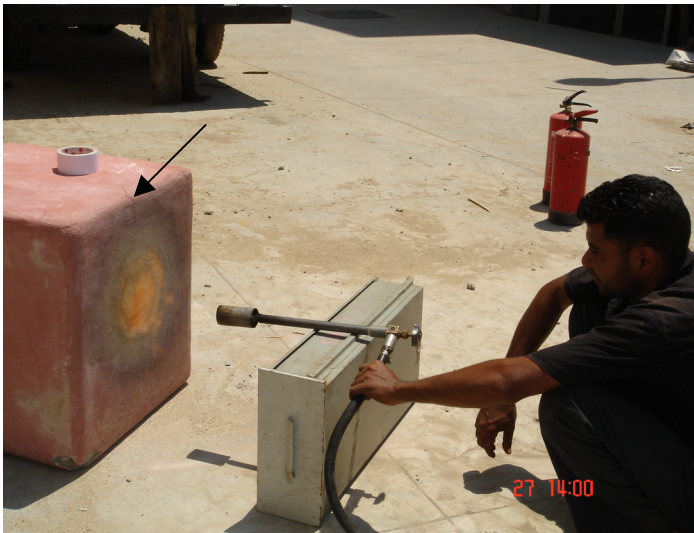
Figure 3: The appearance of a crack on Specimen Mix C after 25 minutes.

Specimen one with the highest lime content, Mix C cement: lime: sand (1: 2 : 9), developed a visible crack at the specimen highest corner above the exposed area after 25 minutes (Figure 3). The crack increased in size by the time and smoke was visible coming out of the crack (Figure 4). Hair cracks appeared on the exposed side of the specimen after about 90 minutes of the continuous flame exposure (Figure 5). The smoke coming out of the upper crack was extinguished with water at the end of the test. After 9 hours of the test completion the specimen was still smoking which required complete soaking down of the specimen (Figure 6).

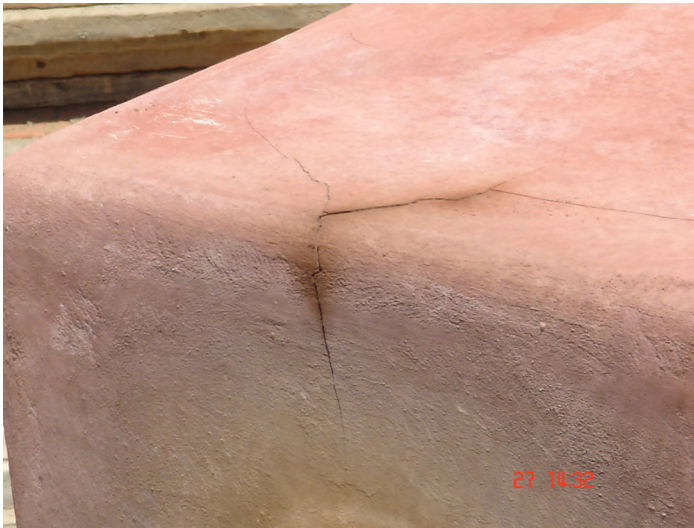
Figure 4: The increase in the crack width in specimen of Mix C after 1 hour.

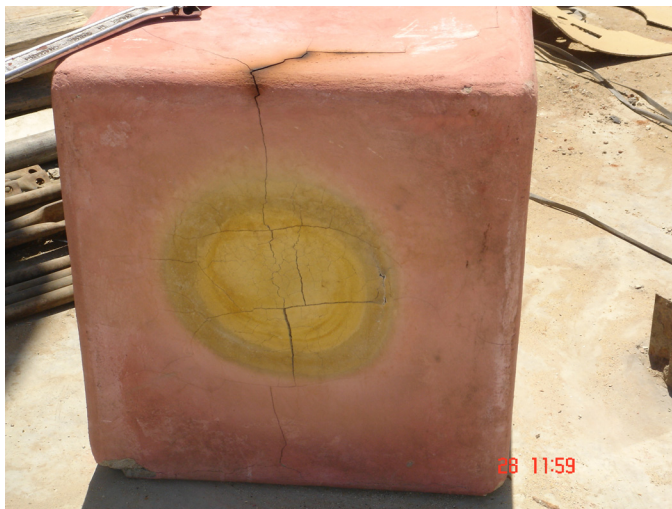
Figure 5: The specimen Mix C after 9 hours of test completion.

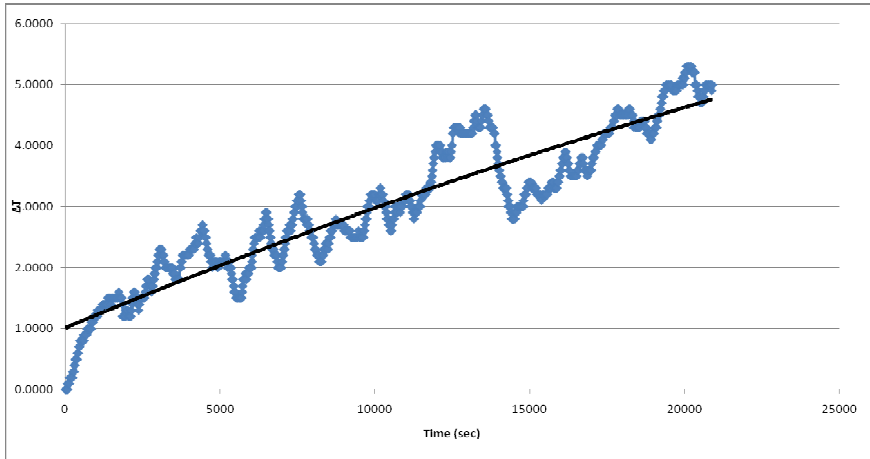
Figure 6: The increase in heat Transfer through Specimen Mix C.

the flame on specimen Mix C. The temperature increased gradually during the total life time of the test to record a total increase of 5.3°C (Figure 7). The initial humidity reading of the sensor was 37% at the beginning of the test.

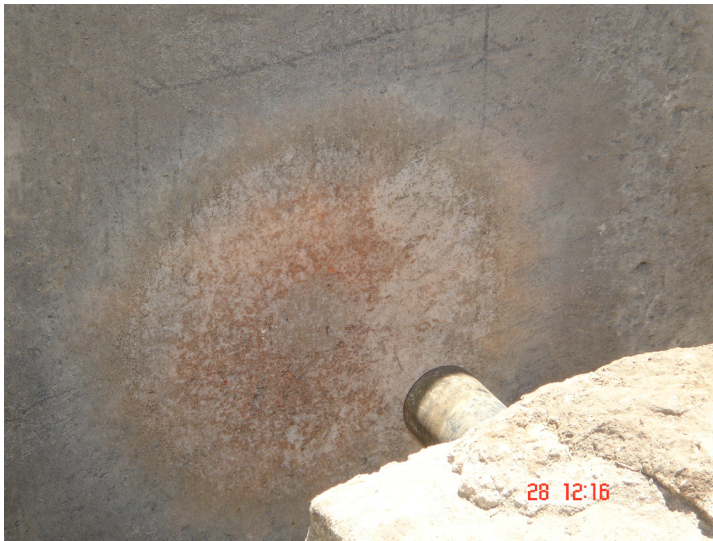
Figure 7: Specimen Mix B after 16 minutes of test beginning.

Specimen two (Mix B cement: lime: sand (1 : 1 : 6) with a lime content half that of Mix C, continued for the two hours of the test and no cracks were noticed till the end (Figure 8). The maximum temperature increase transferred through the specimen width was about 5.3°C during the two hours (Figure 9).

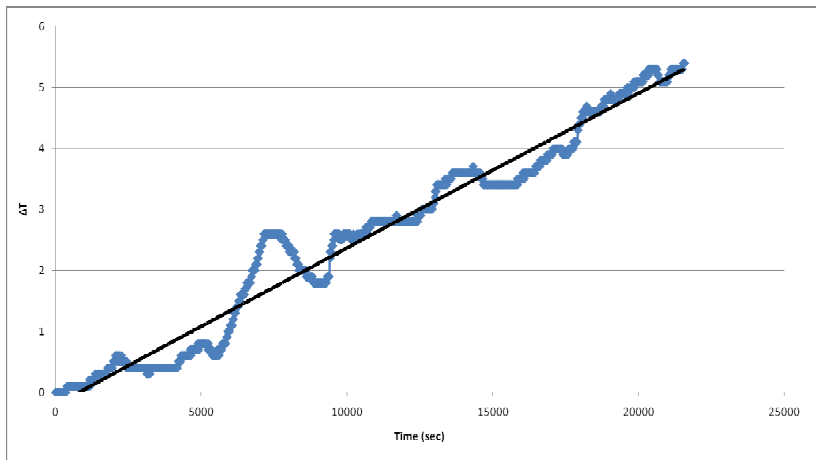
Figure 8: The increase in the heat transfer through specimen Mix B.

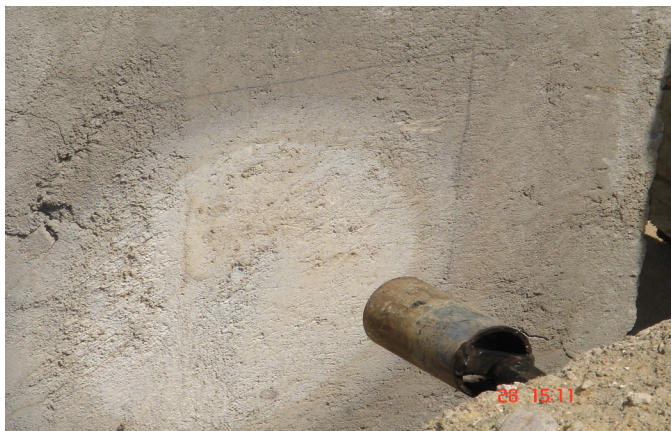
Figure 9: Specimen Mix A after 15 minutes of test beginning.

Specimen three (Mix A cement: lime: sand (1 : 0 : 3) without any lime content showed no signs of minute change during the overall life of the test Figure (10). The sensor showed the same amount of temperature increase through out the total exposure of specimen Mix A. However, some fluctuation in the sensor readings were recorded after one and a half hour of the test life time due to the increase in wind speed and lasted for about ten minutes.
