Experimental evaluation of stone masonry walls with lime based mortar under vertical loads

Abstract

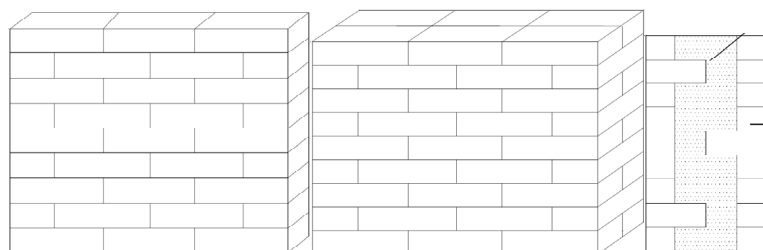
Single wall model

Double wall Model

Cavity wall with infill

Figure 1: Tested models of wall specimens.

1. Wall structure where three different wall systems are used (Figure 1)
 - a. Single wall model of thickness 120 mm
 - b. Double wall model of thickness 250 mm
 - c. Cavity wall model made of external leaf stone blocks of thickness 120 mm and lime based rubble infill of thickness 210 mm. Thus, the overall thickness of the wall is 450 mm.
2. Lime based mortar strength where two types of mortars are used:
 - a. Weak lime mortar
 - b. Strong lime mortar with white cement of 5% of lime weight
3. Three different thickness of horizontal and vertical lime based mortar joints 15, 10, and 5 mm.

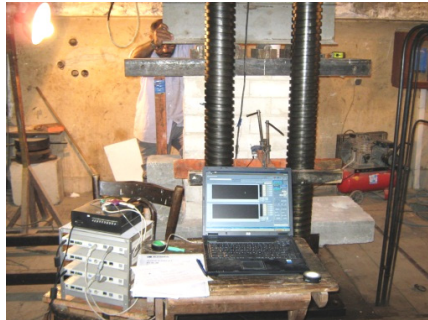
Figure 2: Experimental set-up.

All specimens were built on reinforced concrete base beam to facilitate movement and placement of the specimens on the test frame after 28 days from construction. To ensure even distribution of compression loads on the top of wall models, a system of steel beams were used to distribute the point load of the actuator evenly on the wall (Figure 2 and 3). The capacity of the test frame is 5000 kN connected to a load cell of the same capacity. The instrumentation attached to the specimens also included LVDT to measure the vertical displacement of the wall; LVDT to measure the out of plane movement of the wall during testing, and strain gauges attached to the face of the stone blocks to measure vertical and horizontal strain (Figure 4). All specimens were loaded by increasing in-plane vertical load up to failure. The loads, vertical deformation, lateral deformation and strains are recorded during testing using data acquisition system for further analysis.

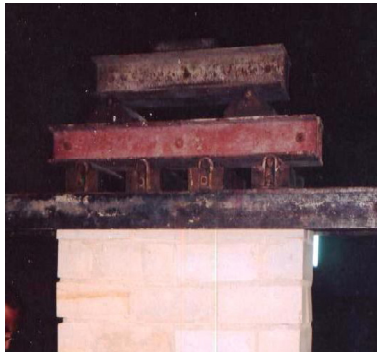
Figure 3: Loading beam on wall top.

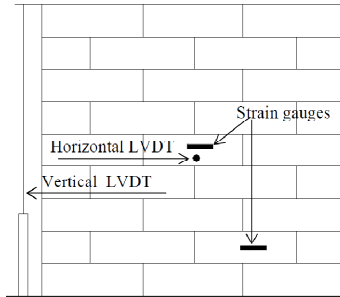
Figure 4: Instrumentation layout.

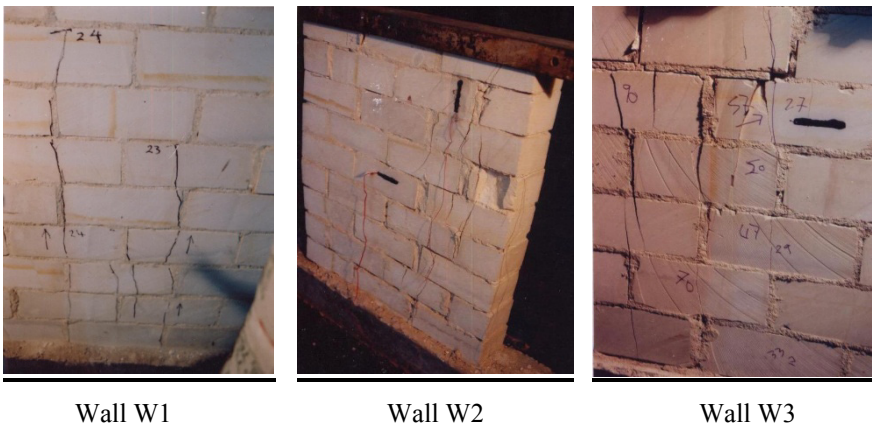
Figure 5: Crack pattern at failure of single leaf wall structure.

The wall specimens were continuously loaded up to failure, and the data was recorded using data acquisition system connected to personal computer. In all tested specimens of single leaf wall models W1 to W6, it was observed that the initial cracking started from stone above the vertical joint and extended up to the top of the wall as shown in Figures 5. The average stress on the wall section was calculated by dividing the applied load by the gross cross sectional area of the wall. Figures 6-11 shows the variation of average stress with the average strain up to failure for single leaf wall models. The values of failure loads and the corresponding stresses for all wall is summarized in Table 2.

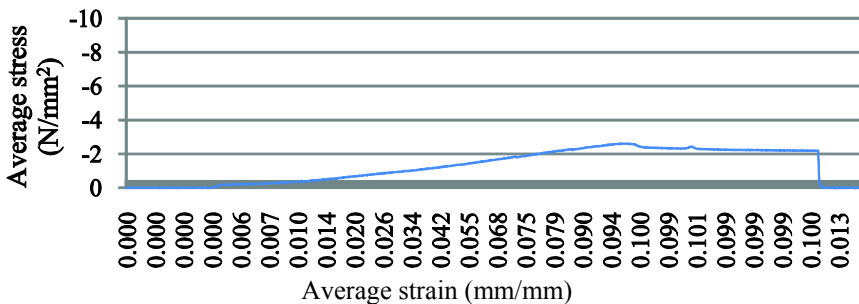
Figure 6: Stress-strain relationship of specimen W1 to failure.

The effect of mortar joint thickness on the overall strength of the masonry walls systems is displayed in Figure 19. It is observed that highest strength is attained at mortar thickness of 10 mm. Increasing the mortar thickness to 15 mm slightly decreases the wall overall strength however improves the wall ductility as shown from the stress-strain curves of Figures 6-11, 13 and 14. Also, decreasing the mortar thickness to 5 mm decreases both the strength and ductility.

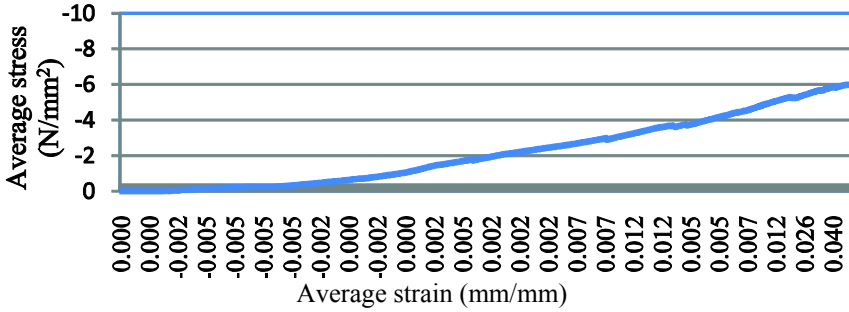
Figure 7: Stress-strain relationship of specimen W2 to failure.

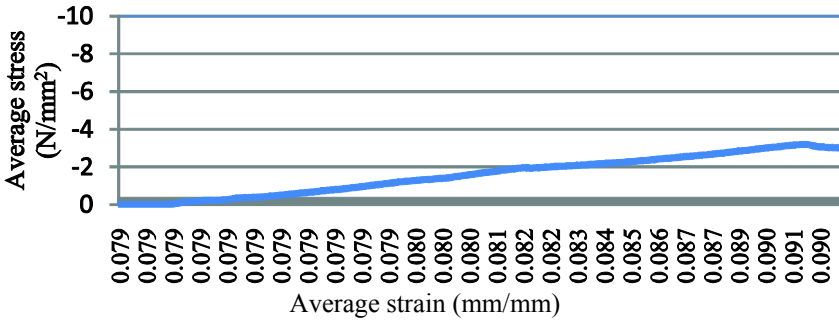
Figure 8: Stress-strain relationship of specimen W3 to failure.

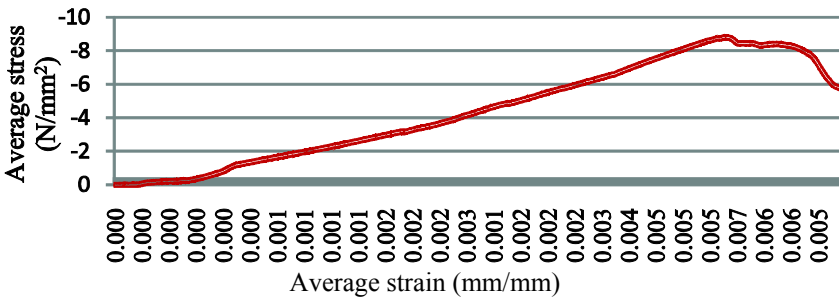
Figure 9: Stress-strain relationship of specimen W4 to failure.

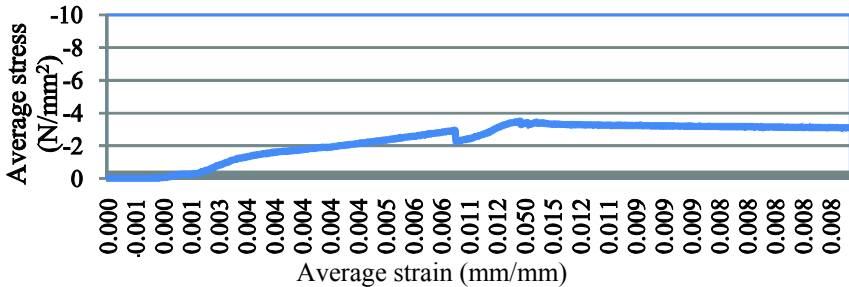
Figure 10: Stress-strain relationship of specimen W5 to failure.

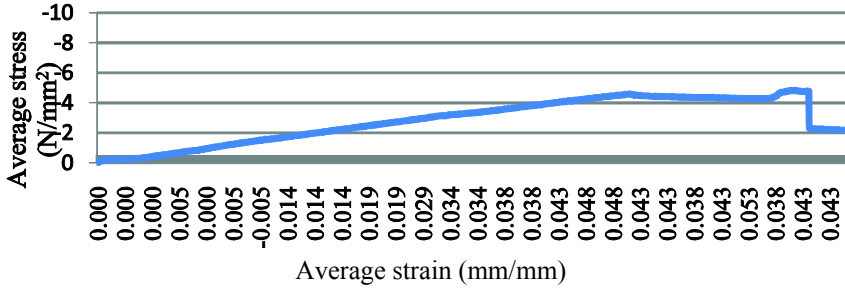
Figure 11: Stress-strain relationship of specimen W6 to failure.

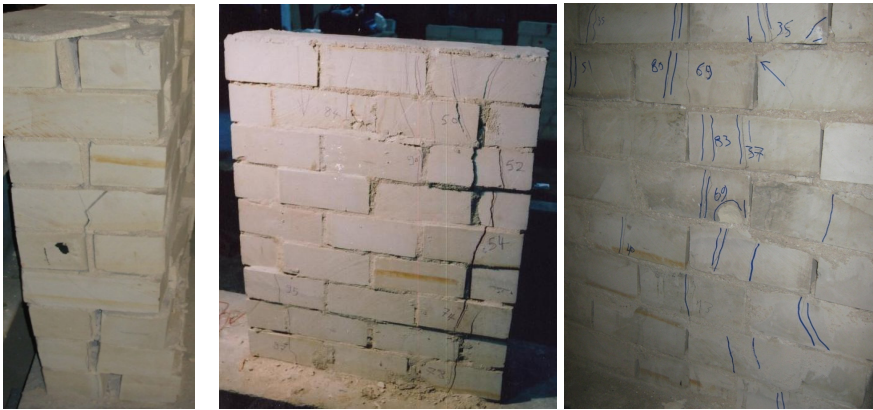
Wall W7

Wall W9

Wall W11

Figure 12: Typical failure of double leaf stone masonry wall specimen.

Double leaf wall models were tested under increasing in-plane compressive load to failure. In almost all walls, cracking due to splitting of stone resulting from transversal stresses due to mortar squeezing started at the bed joint at the bottom of the wall and propagated upward. Eventually the wall failed due to splitting failure of the two faces of the wall as shown in Figure 12. Figures 13

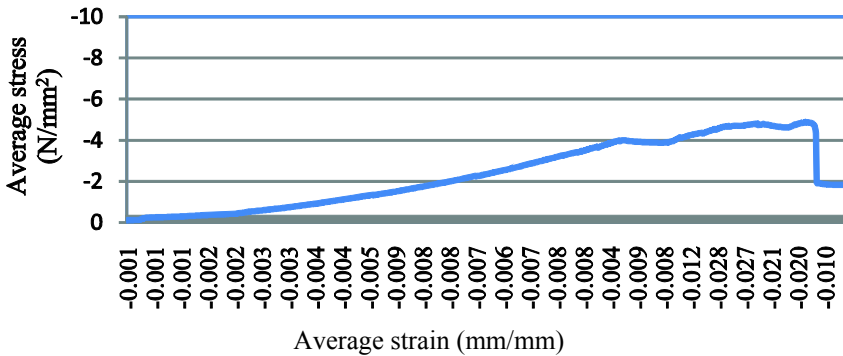
Figure 13: Stress-strain relationship of specimen W7 to failure.

and 14 display the variation of the average compressive stress with the average strain up to failure for wall models W7 and W11 respectively. The results of the test for walls W7 to W11 are shown in Table 2.

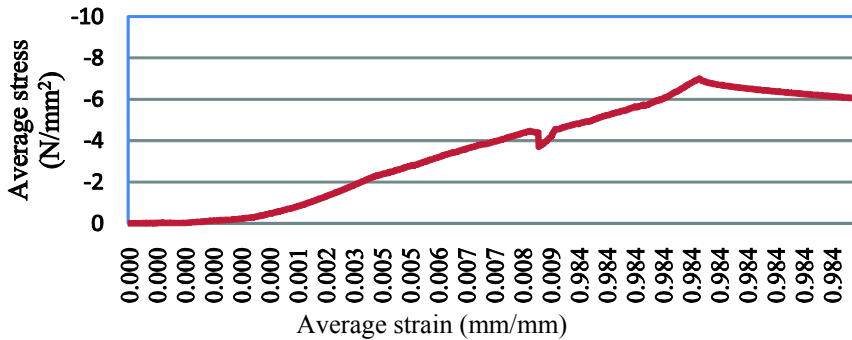
Figure 14: Stress-strain relationship of specimen W11 to failure.

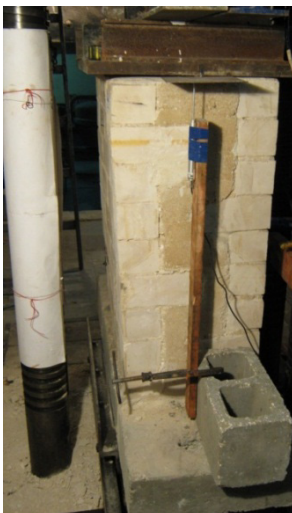
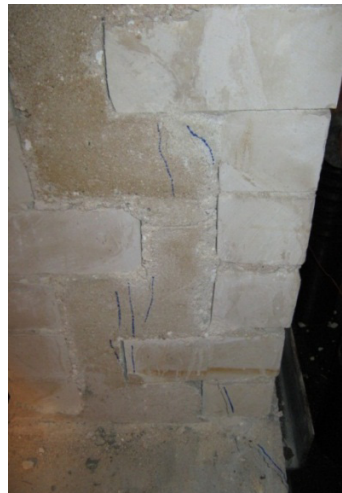
W12 during testing

Crack initiation in W12

Figure 15: Stress-strain relationship of specimen W7 to failure.

Wall W12 is a cavity wall (450 mm thickness) build with lime stone blocks 120 mm thick on the outer faces with 15 mm thick mortar joints. The wall faces are bonded together with 210 mm thick strong mortar with limestone rubble as infill between the wall faces. The specimen was continuously loaded up to failure load at 600 kN. The cracking started from the two side faces of the wall, and propagates upward. The mode of failure was mainly due to separation of the two faces of the cavity wall as shown in Figure 15. Cracks propagated around the stones instead of through stone blocks due to the weakness of the thick mortar infill compared to the stone blocks.

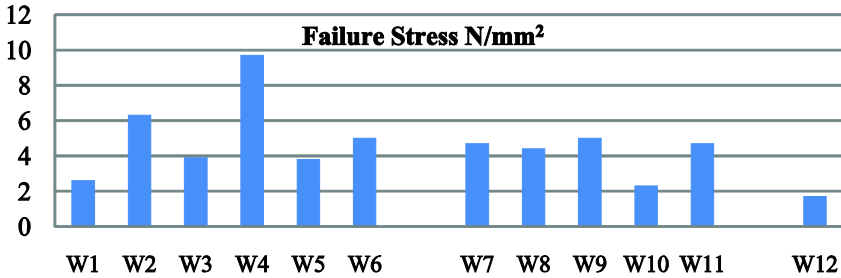
Figure 16: Comparison of the failure stress of the twelve tested walls.

The effect of the different parameters on the wall performance under increasing load up to failure is presented in this section. Those parameters include the mortar strength, the mortar thickness and the wall system. For fair comparison, since not all walls are of the same thickness and structure the analysis shall be based on the average compressive strength instead of the failure load. Figure 16 displays the failure stress of the tested twelve walls.

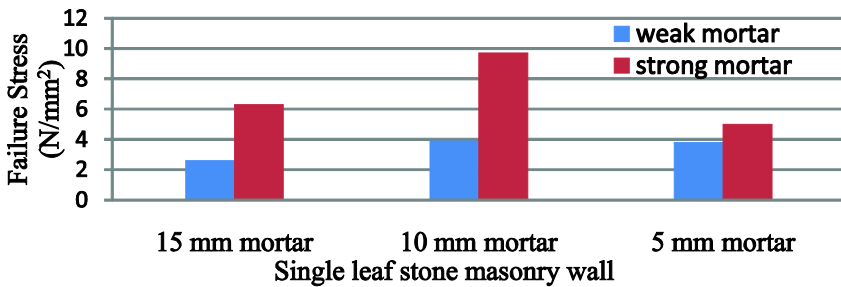
Figure 17: Effect of mortar strength on the strength of single leaf wall.

The existence of small amount of white cement (5% of weight) in the lime mortar increases the mortar strength from 0.14 N/mm^2 to 0.6 N/mm^2 . This results in significant increase in the strength of the walls as shown in Figure 17. This effect was evident for the different thicknesses of mortar joint.

For single leaf walls W1 and W2 with thickness of mortar 15 mm, the strength of wall W2 with strong mortar is higher than that of W1 with weak mortar by almost 2.5 folds (150% increase). The same effect was observed for wall W3 and W4 of single walls with thickness of mortar 10 mm. This effect was less pronounced in walls W5 and W6 with mortar thickness 5 mm where the increase was only 30%. Similar behaviour was observed in the double lead walls.

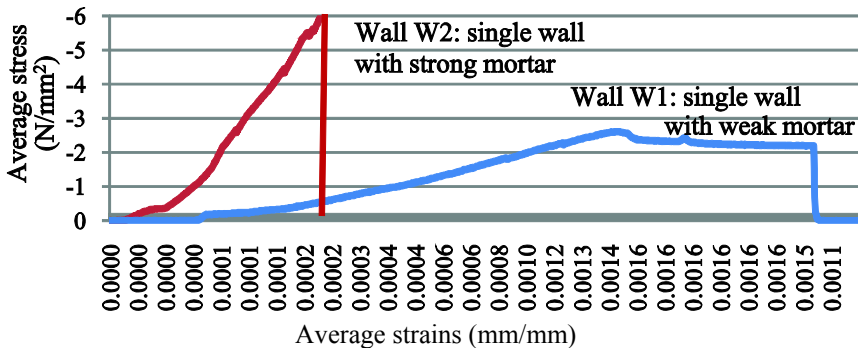
Figure 18: Effect of mortar strength on the stiffness of the wall.

Furthermore, the increase in the mortar strength results in significant increase in the overall stiffness of the wall. This effect is clearly shown in Figure 18 for wall W1 with weak mortar and wall W2 with strong mortar.

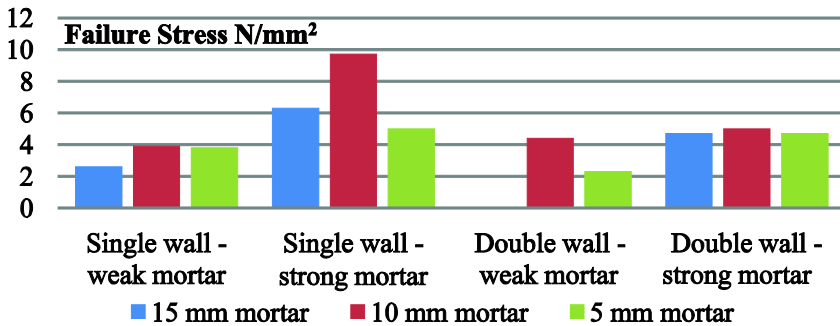
Figure 19: Effect of mortar joint thickness on the wall strength.
