Stone masonry walls and woodworks as architectural heritages in rural areas of the Eastern Anatolia Region, Turkey: case studies from Erzurum, Kars and Ardahan

D. G. Yilmaz

*School of Planning, Architecture and Civil Engineering,
Queen's University Belfast, UK*

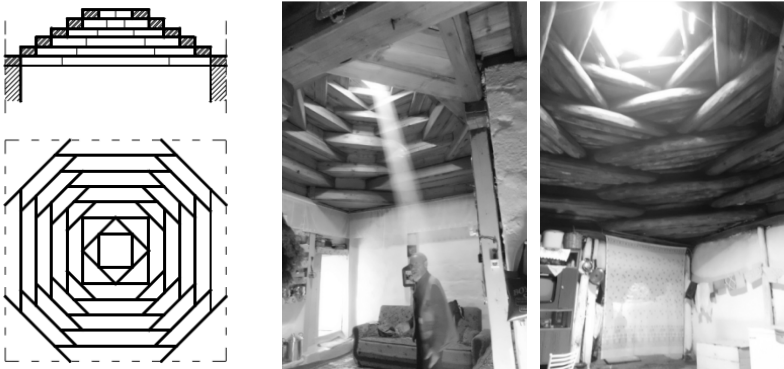
Erzurum has its characteristic and traditional civilian architecture, however today this practice is rarely continued by rural dwellers. The roof style of this sample of architecture is called ‘*kırlangıç örtü*’ (kırlangıç covering), and it covers either living room or baking room of the traditional rural houses (fig. 2). Normally, rectangular shaped timber elements are used to build this traditional roof.

Figure 2: The section and plan of ‘*kırlangıç örtü*’ [7], and its interior view from dwellers’ houses who maintained it; the example of rectangular shaped timber elements (in the middle), and the example of round timber elements (on the right), both use the space as their living room (photos taken by the author).

However, in case of aiming to cover larger spaces, round timber is also used. These timber elements are placed on top of each other as diagonal, and it creates octagonal shape, which ends with a square shape at the top of the roof. This square shaped space is used without glass in order to ventilate the room. Today, due to requiring craftsmanship to build such an example, thus its high cost, this civilian architectural heritage can only be observed in few houses.

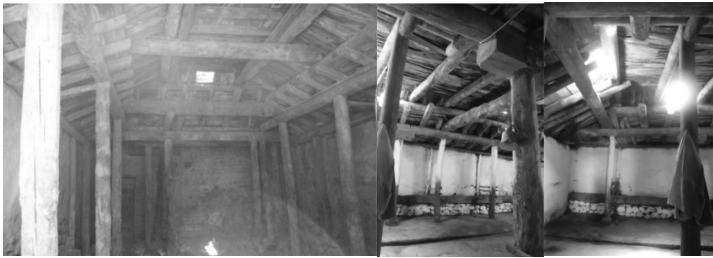
There is also another type of roof style, which is used for covering larger spaces. In this type, timber is kept as raw material with its round shape, but the roof system has its typical configuration. Today, this roof type is generally used to cover barns (fig. 3).

Figure 3: The interior view from a dweller's barn, which was built according to traditional construction practice (photos taken by the author).

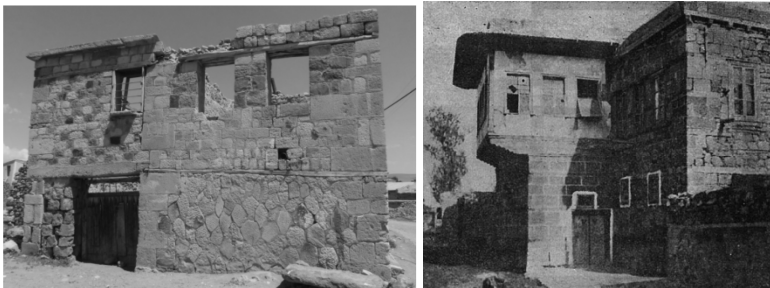
Like in much rural architecture in world countries, stone is the material the most used in the traditional architectural heritage of rural Erzurum. The rural houses can be single or two-storey buildings, and for walling, every kind of shaped stone were used in these houses. Generally, large cut stones were placed at the corners, while rubble or small sizes of cut stones were used to fill the wall. However, today most of them became ruins due to being left unoccupied (fig. 4). Some owners migrated, while some built a new house with non-local materials.

Figure 4: The exterior wall of a traditional house, which is a ruin today, on the left (photos taken by the author), and an old picture of these traditional architectural heritage from the year of 1947, on the right [8].

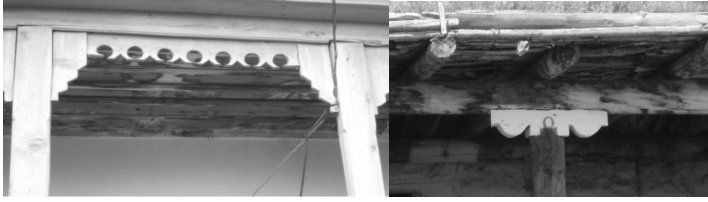
Figure 5: The examples of woodworks applied to the post-head for terrace roof (photos taken by the author).

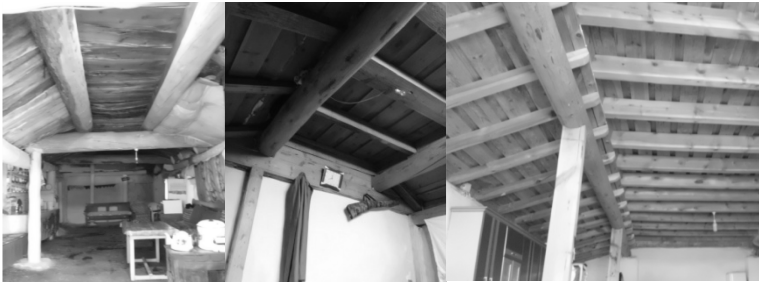
Besides, timber is still in use when building the roof of a house. There are examples of round and rectangular shaped timber in the houses visited. Some families maintained their houses or renewed materials as much as they can afford, which is worth appreciating (fig. 6).

Figure 6: The interior views of round timber used for roof, the left and middle; an example of renewed rectangular shaped timber for roof from a dweller’s house (photos taken by the author).

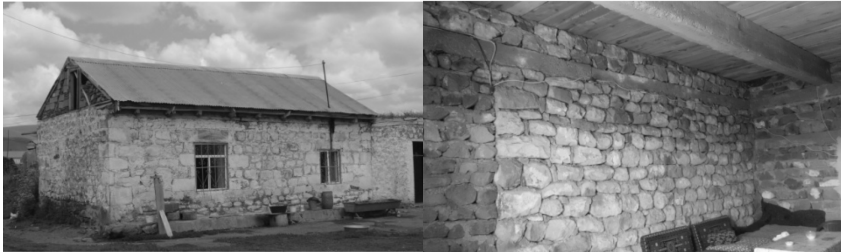
During the field trip, various walling types were observed, thus it is difficult to state which was the genuine architectural practice of the area. However, rubble stone were often used than cut stone. This might be related to the proximity of Kars and their historical bond, which cause to see similar architectural traces in the area (fig. 7).

Figure 7: The exterior view of a maintained house with rubble stone wall, on the left; the interior view of a renewed rubble stone wall, on the right (photos taken by the author).

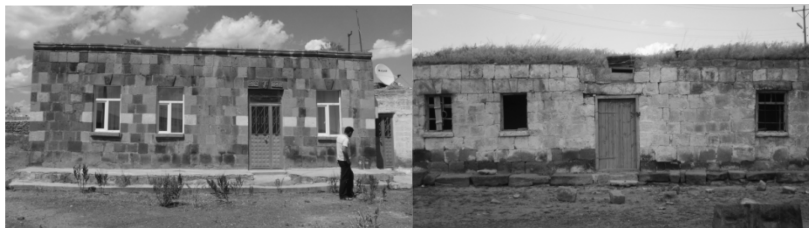
Because, Kars was under the sovereignty of Russia over 40 years, it has significant and qualified traditional Russian architectural heritages. Today, many of these heritages were documented and registered and kept under conservation. Particularly, the city centre area host many of these qualified examples [9]. Although, the typical wall material of the qualified heritage is the cut-basalt stone, this walling type can also be observed in the civilian architectural practice of rural settlements in Kars, which were built with cut-stones locally available (fig. 8).

Figure 8: The exterior view of a maintained house with cut-stone wall, on the left; an unoccupied house with cut-stone wall, on the right (photos taken by the author).

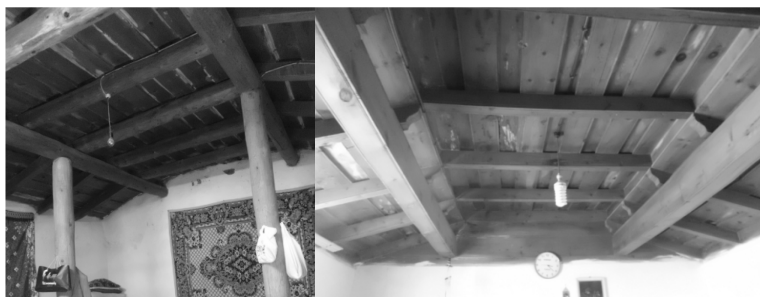
Timber usage has similar types with the examples from Ardahan and Erzurum. It should be noted as well that some houses became ruins due to being left by the owners, while some dwellers maintained their houses as possible as they can (fig. 9). They, fortunately, mentioned that they knew the distinction of the civilian architectural practice in the area, thus they see their shelters as valuable to keep up.

Figure 9: The interior view of a maintained roof with round timber elements, on the left; an example of renewed roof with rectangular timber, on the right (photos taken by the author).

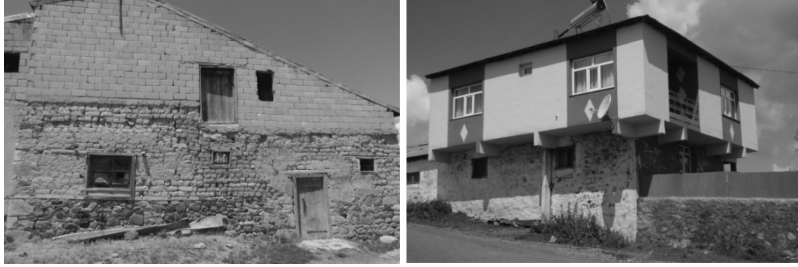
During the field trips, fully and partially examples of traditional civilian architectural heritage were observed in rural settlements of Erzurum, Ardahan and Kars. Although these areas have extensive historical backgrounds, today they started to appear similar to each other due to the supply chain provided for non-local structural materials, such as concrete, steel and aluminium. As a result of easily approaching these materials, and their low prices, rural dwellers started to use and build their shelters with these materials for the last three decades. Such woodworks and stone walling showed in figures of the case studies need craftsmanship, which are hardly found today. Therefore, maintaining the houses or rebuilding the new according to these traditional practices cost more expensive than buying fabricated materials and applying changes by self. This situation generates inevitable results in these rural settlements, which can be called either ‘modernisation’ or ‘uniformity’ of the built environment. In the rural settlements visited, there were more examples of such buildings showed in fig. 10, which are called ‘hybrid structures’ due to being modified with non-local materials. There were also numerous houses built with these materials (fig. 10).

Figure 10: The exterior view of hybrid houses, which were added the second floor with non-local materials, while the walls in ground floor were local materials, samples from Erzurum, on the left, and Ardahan, on the right (photos taken by the author).

Beside the problem of losing the originality, these settlements start to be vulnerable to future earthquakes. For example, buildings as shown in fig. 10, due to the heavy-weight of the second floors added on adobe brick walls of poor quality, these structures are prone to collapse in a seismic motion. Similarly, even they are built fully with non-local materials, as in fig. 10, due to not being controlled by an engineer or architect, they cannot be considered as earthquake-resistant, which is the common reason behind this change in construction practice.

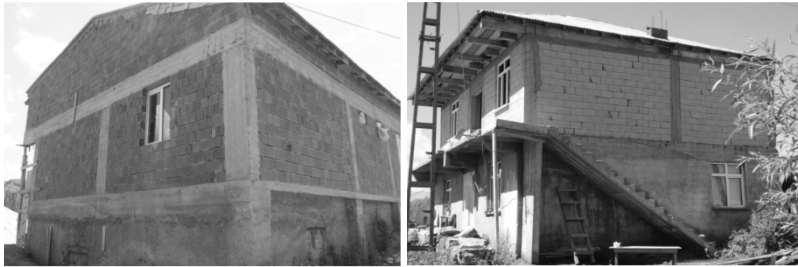
Figure 11: The exterior views of houses built solely with non-local materials, samples from Erzurum, on the left, and Ardahan, on the right (photos taken by the author).
