## **Analysis and diagnosis for the conservation and architectural reuse of the old barn and horse stables of the Chapingo Autonomous University**

F. J. Soria López, F. H. Alfaro Salazar & A. B. García Koch  
*Academic and Research Faculty on Conservation and Reuse of Built Heritage, Universidad Autónoma Metropolitana, Xochimilco in México City, México*

This reuse project is based on the importance and value of built heritage conservation as well as the usefulness of obsolete infrastructure as is the case with the old cow barn and horse stables of the Chapingo Autonomous University (UACH) – the main school of agriculture in Mexico founded in 1854. This plan seeks to continue and consolidate the recovery process of historical buildings of this public university which began more than a decade ago with the intervention in the Main House of the hacienda, the rescuing of the old library, known as the “Parthenon” and, of course, the recovery of the old pig barn, all of the former with new institutional uses. The project basically includes three phases. The first, dedicated to the surveys and recollection of historical data, photographs and general information needed to document the evo

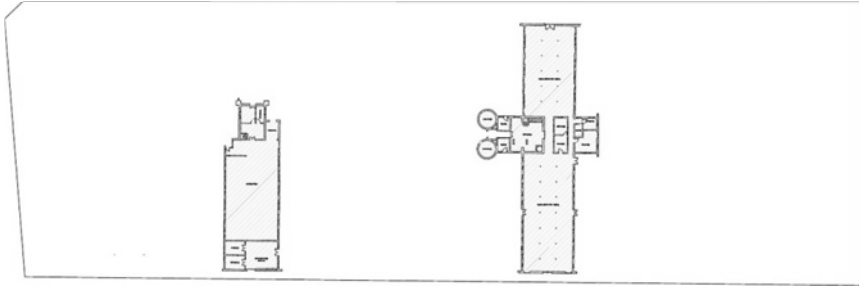
Figure 1: 1926–1930: construction of the ENA livestock facilities, consisting of a series of buildings dedicated to horse stables, cow barns, chicken coops and pig barns (in the drawing are the first two).

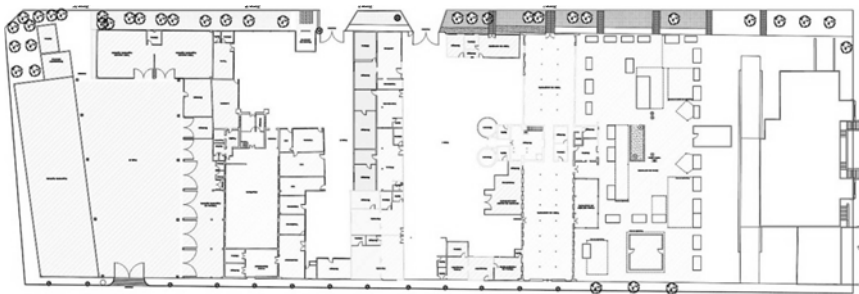
Figure 2: 2000–2010: the drawing records the current situation, with the changes and transformations of the settings since the end of the 1920s until 2010. The chaotic scheme is evident.

These buildings ceased to operate many years ago for their original purposes, when they became obsolete towards the 1970s, undergoing major transformations, as well as their surrounding environment, to adapt them to new and changing spatial and technological needs of the UACH. In this way, the stables and barn were recycled for maintenance activities and are currently used as electricity, masonry and carpentry workshops. Given the conditions mentioned above, even though they are recognized as significant places of the campus, with a very important heritage value, nowadays both buildings have a great physical, functional and environmental deterioration which puts at risk their conservation in the short run as well as their permanence in the near future.

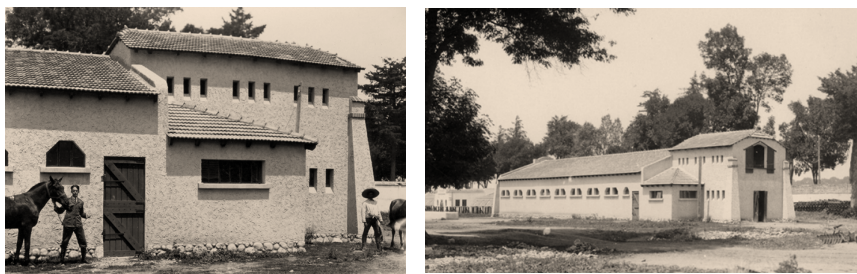
Figure 3: Two images of the horse stables in the 1930s.

The horse stable is a fairly simple building. Its plan has two well defined and distinct parts: the first, occupies a rectangular plan, on the ground floor, without intermediate supports, generating an ample space of 12 x 24 m. On the north side the building has three volumes; in the center a two stories high construction of rectangular proportions (6 x 8 m.); on each side of the former a small square room 3 x 3 m. The bigger space housed the horses, while the northern body served as access control, storage on the second floor and the two adjacent rooms for the staff.

The roof tops are pitched, at different levels, in accordance to the spaces they cover. It is important to mention that the structural solution used for the roof is with steel trusses with I beams and wood slats to support the cement roof tiles as a final cladding.

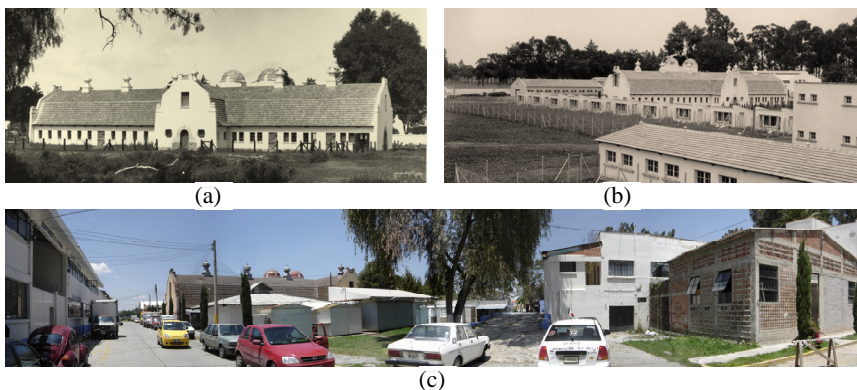
Figure 4: Above, two old images of the livestock facilities; (a) the cow barn seen from the east; (b) a general view of the area; (c) a recent view of the same area seen from the east.

On the other hand, the building that houses the cow barn has a more elaborate design if compared to the horse stables. It is a construction with a rectangular, very long (15 x 50 m) floor plan, two stories high, with a smaller rectangular plan, perpendicular to de former, slightly off the center (which breaks the

symmetry of the building), that forms a cross plan, dividing the barn in two wings, one slightly longer than the other. On the west façade, two big round silos three stories high dominate the composition.

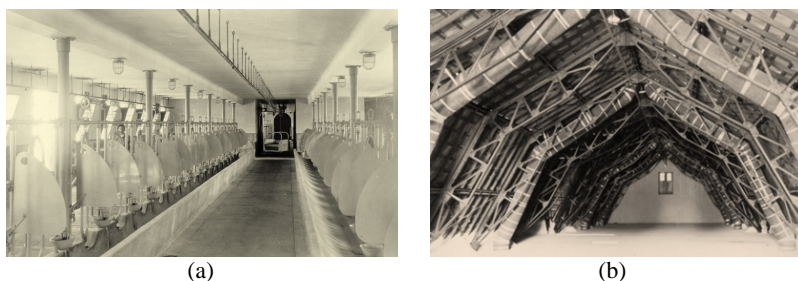
Figure 5: Indoor photographs of the cow barn; (a) the ground floor with individual stanchions; (b) the ample hayloft atop.

- Building of two floors: the ground floor housed the cattle with centralized access and hallway, with steel stanchions to separate animals in individual spaces and the use of the concrete floors. The top floor, of larger dimensions was used to store hay and pasture.
- Well ventilated spaces, through windows on the ground floor and galvanized steel ducts with roof outlets on the top floor.
- The use of gambrel roofs, which made an ample hayloft and could be erected with pre-fabricated trusses. The use of the shawver type truss allowed a self-standing structure that made building easier.
- Incorporation of mechanized technology for easy loading, transportation and food storage.
- The construction of vertical silos at the side of the barn, allowing storage of more fresh pasture for the winter season.
- It was recommended that the milk house be nearby but separate from the stables.

*Agricultural college experiment stations promoted the gambrel-roofed, ground stable barn design, which was widely adopted throughout the country. These barns housed cows on a washable concrete floor in steel pipe stanchions at ground level. The gambrel roof made an ample hayloft and could be erected with pre-fabricated trusses. Ducts from steel ventilators atop the roof provided fresh air for the cows, and long rows of small windows gave light to the stable area [2].*

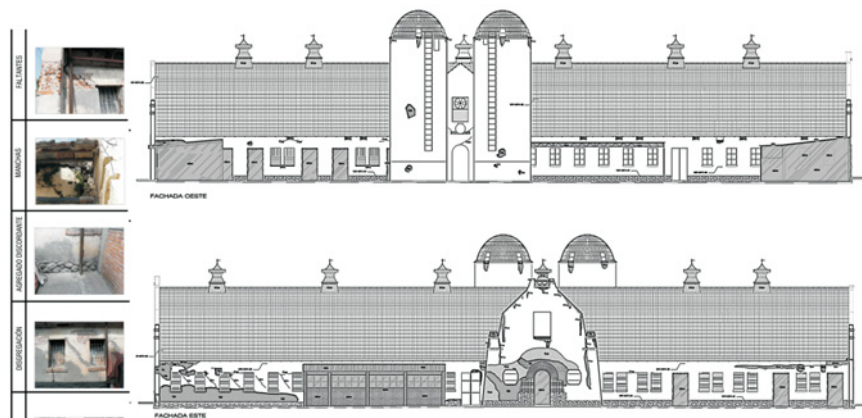
Figure 6: Drawing of the facades of the barn with precise documentation of the main damage and deteriorations they currently have.

stairs that lead to the upper floor. On the second level a generous space of ample proportions for storage. On the outside, with only one level, but tall and slender, two silos for food and grain storage. The original design envisaged three main facades, on the north and south sides which close the main rectangular nave, and one to the east on the smaller perpendicular volume that defines the cross plan. The three are composed of a small stone plinth on the base, brick door and window frames, brick walls covered with lime mortar, painted and crowned with brick tiles on the top perimeter.

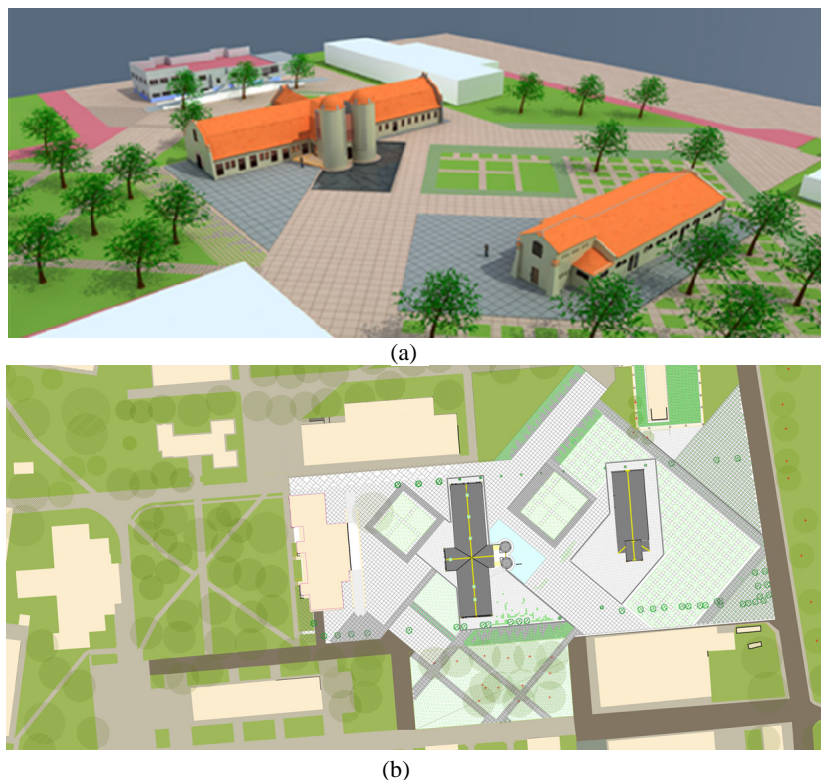
Figure 7: (a) A view of both buildings with recovered open spaces; (b) the general plan of the urban settings.

The project contemplates, as a first approach, to recover the invaded outdoor spaces and involves the demolition of buildings and facilities attached two both heritage constructions. The installations of additional services for the new use include gardens, squares, rest areas, as well as a cafeteria for users and visitors.

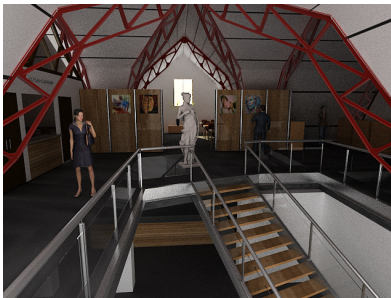
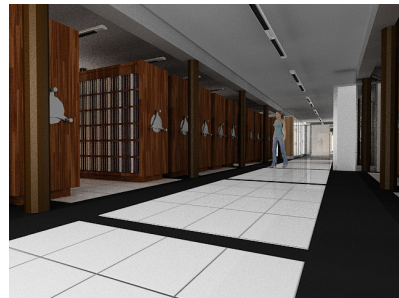
Figure 8: (a) The ground floor of the University Archives; (b) and (c) two interior views of the adaptive reuse project.

- In the first place, the cow barn will become the main headquarters of the UACH Archives, where all administrative, technical, file storage and care activities will be carried out. This property has two distinct levels: the ground level where cattle were kept, which has the more ‘functional’ spaces, with good ventilation and natural lighting virtually in the entire perimeter. The top floor, on the other hand, was a less ‘dynamic’ space, and was designed to store food and hay, was dark, dry, poorly ventilated and with a restricted access. Taking advantage of these features the proposal recovers the vocation of the existing spaces, incorporating on the ground floor the more “active” part of the Archives, that is, reception, classification, repairing, registration, restoration, reproduction, attention to users, as well as

offices of managers and support staff. The upper level will be used to accommodate the main files in special mobile compactor shelving cabinets, and also includes a consultation room.

- The layout takes advantage of the original plan which is a very long rectangle (50 x 12 m. approximately) divided in two non-symmetrical wings by a perpendicular body, smaller than the former, generating a cross plan building. The smaller central body was used to contain the main entrance, vertical circulations and elevator, as well as reception and restrooms services. The bigger South side wing will have the main operational services of the archive, i.e. reception, classification, registration, reproduction and a first file space on ground floor. The smaller North wing will accommodate the offices, as well as general staff areas.

- The top floor also adapts the new use to the cross section plan. In the central part a double height space contains the main lobby with the stairways and leads to the consultation room. The North Wing, houses the historical

archive, which also has a small temperature-controlled Chamber to keep photographs, negatives and documents that require a special temperature. The general file of the UA is located in the South Wing, where special mobile compactor shelving cabinets will be installed.

- The two round and triple-height silos are without doubt the dominant architectural elements of the old barn. It was decided to divide these storage spaces in three inner vertical floors in order to accommodate on the ground level both men and women bathrooms, the digital files and computer equipment on first floor and a storage space in the last section.

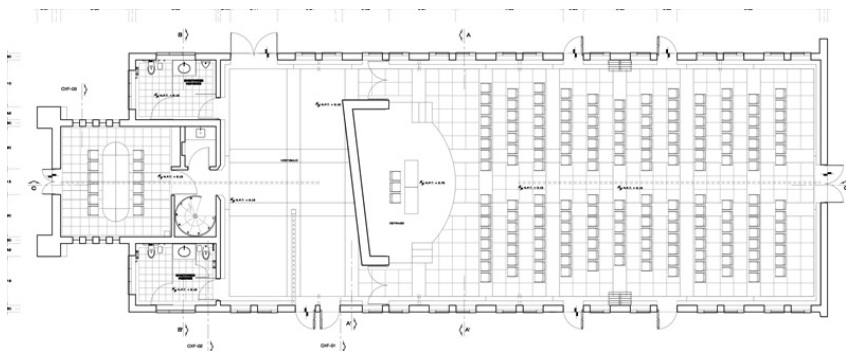
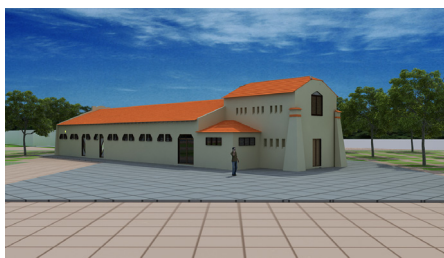
Figure 9: (a) The main layout of the multipurpose facilities in the former horse stables building; (b), (c) two views of the project; on the left, the main nave used as an auditorium; on the right, an outside view of the construction.

- Regarding the building of the horse stables, it will be used to support the AU dissemination activities. This construction has a very simple composition with two well differentiated sections. We sought to maintain its spatial features, especially the wide main nave. The latter will serve as a multi-purpose space that can be subdivided with movable elements to adapt to different activities. Accordingly, a first permanent partition was included to define a main hall or distribution lobby from the multi-purpose space. In order to maintain the spatial continuity, at least partially, the dividing element is solid only up to a height of 3 m. and has transparent glass at the top so the entire structure of the roof can be seen from both sides. The multifunctional space can be subdivided in turn by mobile screens to give different spatial formats: as a broad forum and exhibit space without divisions and as rooms for seminars when it is subdivided. A small meeting room is located on the ground floor of the central body. To the sides in two adjacent small rooms the restrooms were incorporated. Finally on the top floor of the central body, due to the poor accessibility, it was decided to use this room to allocate electrical and computer equipment, with restricted access.
