# **Problems in Rubble-Filled Random Masonry Walls**

D.M. Lilley<sup>1</sup>, A.V. March<sup>2</sup>

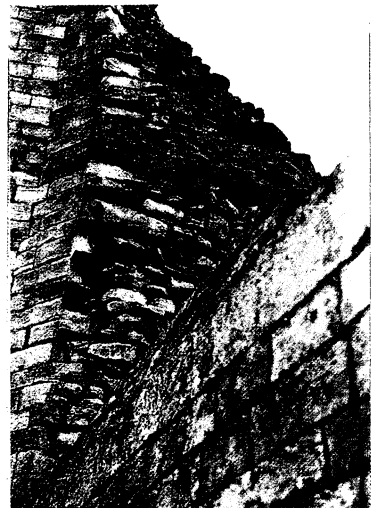
practice in masonry design. In rare cases where ties were provided they took the form of long through-stones bonded into both inner and outer leaves at irregular and infrequent intervals. Such stones were considered objectionable as they would provide continuity of material, creating an uninterrupted path for moisture to pass to the interior face of the wall. The outer leaves appear to rely on restraint provided by occasional header stones projecting into the rubble core (see Figure 3).

Figure 3: Header stones provided for stability

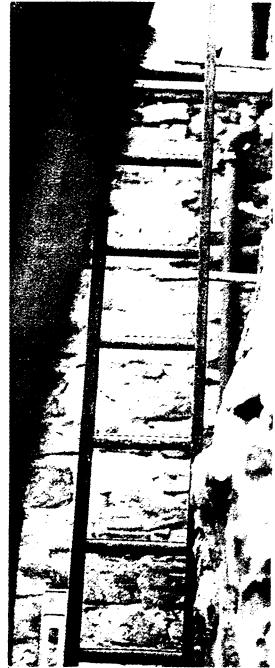
Detrimental effects can sometimes occur when an existing rubble-filled wall is incorporated into a new development resulting in a change in loading within the existing wall. This can result in a greater eccentricity of loading due to greater width of wall. One structural failure has been investigated where residential accommodation had been built on top of a rubble-filled wall. The width of the modern construction was significantly less than that of

Figure 4: Bulging wall

the original wall. No attempt had been made to spread load across the full width of the old wall and loads from the new wall were transmitted directly into the outer leaf which subsequently failed in compression (see Figure 4).
