# Tensometric measurements for static securing of historical buildings

Often during a reconstruction of historical buildings it is necessary to repair or replace damaged element of the structure by a new part. In such situation it is inevitable to reach a stage when the damaged part is not statically stressed. The deformation tensometric measurement was used to monitor and verify stress changes during reconstruction. Electric resistive strain gauges were glued mainly on the supporting metal structure or directly on repaired parts. In this paper some examples how this method was applied are demonstrated on the three structures:

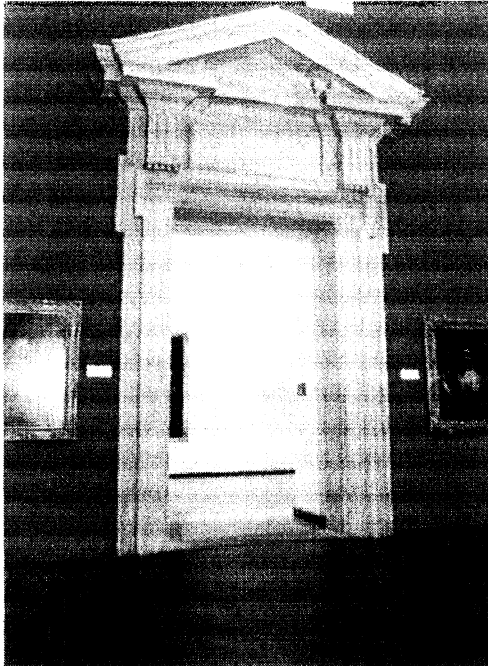
Figure 1: View on the Baroque sandstone portal in the Picture Gallery.

The horizontal lintel of the Baroque stone portal decorated by cornice and by tympanum was damaged by several joints in one of the gallery rooms (Fig. 1). Fall of the lintel segment was expected. Therefore the lintel was secured by two tensile rods inserted in slots of the lower part of the lintel. The tensile rods were anchored by bolts glued inside the wall. Before the start of this work it was necessary to relieve the lintel. In order to lift the tone cornice with tympanum,

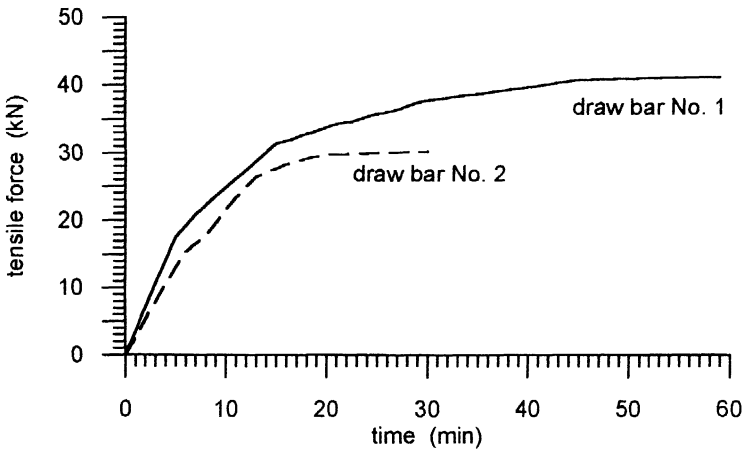
Figure 5: Changes of the tensile force in time after tensile rod cutting.

In the central part each of the outer tensile rod a special fixture with glued strain gauges was fixed (Fig. 4). Steel material of the fixture was tested beforehand for tensile loading in the laboratory. Following installation the tensile rod was cut and deformation of fixture was measured for determination tensile force in the tensile rod. In 60 minutes (resp. 30 minutes) the values of deformation were stabilized (Fig. 5). Small intensity of force found by deformational measure made it possible to remove these tensile rods without any influence on the building static stability.

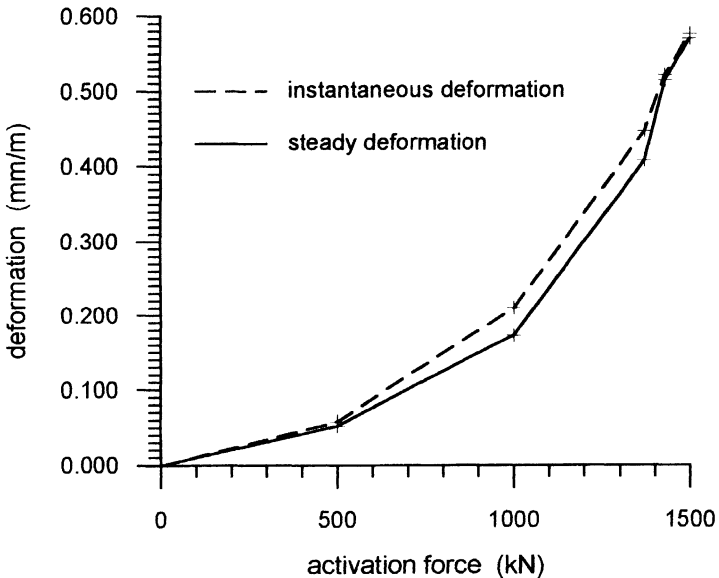
Figure 7: Dependence of the deformation on activation force.

During reconstruction two neighbouring reinforced concrete columns located in bank basement had to be removed and one of them replaced by new steel column. On the upper part of the columns an iron girder was fastened for ceiling supporting and for follow-up relieving lower part of the columns by hydraulic jacks. During activation of the relieving a deformation (extension of the column) was measured in the lower part of both of the columns. Strain gauges were glued on steel reinforcement on the opposite sides of the columns. Deformation changes provided data about decrease of loading. Forecasted value of the total deformation was determined by calculation on the basis of estimated properties of the reinforced concrete. The measurement was carried out continuously during whole relieving of the columns. Forces, applied to the hydraulic jacks, were increased to the final calculated deformation of column by several steps (Fig. 7). At Figure 7 both instantaneous and steady (after some time pause) deformation on the one of the columns are demonstrated. Time dependence of the deformation during particular relieving steps on the same ones is illustrated on the Figure 8. Required value of deformation was reached at force of 1430 kN. Owing to a hydraulic jacks arrest the decrease in deformation were observed. Therefore the activation force was increased to 1500 kN. After arresting the deformation dropped again to the required value.
