Influence of thick mortar joints on the early and late mechanical behaviour of Byzantine constructions

L. Binda⁽¹⁾, C. Tedeschi⁽¹⁾, G. Baronio⁽¹⁾

⁽¹⁾*DIS, Politecnico di Milano, 20133 Milan, Italy*

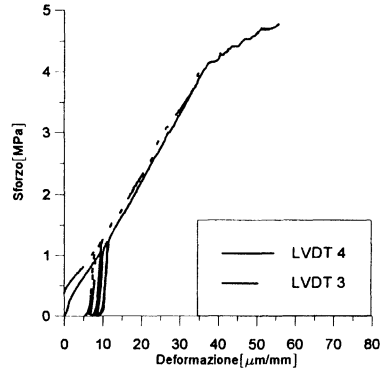
In order to understand better the role played by the mortar joints also the vertical displacements were measured on the joint itself. Since it was difficult to fix the small CPDT1 (Clamp on Point Displacement Transducer) to the joint and it gave too much scatter in the measurement due the weakness of the joint, LVDT3 was fixed between two bricks as shown in Figure 5. Figure 7a,b comparing the deformations measured by LVDT4 and LVDT3 shows how much the mortar deformation is influencing the masonry deformability in the cases of 28 and 90 days of age. This is not so much evident at a late age.

LVDT2 was also applied to one of the bricks at each face of the prism in order to control the reliability of LVDT5 which was not directly applied on the specimen; the results show that the two measurements give approximately the same results. Large horizontal displacements start in the brick at the 75% of the peak stress at 28 and 60 days, and at the 50% of the peak stress at 90 and 365 days.

Figure 7a: Stress-Strain plots of prisms SB2.2

Figure 7b: Stress-Strain plots of prisms SB2.6

This difference explains very well the large displacements measured for the early age specimens. The fact that the first cracks occur in the mortar joints explains also the bilinear behaviour of the 28 days specimens appearing in Figure 6 and more clearly in Figure 7.

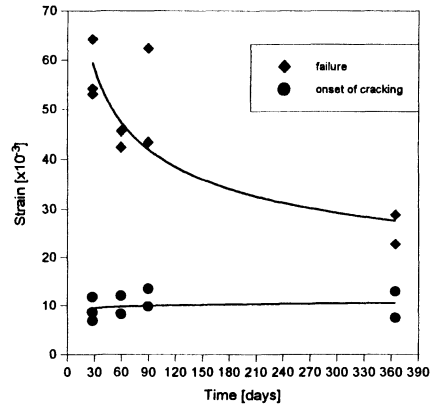
Figure 8: Vertical deformation value at onset of cracking and at failure at different age.

Figure 8 shows the strain values measured at: (i) the peak stress, (ii) the onset of cracking for the different ages. A quick decrease of the (i) values can be noticed from 28 to 365 days, while values (ii) tend to increase with the age.

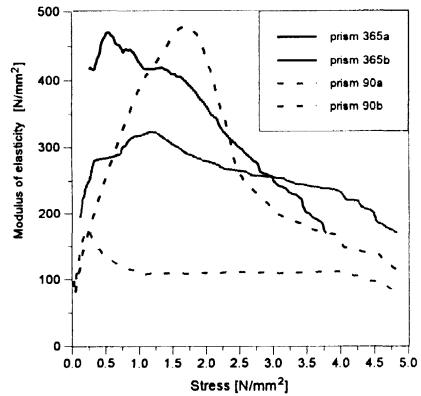
Finally Figures 9a,b show the variation of the elasticity modulus with the stress values at the different ages. The stiffness of the wall is increasing with the age even if the strength does not seem to be so much influenced by the age at least up to 1 year. Fig.9 also means that the stiffness increases much more as the mortar carbonation proceeds to become much higher in a long time (Figure 3).

Figure 9a: Tangent modulus against stress variation of prisms at 28 and 60 days.

Figure 9b: Tangent modulus against stress variation of prisms at 90 and 365 days.
