# Influence of Radical Nitriding on Fatigue Strength of Maraging Steel

## Abstract

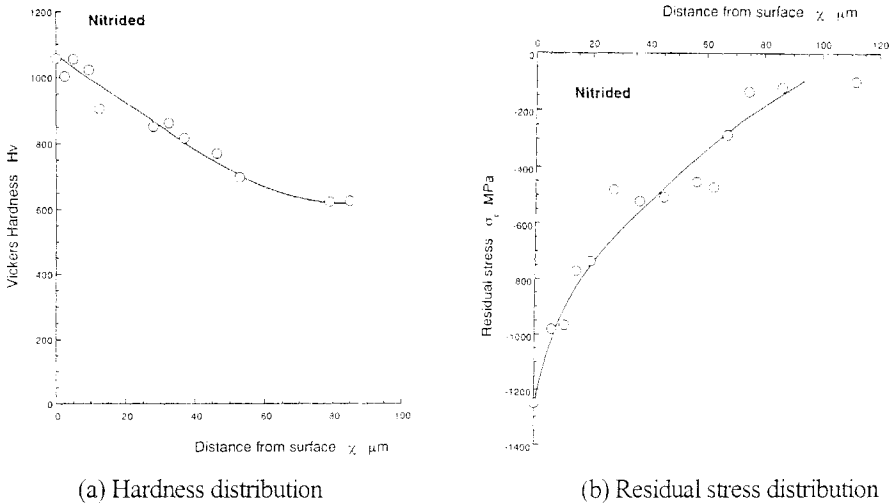
Figure 2: Distributions of hardness and residual stress.

Figures 2(a) and 2(b) show distributions of hardness and residual stress in the nitrided steel. The marked hardening and the formation of compressive residual stress are observed in the surface layer. The depth of the affected layer, case depth, is about 80  $\mu\text{m}$ .

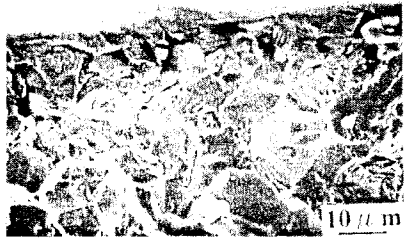
Figure 5: Fracture surface of specimen after tensile test.

Figure 5 shows fracture surfaces of the aged and the nitrided steels. Although typical ductile fracture occurs in the aged steel, intergranular cracks are observed in the nitrided steel and these facts correspond to the results of surface observation.

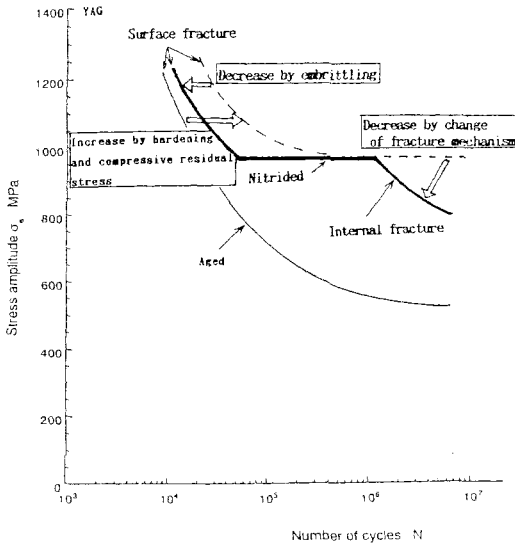
Figure 11: Influence of nitriding on fatigue strength of maraging steel.

Figure 11 shows the illustrated S-N curves indicating the influence of nitriding, as stated above. The dotted line is an assumed one for the strengthened steel by nitriding. The fatigue strength in the nitrided steel is increased due to hardening and formation of compressive residual stress in the surface layer.

However, it is decreased inversely under high stress levels owing to the embrittlement of hardened surface layer. As a result, the increase of fatigue strength is small at high stress levels. This means that nitriding should not be applied to maraging steel subjected to high cyclic loading. On the other hand, at low stress levels, fractures originated from internal inclusions, because the initiation of surface cracks were suppressed by surface hardening. Consequently, S-N curve of the nitrided steel shows a double staged one.
