A CASE STUDY: RESTORATION OF HISTORICAL MUSEUM IN SARAJEVO (1963) – A MODERNIST RUIN

AMIR CAUŠEVIĆ, AIDA IDRIZBEGOVIĆ-ZGONIĆ, NERMAN RUSTEMPAŠIĆ &
LEJLA KAHROVIĆ HANDŽIĆ

Faculty of Architecture, University of Sarajevo, Bosnia and Herzegovina

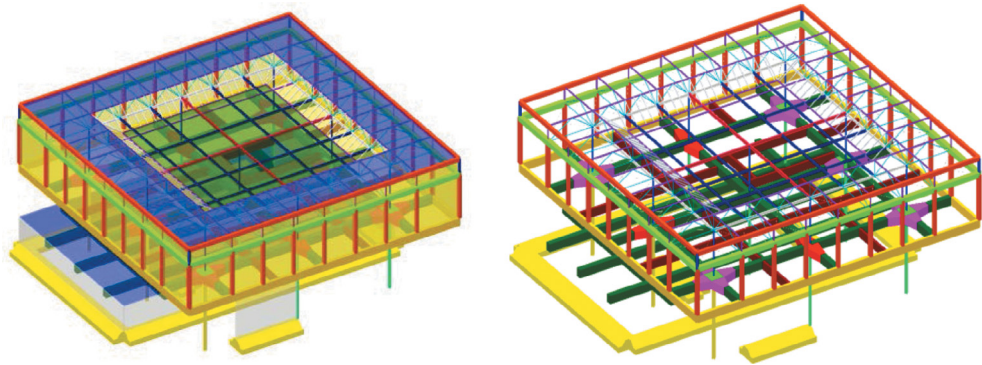
The building's skeletal construction consists of frames tensioned with vertical diaphragms and the elevator shaft. The beams on the first storey are laid in the steel concrete beams. The + cross section of steel columns is 28 and 35 cm on the ground floor and 16 cm on the upper storey; there are nine columns on each storey. The storey concrete slab leans onto the 9-cm-steel concrete grid. The structure of the flat roof is also comprised of steel concrete panels, and the gauge of which is 7 cm in the lower part and 15 cm in the upper part. The oblique parts of the light are constructed using steel hollow rectangular glass-roofed profiles (Fig. 3).

Figure 3: Static model of museum's structure with and without walls.

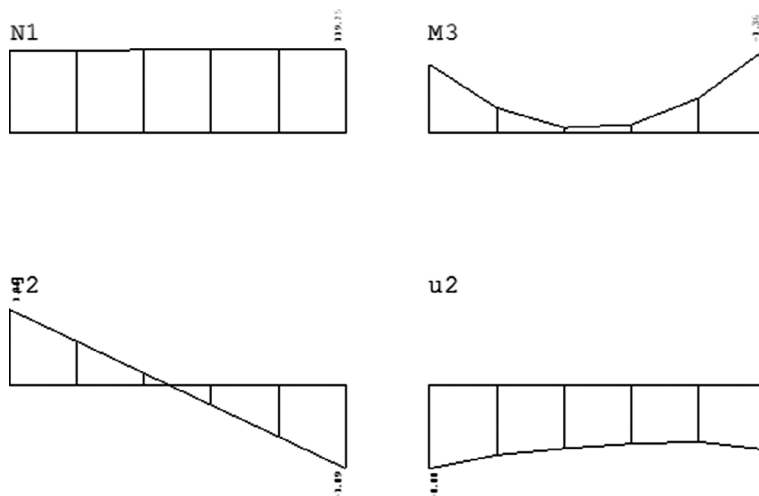
The main bearing system of the horizontal frame bearings on the roof structure level is comprised of four grid bearings with overhanging eaves leaning onto the already mentioned steel columns made as +-shaped profile. In order to reinforce the stability of the existing grid bearings, two hollow steel diagonal poles (Fig. 4).

Figure 4: Internal forces and displacement in the most loaded carrier glass cladding.

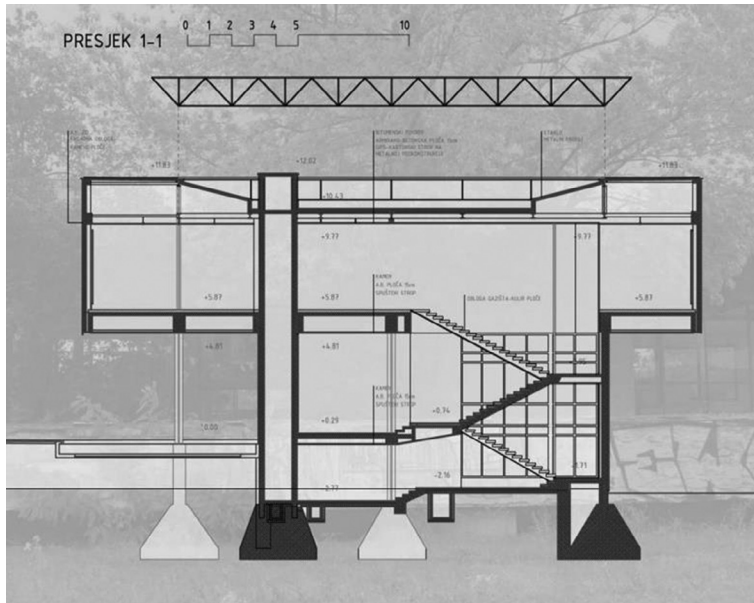
construction's vibration period T_1 is actually torsion. The roof structure has been assessed for the snow load of 1.50 kN/m^2 (Fig. 5).

Figure 5: Cross section of the museum.
