Visual screening for a potential evaluation of seismic vulnerability of historical building: Palace of the Dey (Citadel of Algiers)

A. Abdessemed-Foufa

Department of Architecture, Blida University, Algeria

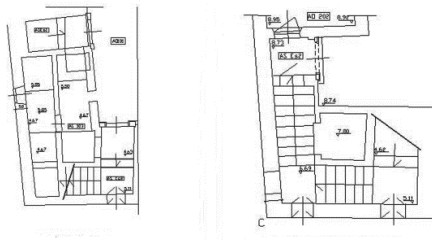
- The stairwell located in the south-western angle (Figures 7 and 8) (PKZ [8]).
- The music room located in the opposite angle i.e. north-eastern (Figures 7 and 9(a)–(d)).

Figure 8: Stairwell plans (PKZ [8]).

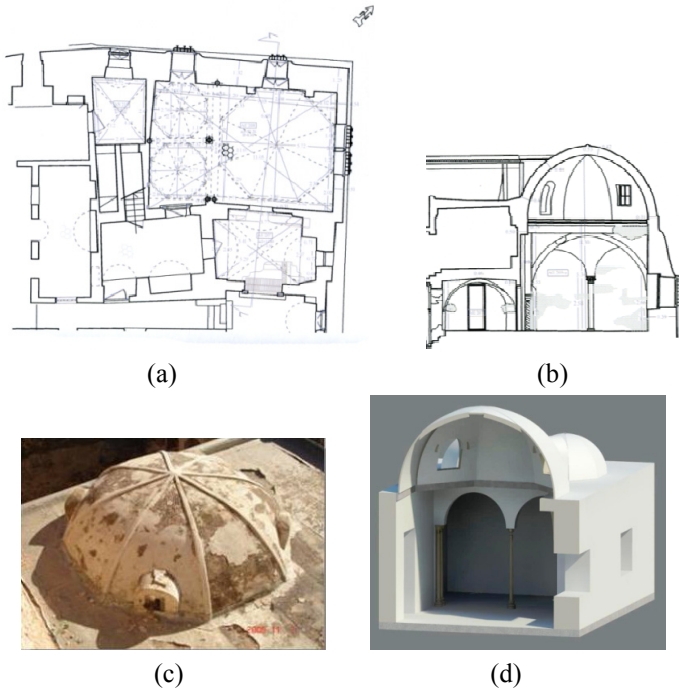
Figure 9: (a) and (b) music room plan, section (PKZ [8]), (c) view, (d) 3D block restitution (Abdessemed-Foufa [7]).
