STRUCTURAL ASSESSMENT OF DUBROVNIK CATHEDRAL, CROATIA

JOSIP GALIĆ, HRVOJE VUKIĆ & DAVOR ANDRIĆ
University of Zagreb, Faculty of Architecture, Croatia

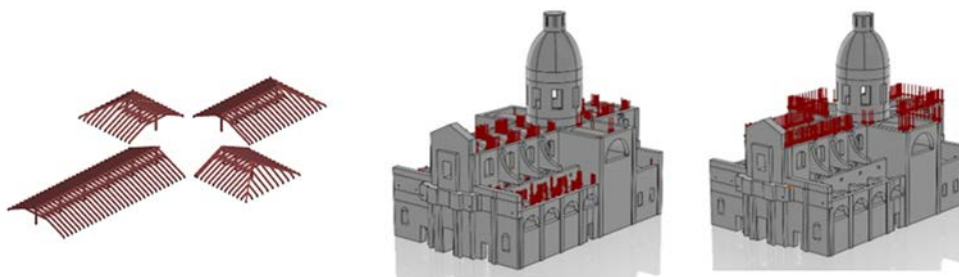
Figure 10: Spatial model roof structure and main structure of Dubrovnik Cathedral.

In the first phase, a static analysis of a model loaded with a dominantly permanent load and imposed load was performed (Fig. 10). The loads defined at this stage include the self-weight of the structure automatically calculated by the program, wind load according to [7], weight of the layers on the vaults, weight of the shotcrete on the inside of the dome and also the loads transferred from the roof structure that included permanent dead loads and imposed loads as wind and snow loads. Deformations and stresses caused by loads in static analysis of the structure indicate that the structure has sufficient rigidity and stability. The only areas that need to be reinforced to prevent further cracking of the structure are the arches at the base of the dome and the vaults of the side naves (Fig. 11). These locations of maximum stresses in numerical model coincide with the visible and observed cracks in the cathedral.
