# Sonic tomography of the stone pillars of a 17<sup>th</sup> century church

L. Zanzi<sup>1</sup>, A. Saisi<sup>2</sup>, L. Binda<sup>2</sup> & E. Cardarelli<sup>3</sup>

Pulse sonic tests were applied to 8 massive stone pillars of a 17<sup>th</sup> century church (S.Nicolò all'Arena at Catania, Italy). The data were processed to obtain 28 tomographic sections showing the distribution of the elastic wave velocity within the tested pillars. The results of the tests are compared in order to check the morphology and the state of damage of the pillars. A preliminary frequency analysis of the data seems to indicate that these experiments can be used to extract the energy absorption distribution.

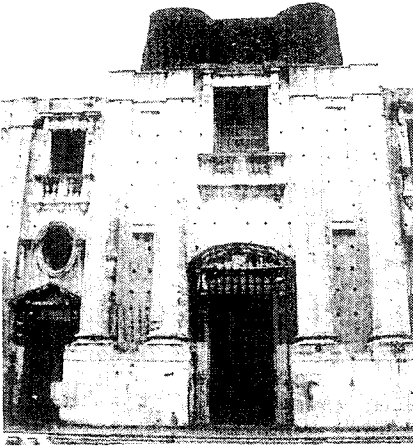
Fig. 1. S. Nicolò Church. View of the facade.

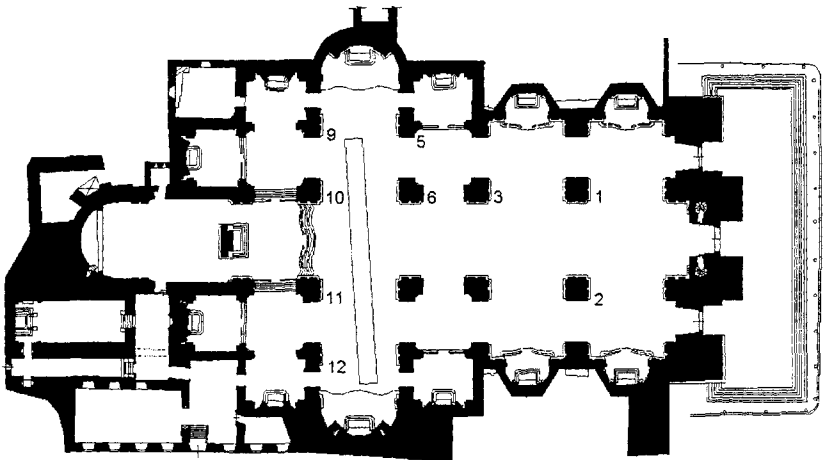
Fig. 2. Localisation of the tested pillars.

The two most damaged pillars at the entrance of the church (pillars 1 and 2 of Fig. 2) have been investigated with much care: five horizontal sections at different heights plus vertical sections have been executed on each pillar.

The very low velocities that have been found in the pillars 1 and 2 confirm the need of urgent preservation actions. From an external observation, the masonry texture seems, in fact, very poor, characterised by the presence of the so called "incoccio". It is also worth remembering that these pillars show a dangerous crack pattern (Fig. 9). From coring of the pillars it was also clear that the internal mortar was very weak.

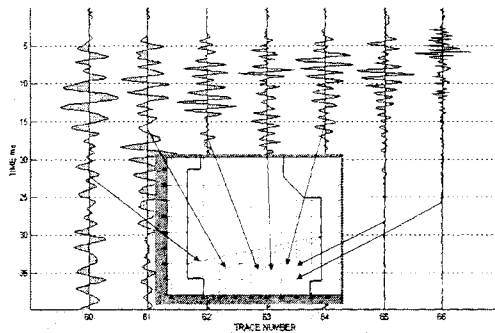
tomography [14]. Fig. 12 shows a selection of a few sonic traces indicating that this effect is also observed in our experiments: moving from data collected near the source to data collected far from the source the dominant components of the signal move towards lower frequencies. However, this type of data collected around a pier needs a careful pre-processing to exclude from the spectral analysis the contributions of high frequency components given by energy travelling in air.

Fig. 12. Example of sonic traces.

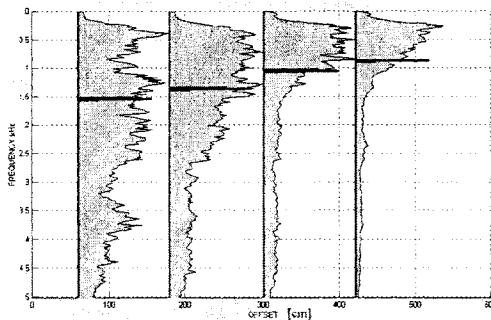
The parameter that is normally used to measure the frequency downshift effect is the spectrum centroid. Some analysis has been done to test whether this parameter is expected to be sensitive enough to extract the downshift effect from our data. As an example, Fig. 13 shows some average spectra

obtained on different clusters of data grouped according to the range of the source-receiver distance. The data belong to a tomographic experiment on a section that was found to be quite homogeneous by the velocity analysis and by other inspection methods; thus, we might also expect that the absorption properties do not vary so much and that the down-shift effect will be consistent with the raypath length.

Fig. 13. Average spectra.
