RC frame structure strengthening by reason of insufficient concrete strength

P. Stepanek, I. Lanikova & P. Simunek
Brno University of Technology, Czech Republic

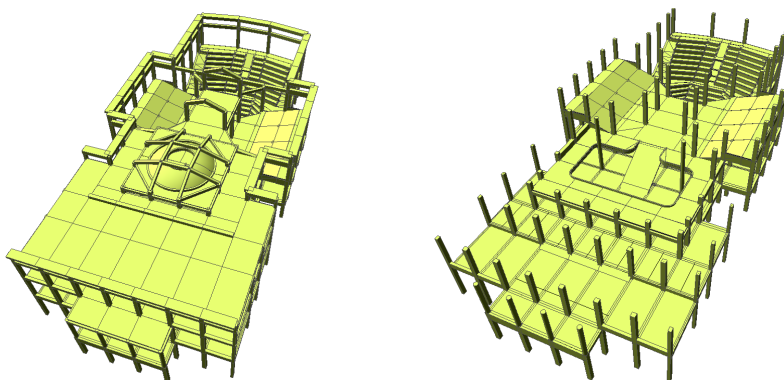
Figure 2: FEM computing model.

Based on the economic, structural and technical aspects (minimising of additional load) of the proposed solutions, the variant using bandages and involving additional external prestressing of the majority of the girders was preferred. Some girders will be provided with steel supports; massive and low-loaded girders are considered to require bandages only. A three-dimensional model of the structure was set up to enable a detailed static assessment; it was analysed via FEM (Fig. 2).

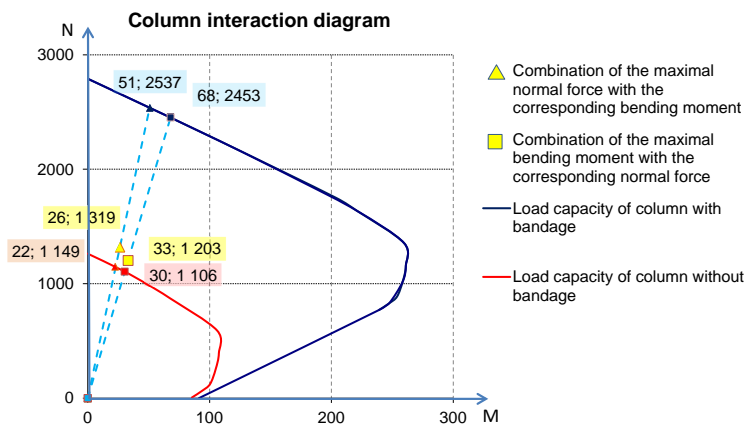
Figure 10: Column interaction diagram with and without consideration of bandage application.

Only those steel angles that are located in the compression zone of the column were taken into account when evaluating the resistance of the column. Load capacity was calculated for the load eccentricity in the case of maximum normal force (and / or maximum moments in either direction) and also for the normal force of the combination which caused the greatest interaction between moments in mutually orthogonal directions (Fig. 10).

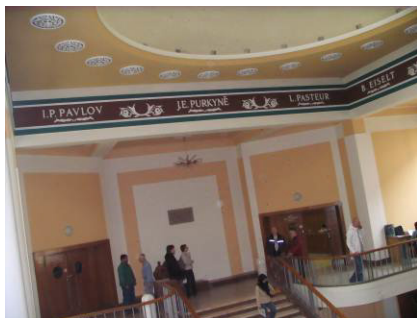
Figure 19: Primary beam, foyer.

The gable wall above the primary RC beam of foyer m was cracked. The damage was caused by beam deflection (elastic, shrinkage and creep, etc.).
