Restoration of thin shell brick domes: the chapel of the 'Hospital de la Caridad'

P. Valcárcel, Jr.^a, F. Escrig^b, S. Muñiz^a

Abstract

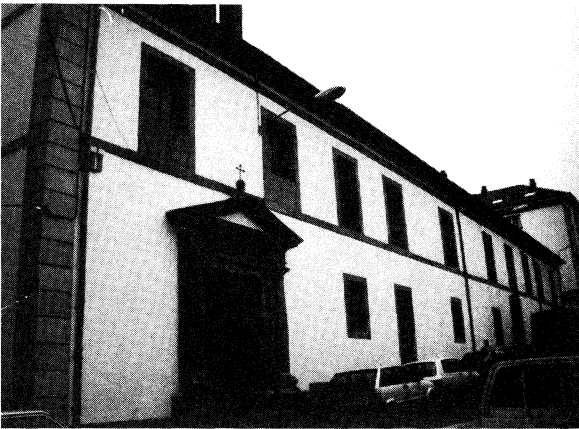
Fig 2.- Hospital de la Caridad

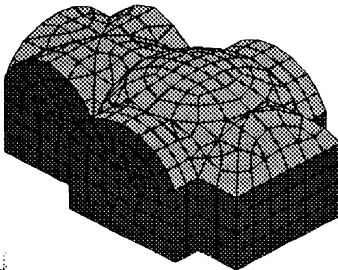
HOSPITAL CARIDAD. FERROL

Fig. 6.- Mathematical model.

The obtained element was applied to all the vaults and it could be checked that the stability of the vaults was guaranteed, considering fissures closed with mortar of epoxy. However the transverse stability of arch ribs could be awkward from what it was taken the criterion of supporting the upper part of arches by means
