# **The Berlin “Neues Museum” – structural analysis, stabilization and structural design for restoration**

J. Seiler & G. Eisele

*Ingenieurgruppe Bauen, Karlsruhe – Mannheim – Berlin, 10999 Berlin, Leuschnerdamm 13, Germany*

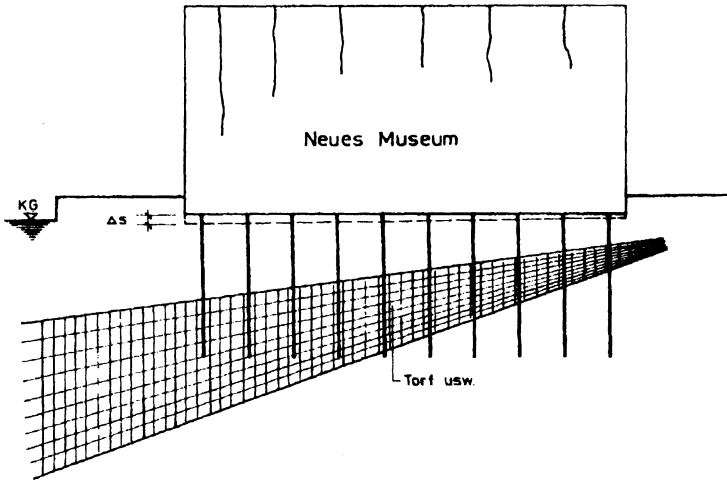
Figure 2: Cross-section of the foundation situation

Back when the building was originally under construction, the builders were aware of the problem but decided that it could be solved by providing the edifice with a wooden pile foundation. As the length of the wooden piles was limited, the original builders used „floating“ wooden pile raft footings for the northwest section. (Figure 2.) This foundation had already caused so much settlement damage by the time the building was opened in 1855 that renovation became necessary shortly thereafter.

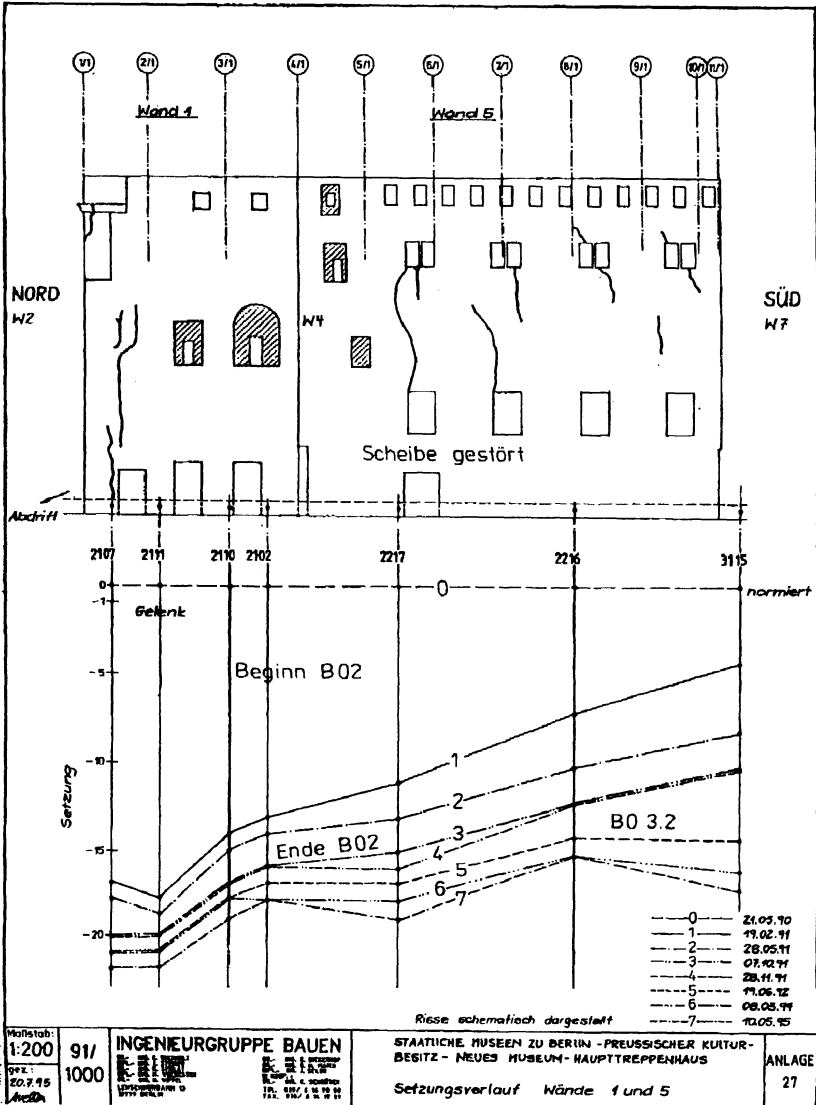
Figure 7: Assessment of the mechanisms of movement (exemplary)
