# A study of the earthquake-resistance of masonry buildings constructed with local materials

## Abstract

*Keywords: masonry building, earthquake analysis, repair and strengthening.*

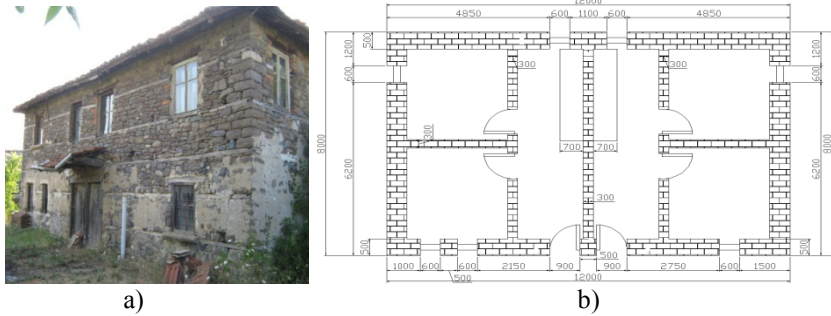
Figure 2: a) Photo and ground floor plan of stone masonry house in the Edirne region. b) Ground floor plan of masonry structure.

village houses in Turkey, it is seen that the plan is very simple and there are 2 or 3 floors in the highest structures, and that wall thicknesses are between 20 and 55 cm. There are some plans and photos of village houses in Figure 2.

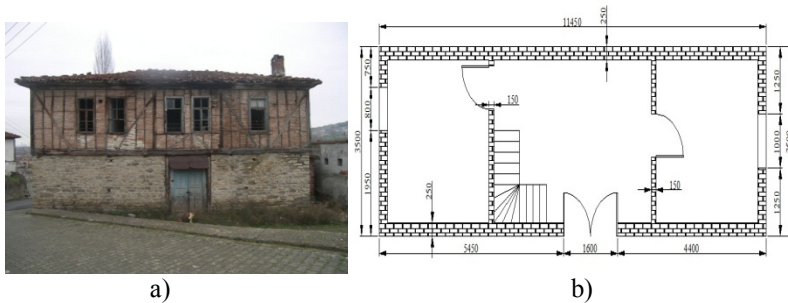
Figure 4: a) A structure with stone masonry walls in ground floor and half-timbered walls in upper floor in the Samsun region. b) Plan of ground floor of structure.

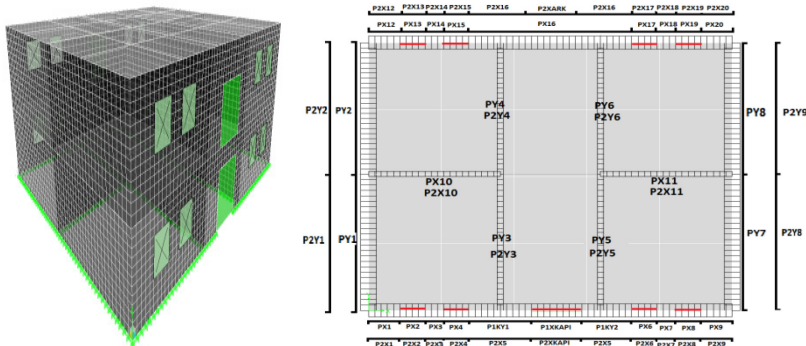
Figure 6: Image and plan of the 1<sup>st</sup> model.

At the end of the analyses of models, all the data were obtained, and shear force on walls and shear stresses were calculated according to TSE. Obtained vertical stress values, shear stresses and calculated security stresses are given in Tables 2 and 3 (for 2-storey structures) and Table 4 (for 3-storey structures). All of the calculations were performed according to the Turkish Seismic code. “√” sign denotes that the structure is safe according to the code, and “X” sign denotes that the structure is not safe. The model images of the buildings are given in Figures 6–8.

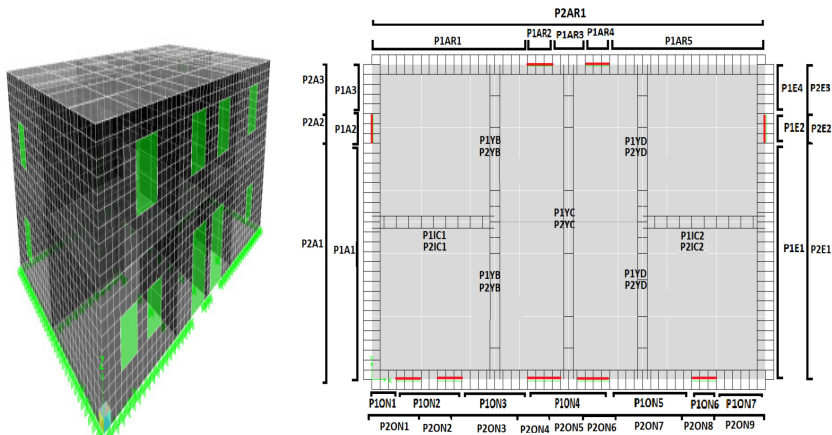
Figure 7: Image and plan of the 2<sup>nd</sup> model.

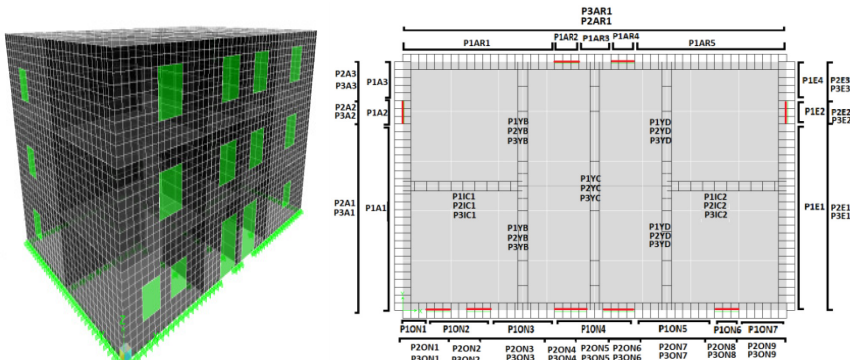
Figure 8: Image and plan of 3<sup>rd</sup> model.
