# NUMERICAL EVALUATION OF BARELY VISIBLE IMPACT DAMAGE IN A CARBON FIBRE-REINFORCED COMPOSITE PANEL WITH SHEAR LOADING

JAKUB ŠEDEK & PETR BĚLSKÝ

VZLU, Aerospace Research and Test Establishment, Prague, Czech Republic

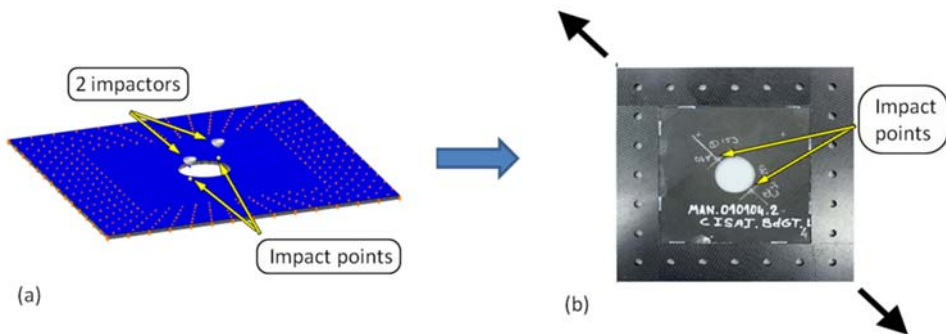
Figure 1: Two stages of strength evaluation of the panel with BVID. (a) Double low-velocity impact; (b) Shear loading.

The process of strength evaluation can be split into two stages, which are taken specifically from the simulation point of view. The first stage is double low-velocity impact ( $v = 10$  m/s) and the second stage is subsequent shear loading (see Fig. 1). Simulation can be taken also accordingly. Low-velocity impacts cause the development of a damaged zone in the vicinity of impact points and shear loading is applied to evaluate the strength influenced

The second phase of strength evaluation of the panel with BVIDs deals with shear loading. The panel is loaded so that BVIDs caused by impacts are situated in compression diagonal zones (see Fig. 1). In the second diagonal, tension loading appears. The principle can be easily understood from the idea of corner-loaded rectangular which is reinforced in diagonals. The diagonal perpendicular to the loading direction is loaded in compression and the diagonal parallel with loading is loaded in tension. The following paragraph demonstrates the behavior during shear loading of the panel without BVID.

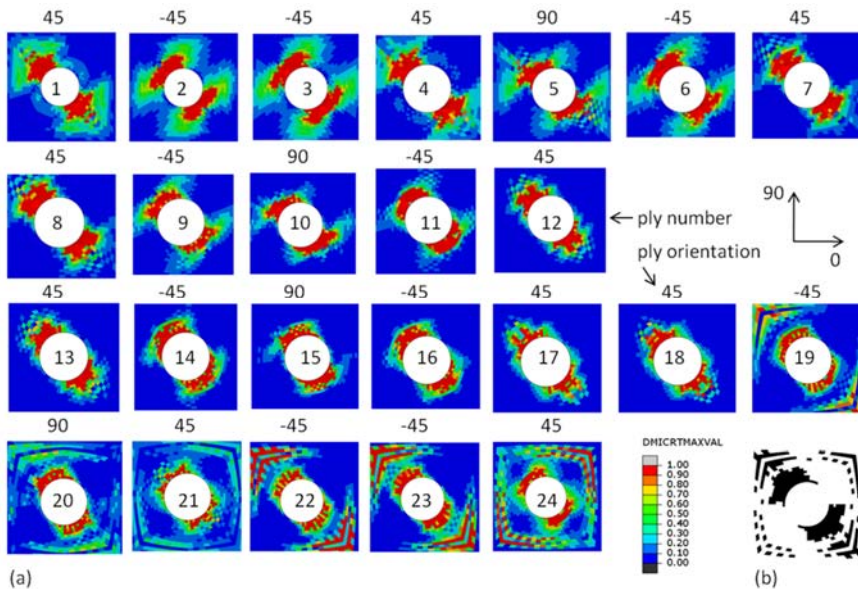
Figure 4: Damage of plies caused by two impacts evaluated by maximum damage initiation value (DMICRTMAXVAL); FE analysis. (a) Separate plies; (b) All plies together. Black color – DMICRTMAXVAL = 1.

Damaged zone in a ply can be evaluated by displaying maximum damage initiation value (DMICRTMAXVAL [16]) as shown in Fig. 4. In the top layers, damage develops mostly in the direction perpendicular to fibers, around the middle of the thickness damage is concentrated under the impact point and it is not spread further. In bottom layers, damage caused by the rectangular support is visible.

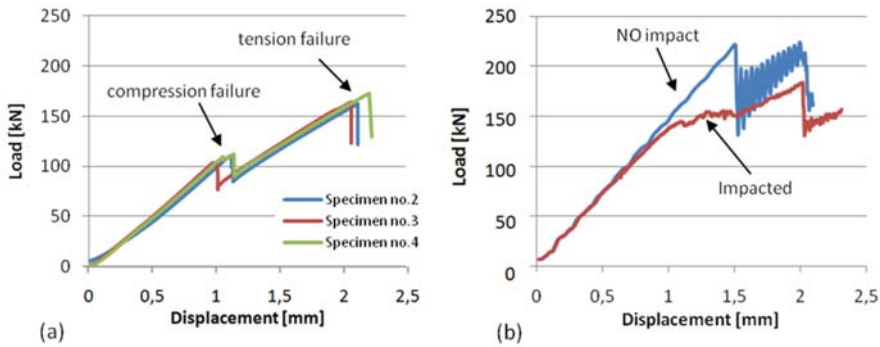
Figure 9: Load-displacement curves of composite panel. (a) Experimental results of impacted panels; (b) Results of FE analysis of impacted and non-impacted panels.
