Investigation into microstructural changes due to the rolling contact fatigue of the AISI M50 bearing steel

Abstract

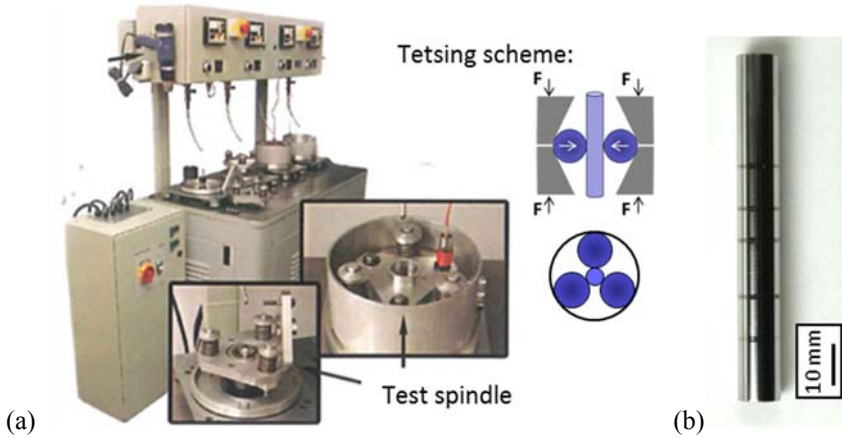
Figure 1: (a) BoR-tester with four test spindles and testing principle and (b) cylindrical specimen with five wear tracks.

The RCF tester with four test spindles and a scheme of the testing principle can be seen in Figure 1(a). The circular specimens have a diameter of $\varnothing 9.525$ mm and a length of 76 mm. The balls are made of M50 too and have a diameter of 12.7 mm. Figure 1(b) shows a specimen with five wear tracks. Experiments were stopped manually after a specific time of overrolling or carried out until failure, which means an automatic shut-down because of too high vibrations. In both cases the samples were examined metallographically to characterise potential damage and microstructural changes.

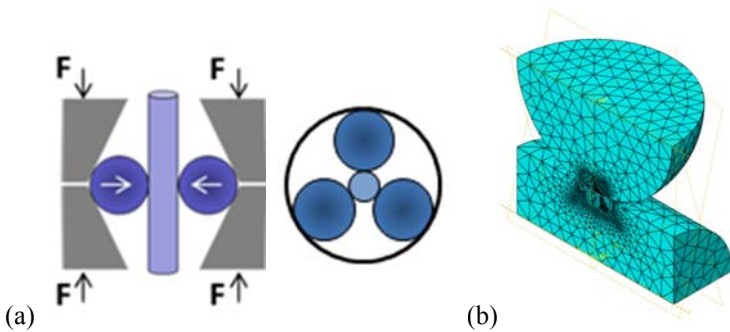
Figure 2: (a) Scheme of the testing setup in the BoR test and (b) quarter-model for the FEM analyses with ball on top and specimen below.

To estimate the stress distribution in the specimen, an analysis with finite element method (FEM) was made. The testing setup (Figure 2(a)) was transferred in an FEM model by the use of symmetric plains of the ball and specimen, so a quarter-model was created (Figure 2(b)). The modelling and linear-elastic calculation was performed in Abaqus 6.12 standard.

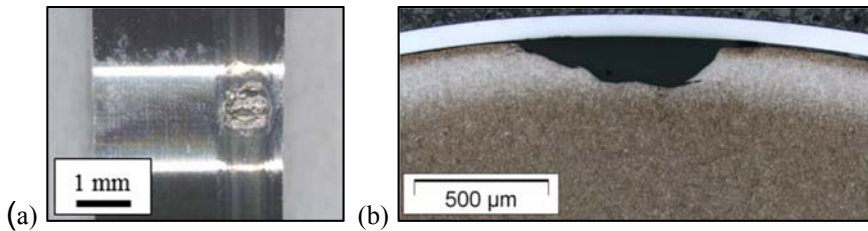
Figure 3: (a) Stereomicroscopic image of a wear track with pitting and (b) light optical micrograph of an axial cross-section trough the pitting after Nital etching.

In the performed BoR tests the lifetime of the specimens is limited by pitting, which is a spalling of material. Figure 3(a) shows a typical appearance of a pitting on a vertically wear track of approx. 1 mm width. An axial cross-section through the pitting after etching with Nital can be seen in Figure 3(b). The pitting has a depth of about 250 μm and the WEA is from about 25 μm to 300 μm . Pitting depths from approx. 70 to 350 μm were measured using confocal microscopy on various testing samples, which correlates well with the depth of the shear stress maximum. In Figure 4(a) the distribution and values of the shear stress using the FEM analyses of the BoR test is shown, whereas the shape of the WEA in a radial cross-section after Nital etching can be observed in Figure 4(b).

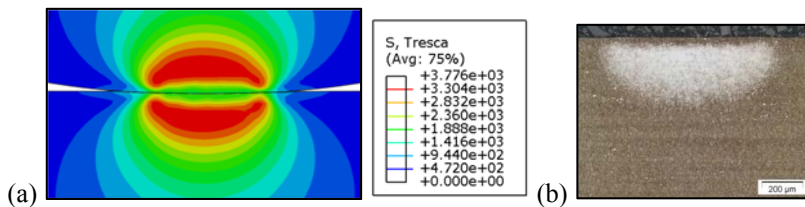
Figure 4: (a) FEM analyses of the shear stress distribution in ball (upper) and specimen (lower part) after Hertzian contact pressure of approx. 6.4 GPa and (b) light optical micrograph of a radial cross-section through the raceway after etching with WEA.

The comparison shows a good match of the FEM analyses with the zone of the WEA with a maximal shear stress of approx. 3780 MPa.

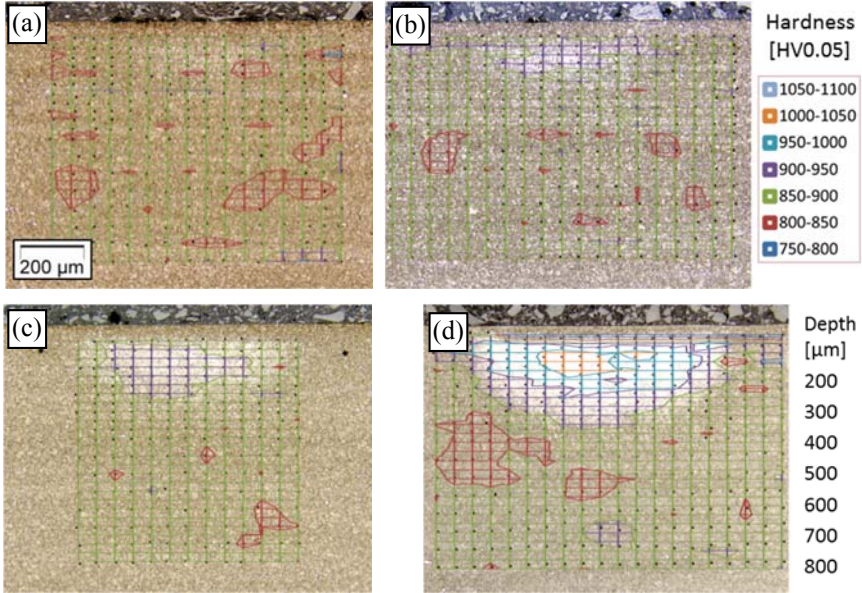
Figure 5: Optical micrographs on radial cross-sections through the raceway after etching and overlay with the hardness map after (a) 104, (b) 105, (c) 106 and (d) 1.9×10^8 overrollings.

The build-up of the WEA was investigated by radial cross-sections and hardness maps after defined number of overrollings as shown in Figure 5, with numbers of overrollings until test stop in (a) 10^4 , in (b) 10^5 , in (c) 10^6 and in (d) 1.9×10^8 . It was observed, that after 10^4 overrollings no WEA can be identified and the hardness remains constant at about 850 HV0.05, which is the initial hardness. With higher numbers of overrollings, a WEA develops with increasing width, depth, and also the intensity of etching contrast and the hardness in the WEA rises as shown in Figure 6. At the specimen with 1.9×10^8 overrollings a hardness of about 1050 HV0.05 was measured in the centre of the WEA. The shape of the WEA, which is similar to the half of an ellipse, can be explained by the shape of the Hertzian contact pressure, which is an elliptic curve with low values at the sides and a distinctive maximum in the middle of the contact area of cylinder and ball [1]. In addition, the specimen with 10^5 overrollings was investigated for existing BW, but none could be found on various longitudinal cross-sections.

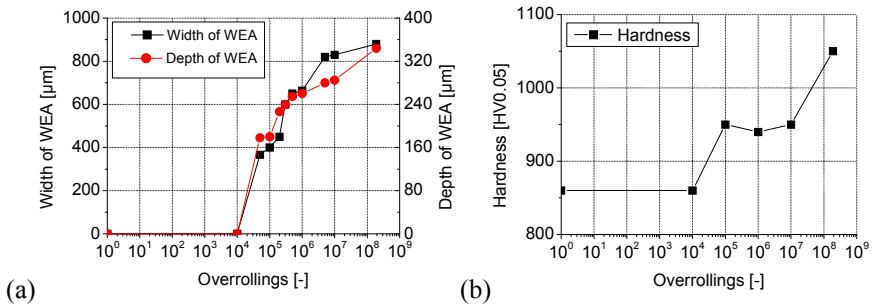
Figure 6: Increase of (a) width and depth of the WEA and (b) maximum hardness with increasing overrolling in the BoR test.

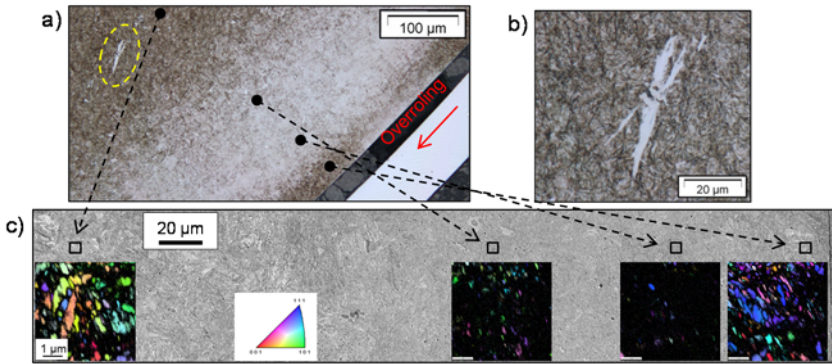
Figure 7: a) Optical micrograph of an etched longitudinal cross-section of a RCF specimen after 108 overrollings with WEA and BW (yellow mark). In b) an enlargement of the BW is shown. A SEM image of the WEA and EBSD analyses in the black squares can be seen in c).

An optical light micrograph of the axial cross-section after almost 10^8 overrollings can be seen in Figure 7(a). In addition to the WEA a BW can be seen in the upper left area (yellow dotted mark), which is enlarged in (b). A SEM

image of the WEA and four EBSD measurements in the black squares of $5 \mu\text{m} \times 5 \mu\text{m}$ is shown in (c). Due to the high cyclic plastification all areas show sections, where an indexing of EBSD pattern is not possible. Near the raceway, in a depth of approx. $10 \mu\text{m}$ the indexable amount is 34%, which decreases to only 5% at $60 \mu\text{m}$, before it increases slightly to 12% and 45% at $150 \mu\text{m}$ and $350 \mu\text{m}$ respectively. Moreover, by comparing the EBSD analyses at a depth of $10 \mu\text{m}$ and $350 \mu\text{m}$, it looks like an orientation of the grains near the raceway takes place.

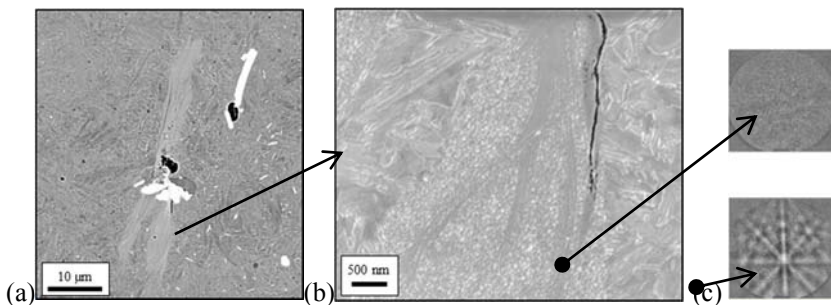
Figure 8: SEM images of the BW: (a) shows an overview and (b) a detail of the lower part, whereas in (c) EBSD patterns of the BW (upper) and the matrix (lower picture) can be seen.

A SEM image of the BW is shown in Figure 8(a), in which the wings can be identified by a slightly brighter contrast than the martensitic matrix. Micro-cracks were initiated and run on the upper and lower side of the BW near the boundary to the matrix. In the middle of the BW a cluster of MC and M_2C carbides can be seen, which acted as stress concentrators and led to a high accumulation of strain during the operation time. In higher magnification the nano-crystalline structure and also the micro-crack on the lower part of the BW is obvious (Figure 8(b)). In this micrograph the existence of a kind of doubling with martensitic matrix in-between the nano-crystalline structure on the lower part is clearly visible. In the BW no EBSD pattern can be identified due to the very small grain size of few nanometers, by contrast to the matrix with distinct Kikuchi patterns as shown in (c). The reason for the transformation into this nano-crystalline structure might be a low-temperature recrystallization due to the high cyclic strain around inhomogeneities, thus crystal point defects become stabilised as described by Grabulov in [10].

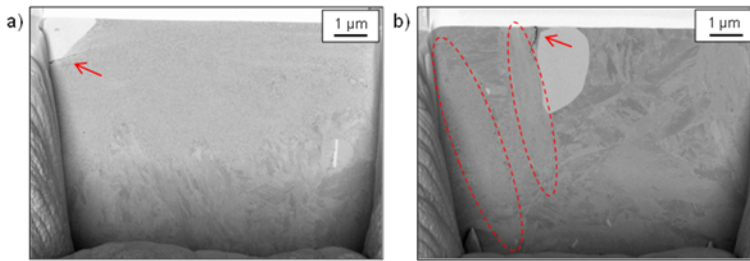
Figure 9: SEM images of the BW after FIB cuts in a) along and in b) across the BW. The red arrows show micro-cracks at the interface to carbides, where the dotted mark shows the two areas of the BW.

Figure 9 presents FIB cuts into the BW in which the nano-crystalline structure and micro-cracks near to M_2C carbides (red arrows) can be seen. In (a) the cut was made lengthwise into the BW and a curved shape of the boundary to the matrix was revealed. The FIB cut in (b) was performed crosswise to the BW and the double BW structure with martensitic matrix in between can be seen again (red dotted marks). The BW ends approx. in a depth of $7\ \mu\text{m}$ below the cross-section. Assuming the cross-section is exactly in the middle of the BW, this implies a height in axial direction of $\sim 14\ \mu\text{m}$ for the BW.

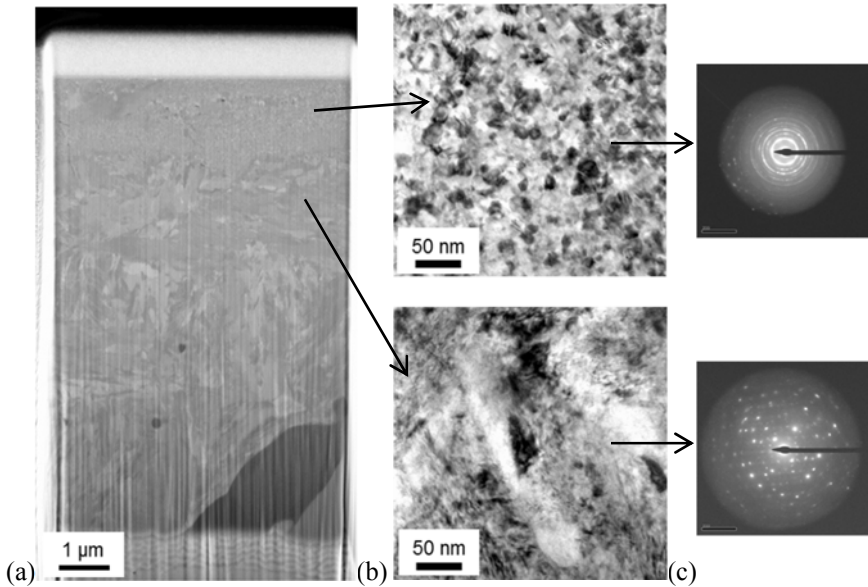
Figure 10: (a) SEM image of the prepared TEM lamella using FIB cutting and thinning with BW area in the upper right corner. In (b) a TEM image of the transformed, nano-crystalline structure (upper) and the matrix (lower picture) is shown, whereas in (c) the respectively diffraction patterns can be seen.

In order to investigate the nano-crystalline structure more precisely, TEM lamellas were prepared using FIB cutting across BWs. SEM images of these two lamellas are shown as an overview in Figures 10(a) and 11(a) with the nano-crystalline structures in the upper right areas. In Figures 10(b) and 11(b) TEM images in higher magnification of certain regions indicated by arrows, can be seen. It can be clearly seen, that a transformation of the martensitic matrix to grain sizes of few dozen nanometers takes place. Diffraction patterns are shown in Figure 10(c) with distinct dots in the martensitic matrix (lower picture), whereas in the BW area rings can be observed, because of the very small grain size (upper picture). The TEM lamella in Figure 11(a) is containing several carbides nearby the BW. In Figures 11(b) and 11(c) TEM images in different magnifications of two interfaces to carbides can be seen. In the upper picture no delamination of the interface occurred, but in the lower picture a debonded zone between the BW and the carbide is obvious (dotted line).

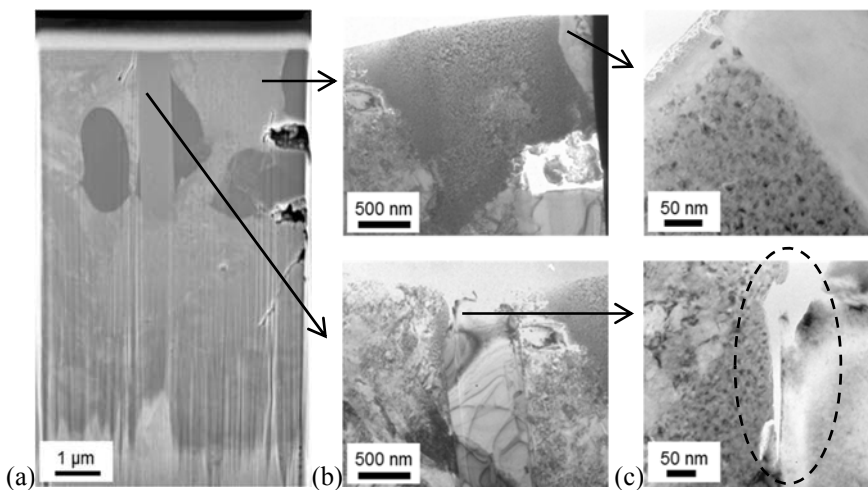
Figure 11: (a) SEM image of a TEM lamella of a BW with nearby carbides. In (b) and (c) TEM images of selected areas in different magnifications are shown, where partly debonded boundaries are shown (dotted line).
