# Hydrologic evaluation of flood flows from a burned watershed

A. W. Miller & E. J. Nelson Department of Civil & Environmental Engineering, Brigham Young University, USA

WIT Transactions on Ecology and the Environment, Vol 133, © 2010 WIT Press www.witpress.com, ISSN 1743-3541 (on-line) doi:10.2495/FRIAR100221

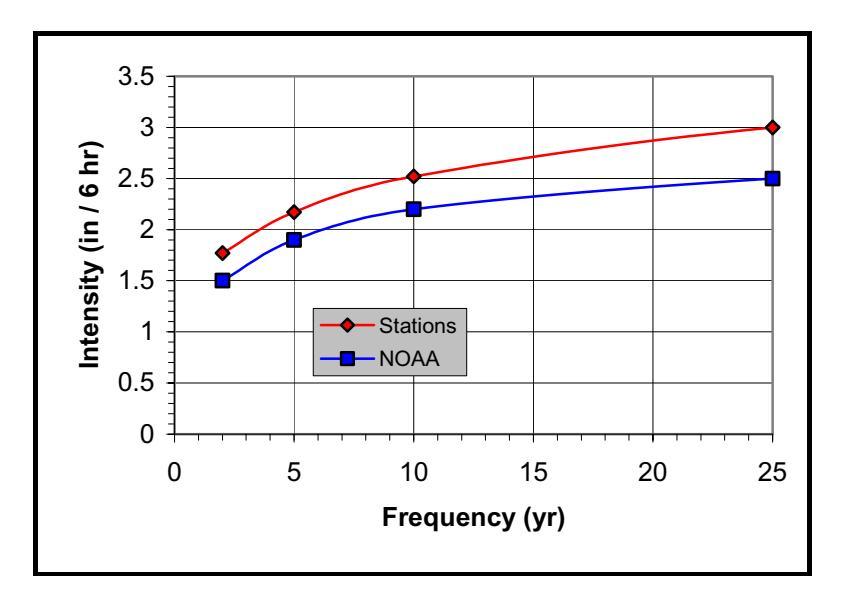
Figure 2: IDF curves for Mud Canyon.

Rainfall data for these stations are only daily totals, not hourly. However, according to Leopold [8], storms in this region are generally short and intense during the summer season, so it was assumed that a single storm generally lasted less than six hours. The average intensities (inches (mm) / 6 hrs) and frequencies of these stations were used to create the IDF curves shown in figure 2.

The second method used precipitation values from the NOAA Atlas 2 maps from [3]. These maps indicate how much precipitation is expected for a given frequency and storm duration for a given geographic region. The maps are derived for a 6-hour duration and frequencies of 2, 5, 10, 25, 50, and 100 years. The IDF curve derived from these values is also shown in figure 2, and compares well with the curve derived using historical data.

The results of this analysis showed that the total rainfall required to produce a peak flow of 1620 cfs (45.9 cms) was about 1.6 inches (40 mm) and for 2700 cfs (76.5 cms) was about 2.1 inches (53 mm). On both IDF curves (figure 2), 1.6 inches and 2.1 inches of rain correspond to about a 10-yr return period, or less.

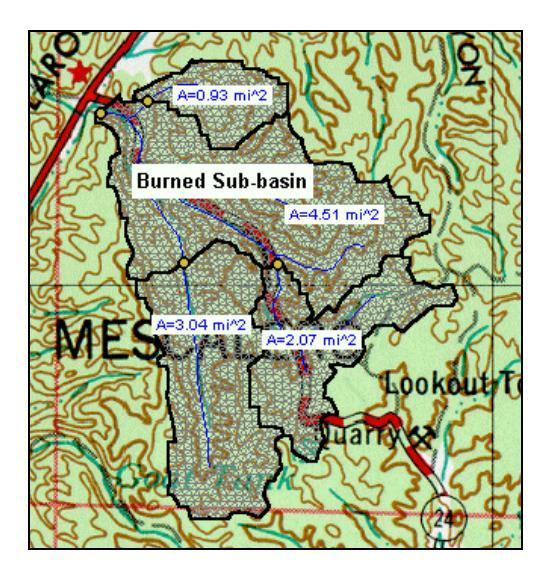
A digital elevation map (DEM) was obtained from the Bureau of Indian Affairs' geographic data center in Colorado. The portion of the DEM containing Mud Canyon Basin was extracted and these elevation data were used by WMS to delineate sub-basin boundaries shown in figure 3. Once the watershed boundary was delineated, geometric parameters for Mud Canyon Basin were computed.

Figure 3: Sub-division of Mud Canyon into burned and unburned basins.

Mud Canyon Basin was further subdivided (figure 3) so that different parameters could be assigned to the burned and unburned areas. The natural sub-basin drainage boundaries were closely aligned with the burned regions. The BAER team reported [1] that the burned region covered approximately 42% of the basin whereas the burned sub-basin in figure 3 covers 45% of the watershed.

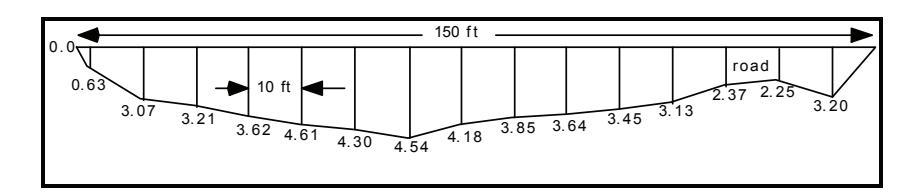
The cross section at the mouth of Mud Canyon used to calculate conveyance parameters in Manning's equation was surveyed and is shown in figure 4. The cross sectional area was 490 ft<sup>2</sup> (45.5 m<sup>2</sup>) and the wetted perimeter was 160 ft (48.4 m). The channel and floodplain upstream slope was surveyed and found to

Figure 4: Stream channel cross-section near the mouth of Mud Canyon (feet).

be about 2.5%. The range of flood flows was calculated based on a range of Manning's roughness coefficients from Maidment [11] for floodplains with flow depths into the tree branches of 0.09 to 0.15. The flow at n = 0.09 was 2700 cfs (76.5 cms) and flow at n = 0.15 was 1620 cfs (45.9 cms).

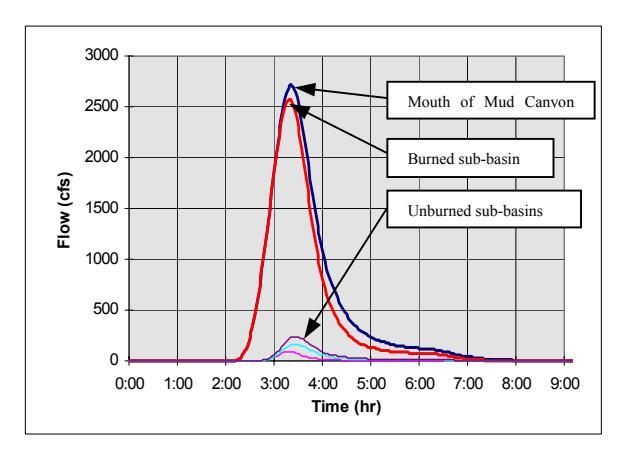
The hydrograph in figure 5 shows that of the 2683 cfs (76 cms) (table 3) produced by the 2.1 inches (53.3 mm) of rain, about 2500 cfs (71 cms) was contributed by the burned sub-basin alone. In other words, less than 50% of the basin produced about 95% of the total peak flow. This was verified by Curtis

Figure 5: Hydrographs of entire Mud Canyon and sub-basins.
